VESSEL INSPECTION SUMMARY

Report #: **141136-PM-14**
Inspect Date: 01/26/2010
Page: 1 of 4
IRISNDT #: 141136

Client: Cnrl District: St. Albert Field: Byemoor
Facility: 08-32-034-17W4 Unit / Skid #: N/A LSD: 08-32-034-17W4
Jurisdiction #: A0225183 Equip Tag #: N/A Serial #: 85C339007
CRN #: F1578.2 Nat'l Bd #: N/A Year Built: 1985
Manufacturer: Alco Gas & Oil LTD. Equipment Description: Glycol Accumulator
Status: In - Date Removed From Service: Service: Sweet
MAWP Shell: 150 Psi @ 150 °F Height/Length: 1955 mm Code Stamp: ☒ Y ☐ N
MAWP Tube: @ Size/Diameter.: 324 mm O.D. Insulated: ☐ Y ☒ N
MDMT: °F RT: RT-3 Volume: PWHT: ☐ Y ☒ N
Support Type: Skirt Manway: ☐ Y ☒ N
C.A.: 1.58 mm Coated ☐ Y ☐ N Clad: ☐ Y ☐ N J.E.: _____

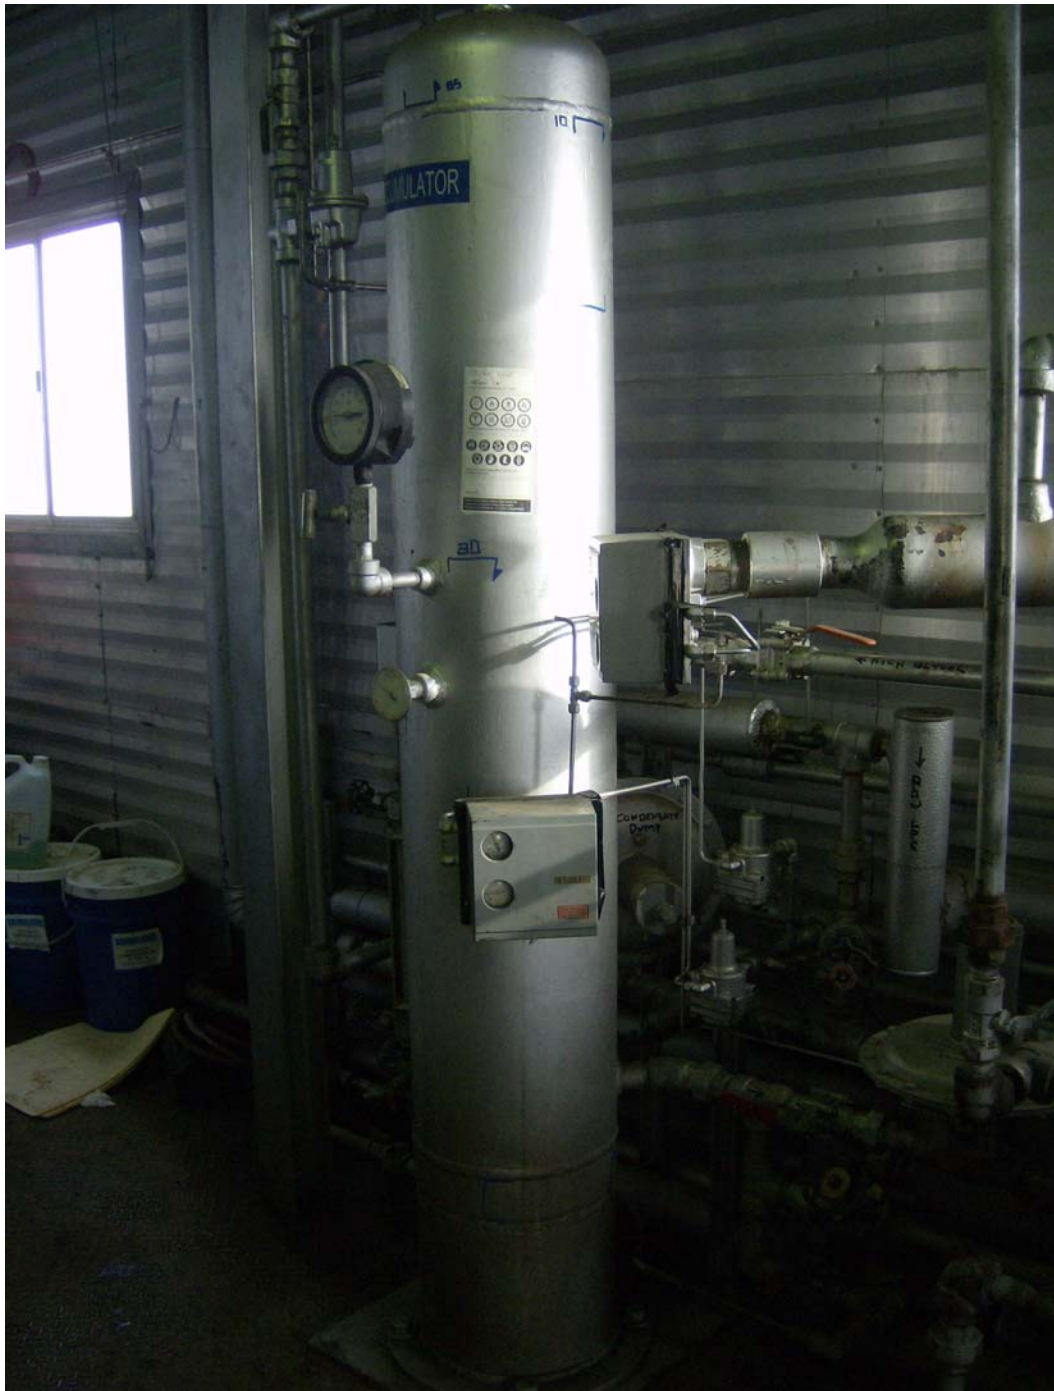
A0225183_Overview_26Jan2010

- Where exposed all piping, flanges and bolting were in good condition.
- The vessel is supported by skirt bolted to skid floor. Vessel is secure and level.

- The vessel appears to be in good operating condition for continued service based on the external visual observations and UT thicknesses recorded.

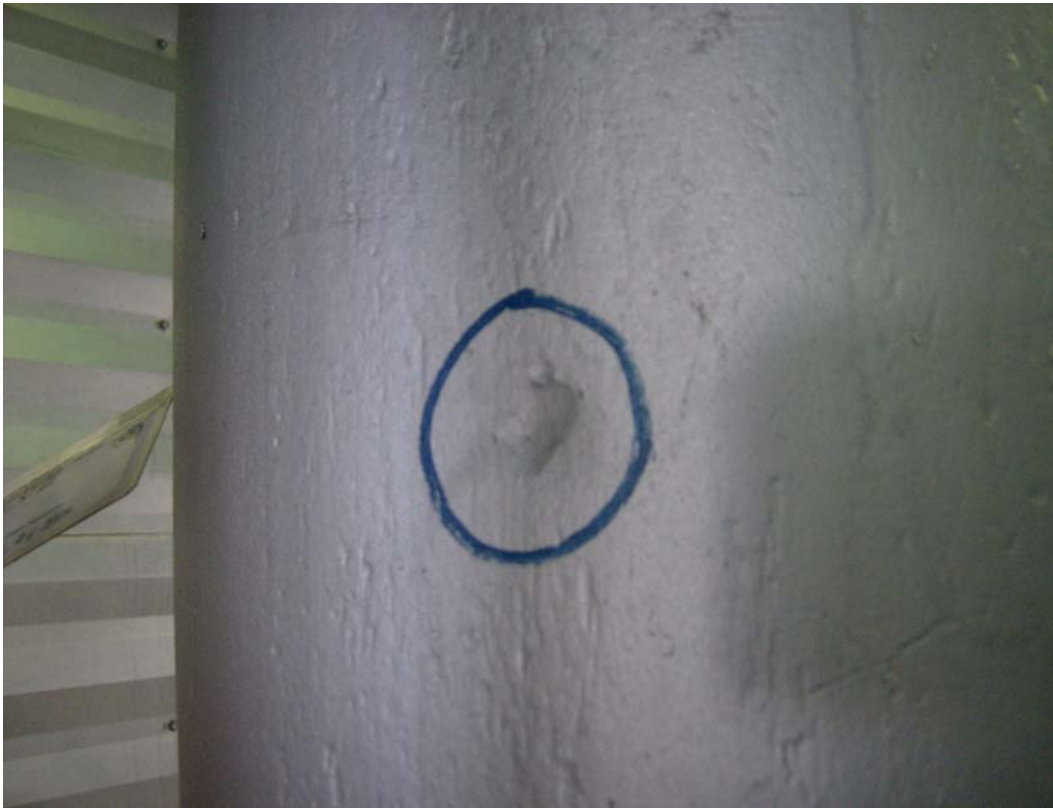
- The vessel was operating at time of inspection. No process leaks or vibrations were noted..
- The paint is on shell and piping in good condition and it is noted that shell has had previous external corrosion that has been painted over. An external pit on upper north shell has been painted over. Pit is approximately 0.250" in diameter and 0.100" deep. UT reading were taken around area and no internal corrosion was detected.

A0225183_Previousexternal pit painted over_26Jan2010

- Continue to inspect vessel at regular scheduled intervals.
