**Canadian Natural Resources Ltd.
GENERAL PRESSURE VESSEL INFORMATION**

Job# 105.00390

District: Fort St John, BC		Skid No.				
Facility: Ladyfern Compressor		Location (LSD): b-88-H/94-H-01				
Vessel Name Equipment Number: Inlet Separator // V 310						
Orientation: Horizontal						
Status: In Service			Regulatory Inspection			
PRESSURE VESSEL NAMEPLATE DATA						
"A" or "G" or "S" (Sask.) or BC Registration Number. A0462558			CRN Number: P-5003.2			
Vessel serial number: 01129-101			Size: 6' X 20'			
Shell thickness: 76.2mm			Shell material: SA-516-70			
Head thickness: 76.2mm			Head material: SA-516-70			
Tube wall thickness:			Tube material:			
Tube diameter:			Tube length:			
Channel thickness:			Channel material:			
Design pressure	Shell: 9930 Kpa		Operating pressure	Shell: 0 Kpa		
	Tubes:			Tubes:		
Design Temp.	Shell: 38 deg C		Operating temperature	Shell: 0 deg C		
	Tubes:			Tubes:		
X-ray: RT-1			Heat treatment: Yes			
Code parameters: ASME Sec VIII			Coated: No			
Manufacturer: Propak Systems Ltd.			Year built: 2001

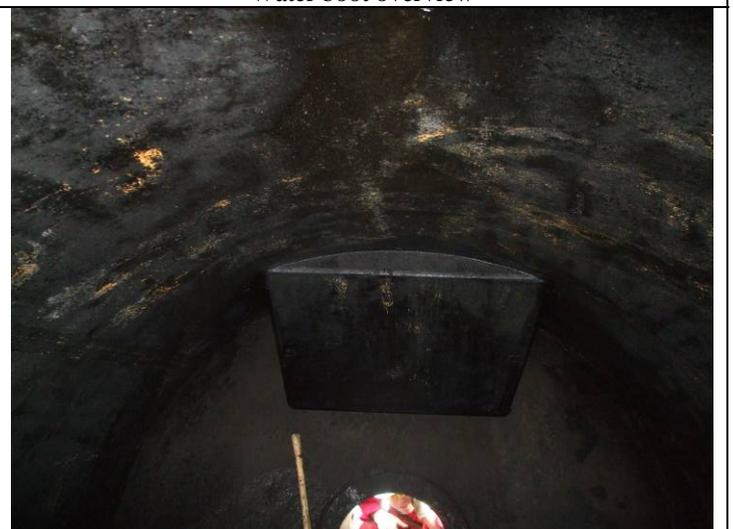
Top shell overview

Shell Sections Record number of shell sections. Record location, size and depth of all erosion, corrosion or mechanical damage. Describe general condition. If any corrosion greater than corrosion allowance is observed in either shell or head, discuss with Chief Inspector before closing vessel.	X				As best effort inspection performed, Vessel was not completely clean. Three shell sections were found to form this vessel & it is in good overall condition. No corrosion or erosion was found. No service related damages noted.
Demister Pad If present, describe condition and location.	X				Old demister pad was heavily fouled; it was replaced with a new one.
Heat Medium Coil Note all corrosion, erosion or mechanical damage.				X	None.
Fire Tube Note all corrosion, erosion or mechanical damage. Take thickness readings on selected areas of tube and carry out Magnetic Particle Inspection on flange to tube welds.				X	No fire tube was noted inside this Separator.

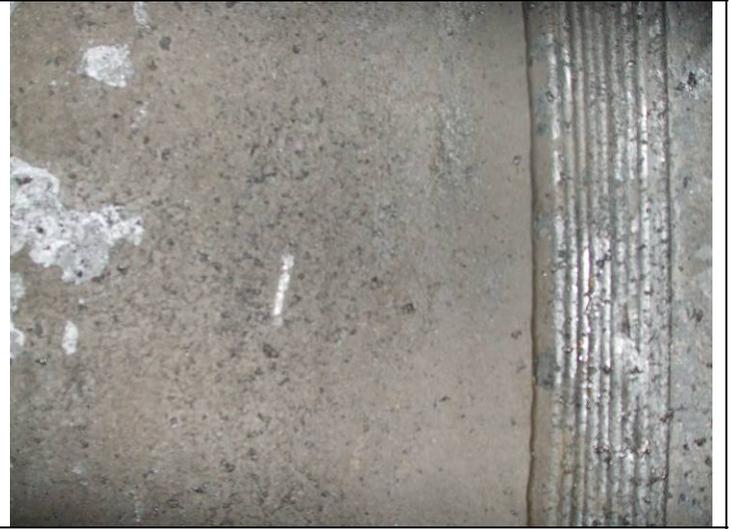
Inlet circ weld

Welds Inspect all welds, including attachment welds. Record all service-related damages and if there is any discuss with Chief Inspector before closing.	X				As best effort inspection performed; All visible welds appear to be in good overall condition. No mechanical damage, corrosion or erosion was detected.
Repairs Required. If yes, ensure procedure and copy of AB 40 is on file, and one sent to local ABSA, and Chief Inspector				X	None.
NDE Was any NDE done. (MI coordinator to review results) Include tubular inspections in document and results.	X				No internal NDT inspection was performed.
<p>Recommendations or corrective actions: Vessel is Fit for Service or describes corrective actions required). (MIC to review corrective actions with Operations, discuss with Chief Inspector where necessary, and get remedial action implemented)</p> <p>Other Observations:</p> <p>Recommendations: 1. No recommendations at this time.</p> <p>Summary: This Inlet Separator is in good over all condition, visual internal / external carried out – no metal thickness was detected below nominal in the shell.</p> <p>Vessel is fit for service.</p>
