Pressure Equipment Static Data

Pressure Vessel Internal Inspection

Date:	September 14, 2021	Equip Name:	Glycol Reboiler
Inspector:	Armando El Sayed	Prov #:	N/A
Client/Owner:	CNRL	S/N:	N/A
District/Region:	Fort St. John Central	Unit /Skid #:	N/A
Area:	LadyFern	Equip #	C73746
Facility:	Plant	Location:	Surface: b-17-I/94-H-1
			UWI/DH: b-17-I/94-H-1
Component	Condition	Comment	
Shell	Acceptable	The shell is in good condition, no corrosion or pitting noted. Material scale was cooked on the side of the shell, no corrosion noted under the material scales.	
Heads	Acceptable	The west head and the firetube cover plate are in good condition, no corrosion or pitting noted.	
Manway	N/A		
Nozzles	Acceptable	All the internal nozzles are in good condition, no concerns noted.	
Gasket Surfaces	Acceptable	The firetube opening gasket surface is found in good condition, no corrosion or mechanical damage noted.	
Internals	N/A		
Welds	Acceptable	All the visible weld seams have full profiles, no concerns noted.

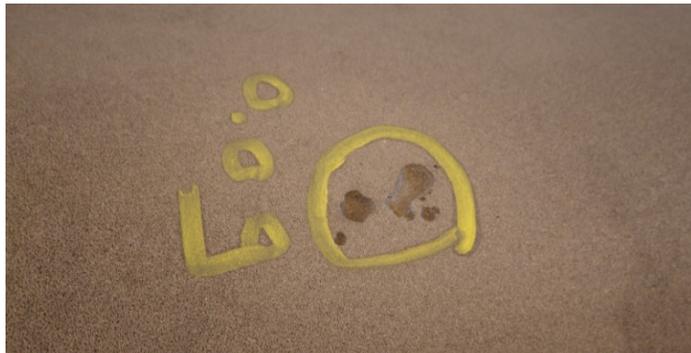
Coating	N/A		
Firetube	Concern	Corrosion and pitting noted in the fire tube hot side pipe starting 40" from the cover plate. The pitting depth is between 0.05" and 0.130", where the nominal thickness is 0.375". And Pitting noted in the miter section, pitting depth is between 0.01" and 0.07". The pitting have sharp edges and have groove shape.	
Tubesheet	N/A		
Tube Bundle	N/A		
Other	Acceptable	The deflector plate on the west head and the still stack are in good condition, no concerns noted.	
NDE Methods	Acceptable	UT and BWMPI were performed on the fire tube.	
Inspection Summary	Corrosion and pitting noted in the fire tube hot side pipe starting 40" from the cover plate. The pitting depth is between 0.05" and 0.130", where the nominal thickness is 0.375". And Pitting noted in the miter section, pitting depth is between 0.01" and 0.07". The pitting have sharp edges and have groove shape.		
Recommendations		NCR #

Pitting noted in the Firetube Hot Side Pipe

Monitor the corrosion in the firetube and Be prepared to repair the firetube at the next shutdown.

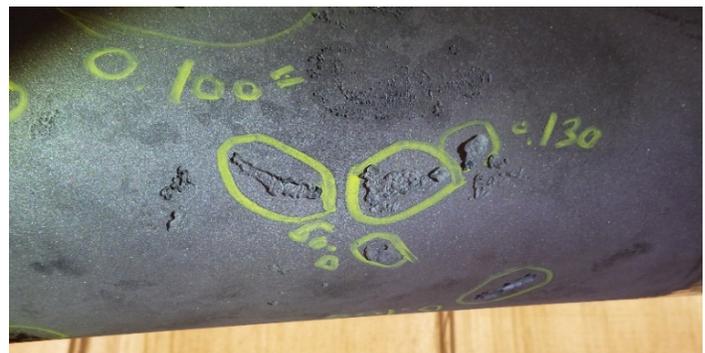
Pitting noted in the Firetube Hot Side Pipe

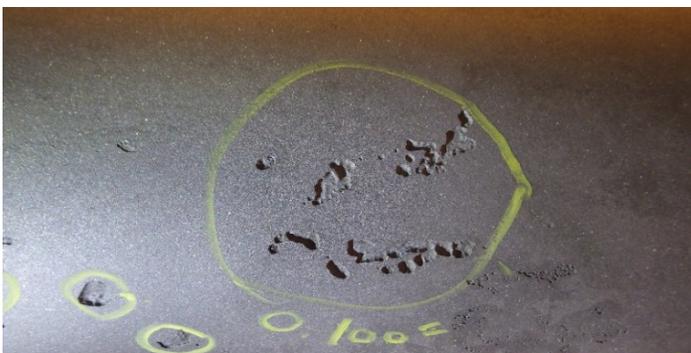
Pitting noted in the Firetube Hot Side Pipe

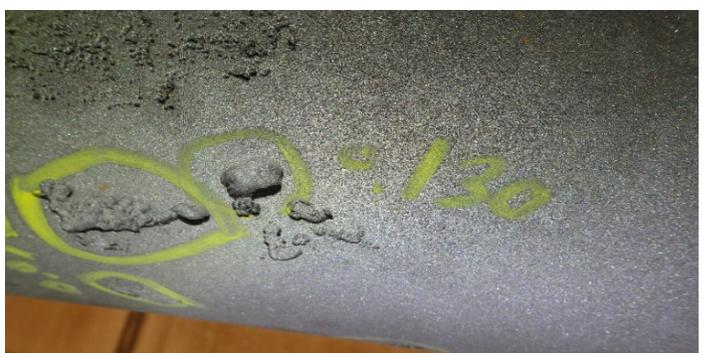
Pitting noted in the Firetube Hot Side Pipe

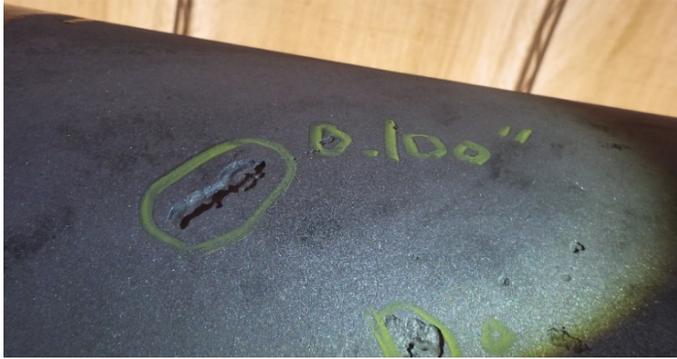
Pitting noted in the Firetube Hot Side Pipe

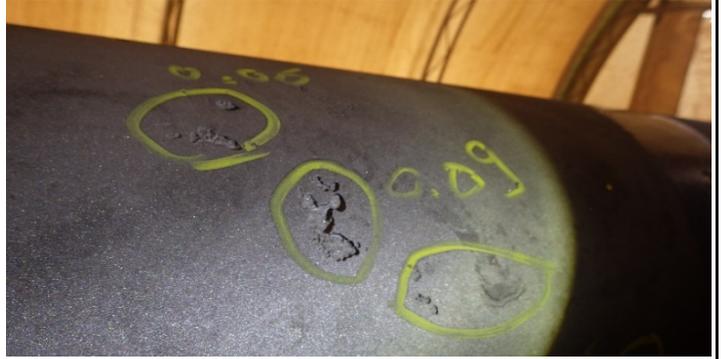
Pitting noted in the Firetube Hot Side Pipe

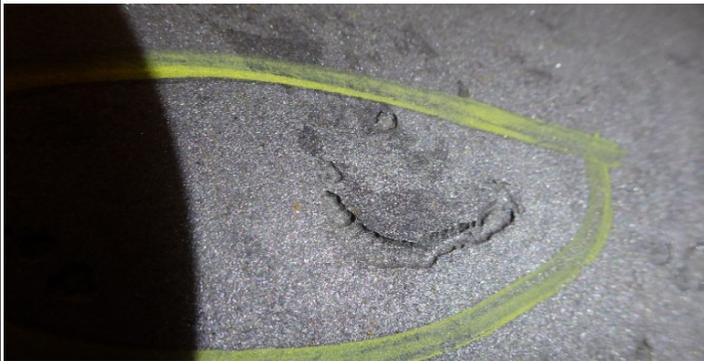
Pitting noted in the Firetube Hot Side Pipe

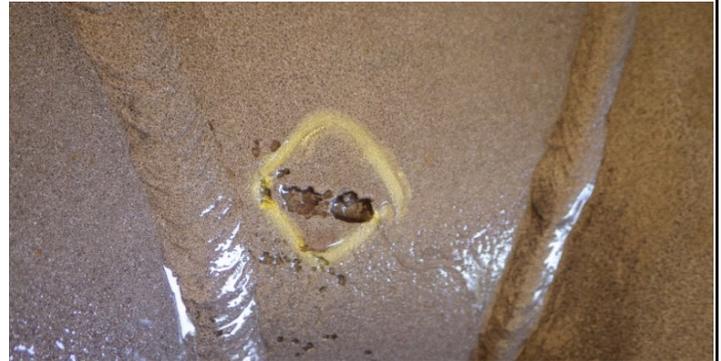
Pitting noted in the Miter Side

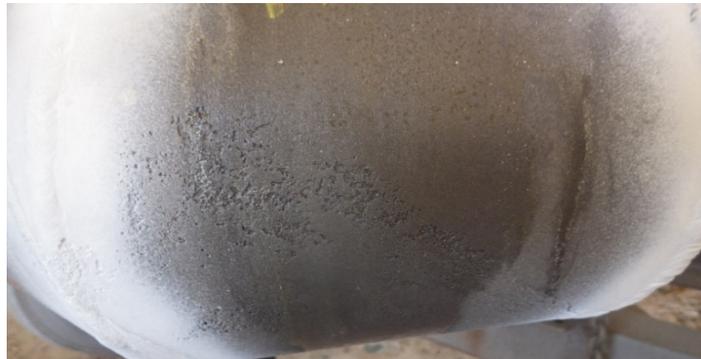
Pitting noted in the Miter Side
