# Mountain West Services Ltd.

## Field Inspection Report - CNRL 475023\_6/5/2011\_VT\_External

<b>Vessel Number</b>	475023	<b>Vessel Name</b>	SEPARATOR	<b>Province</b>	Alberta
<b>District</b>	WEST COUNTY	<b>LSD</b>	02-03-075-11W6	<b>Location</b>	VALHALLA
<b>Method</b>	VT	<b>Access</b>	External	<b>Cleaning</b>	Good
<b>Inspection Date</b>	6/5/2011	<b>Inspection Interval</b>	60	<b>Next Inspection</b>	6/5/2016
<b>CRN</b>	P2421.2	<b>Skid Number</b>	SKID0223	<b>Service</b>	Sour
<b>Manway</b>	NO	<b>Coating</b>	False	<b>Status</b>	In Service
<b>MAWP (PSI)</b>	1440	<b>MAWP (Kpa)</b>	9928.51		
<b>MAWT (F)</b>	54.44	<b>MAWT (C)</b>	130	<b>Outstanding NCRS</b>	0

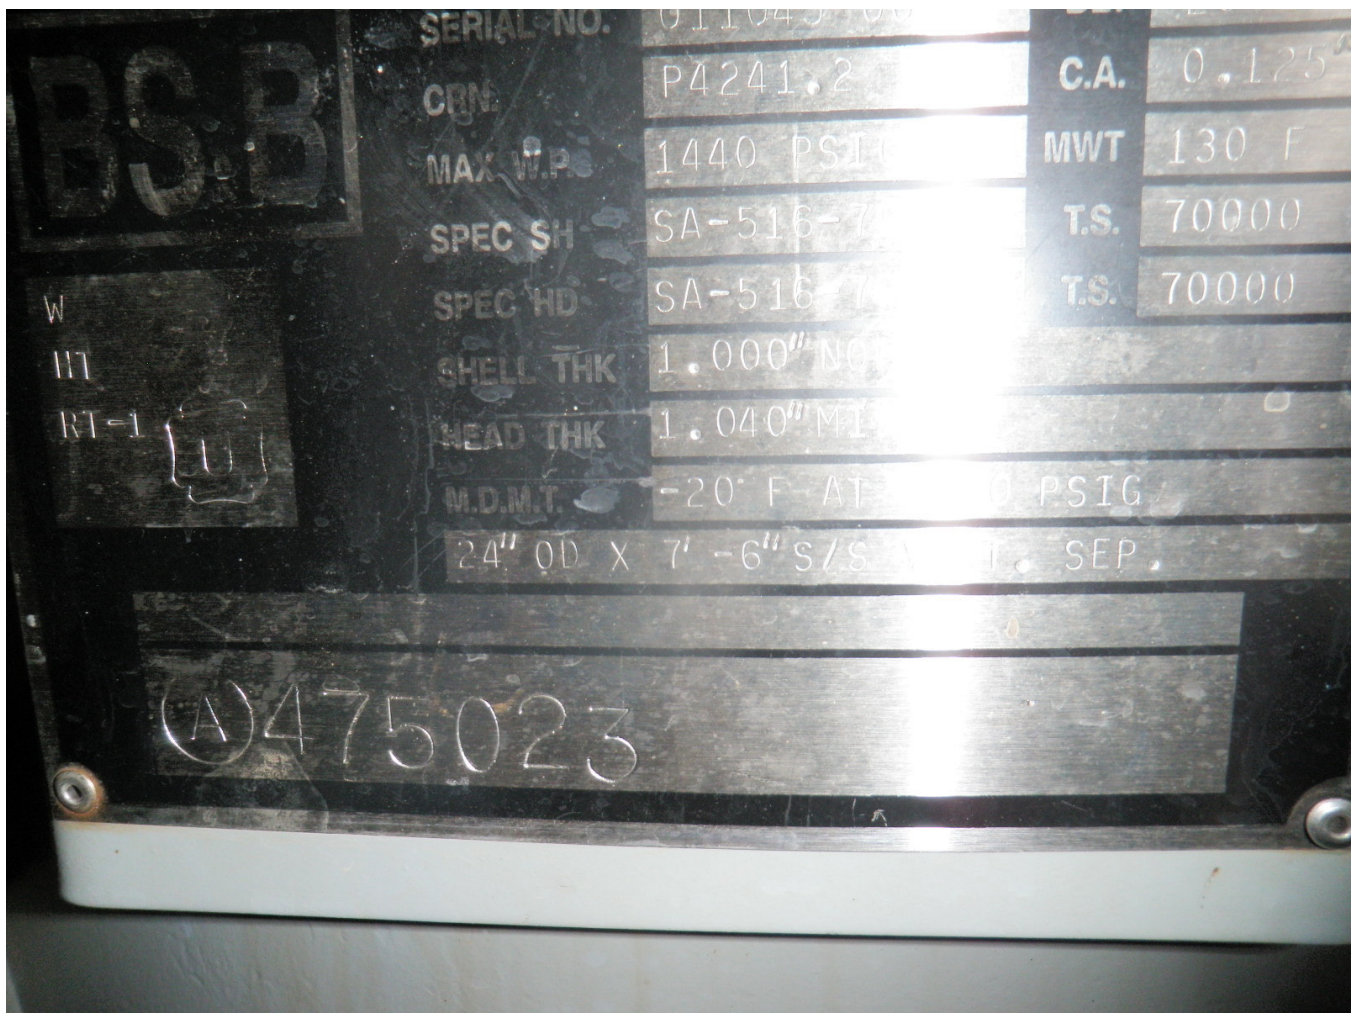
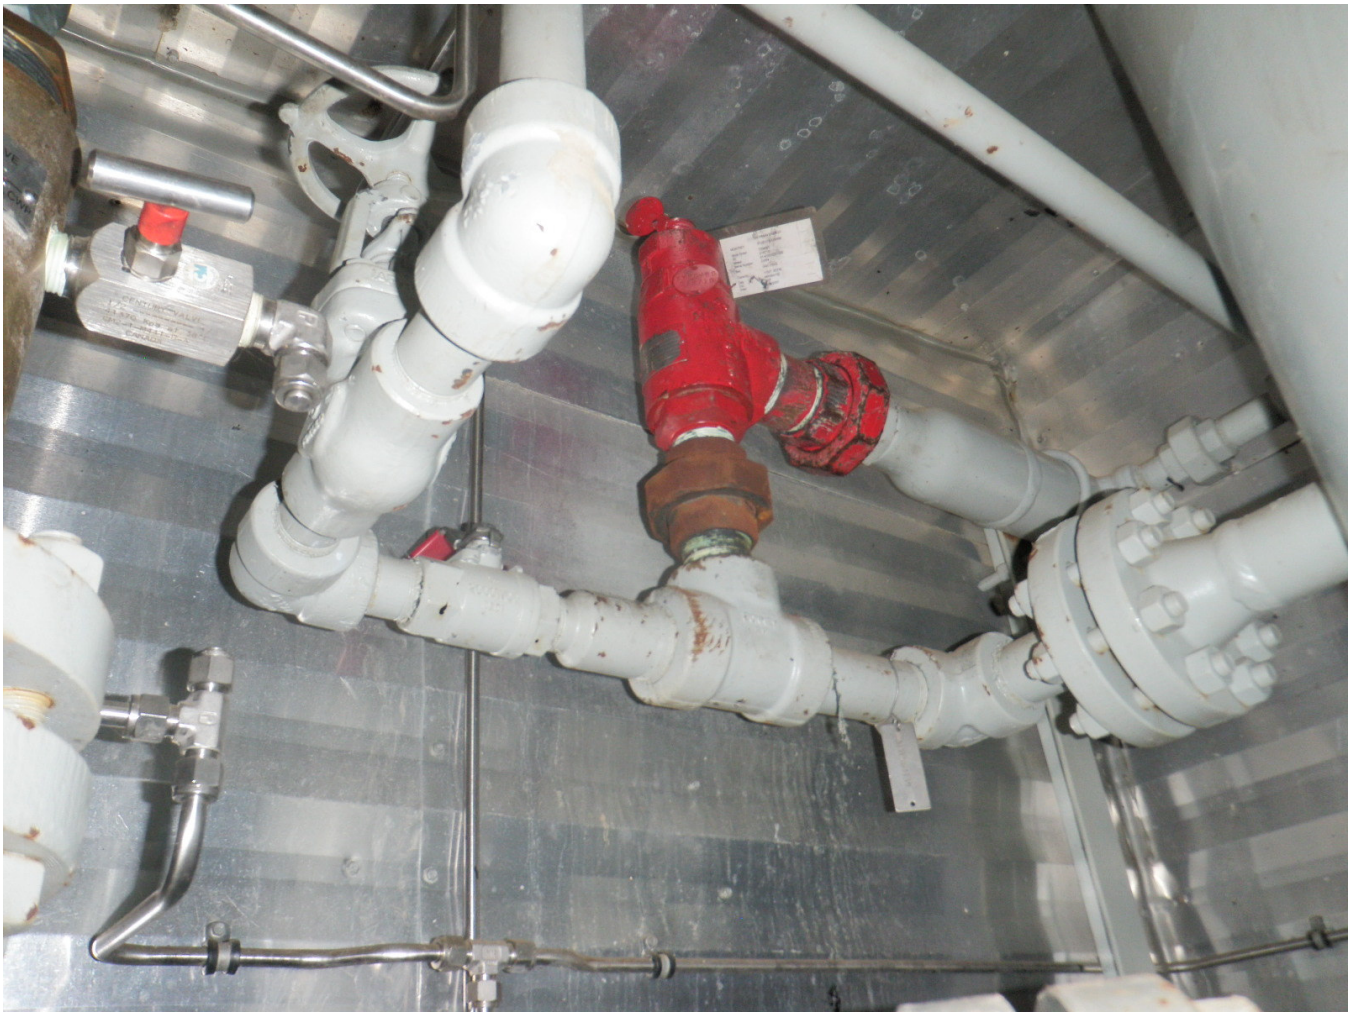
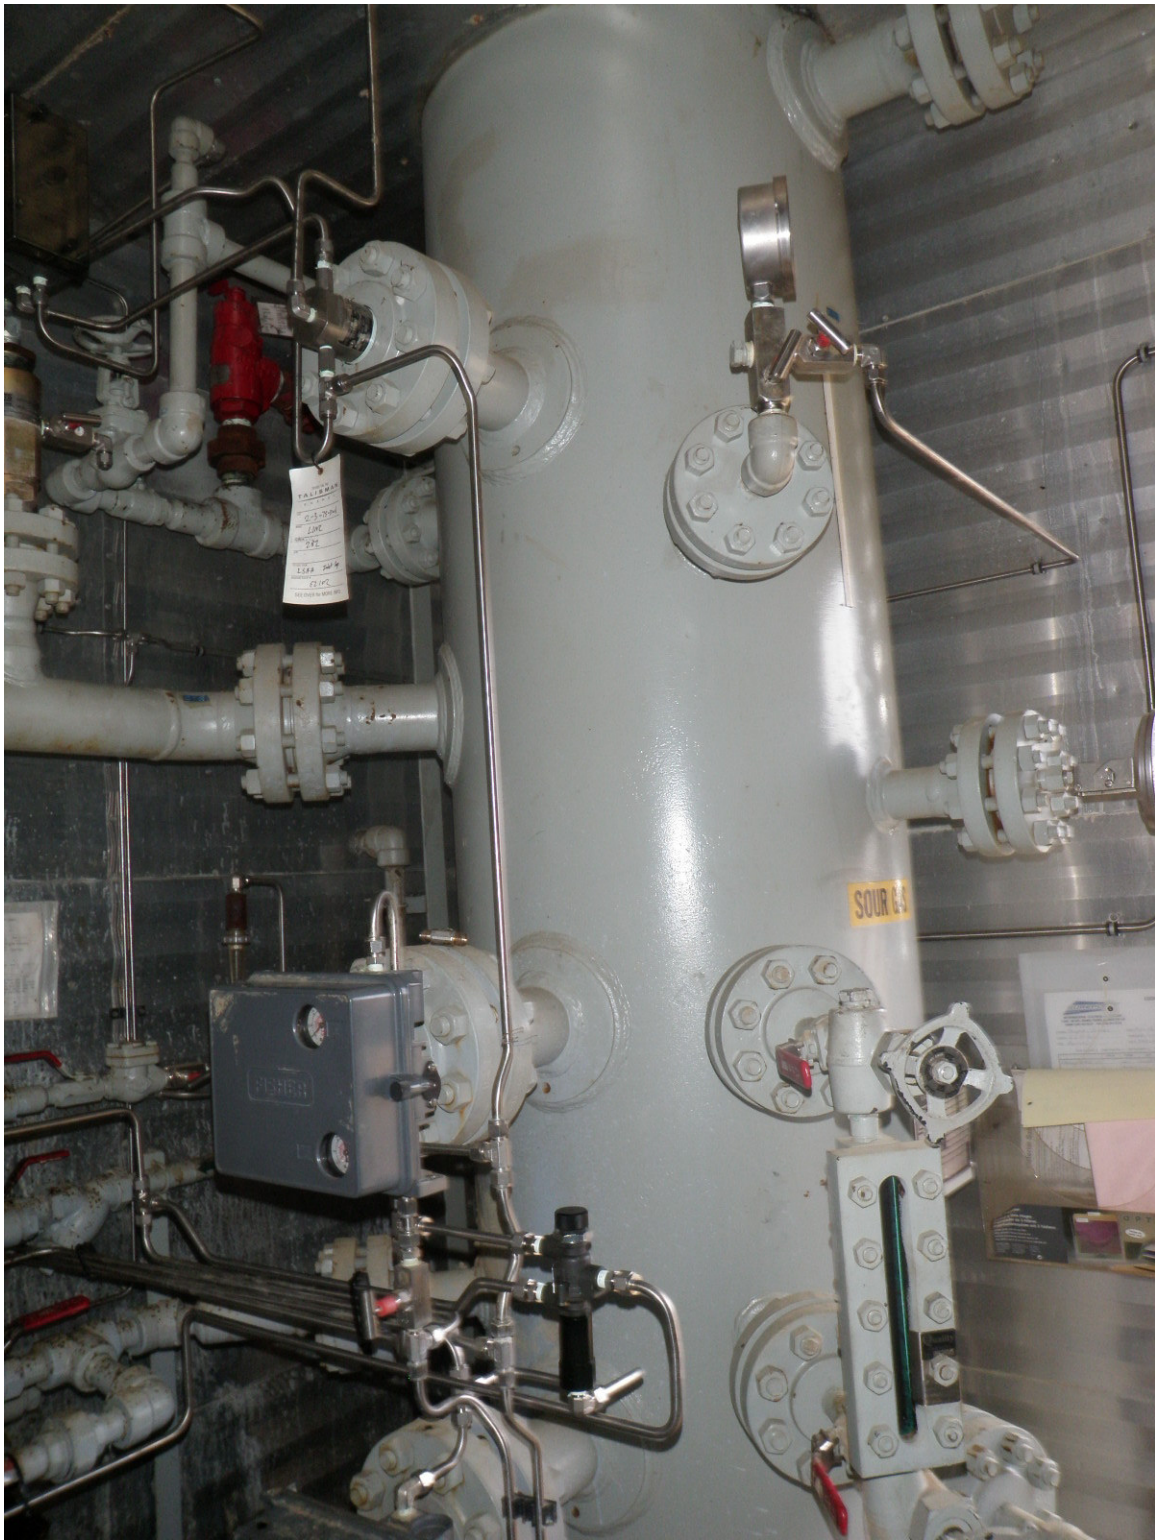
All visible shell surfaces and nozzles appear in good condition. Name plate is intact and legible. Vessel supports, foundation, electrical bonding and external coating appear good. Associated piping, supports and components appear in good condition and alignment with no signs of leaks or defects present at the time of inspection. PSV protection and PSV's are properly installed with any block valves locked/sealed open. PSV has correct code stamp and MWS tagging, and was last serviced within the required interval guidelines.
