**ConocoPhillips Canada
 GENERAL PRESSURE VESSEL INFORMATION**

District: Grande Prairie, AB	Skid No. 15197
Facility: Valhalla Oil & Gas Gathering	Location (LSD): 06-21-75-11 W6M
Vessel Name Equipment Number: Inlet Separator	
Orientation: Vertical	
Status: In Service	Regulatory Inspection: Yes

**ConocoPhillips Canada
GENERAL PRESSURE VESSEL INFORMATION**

District: Grande Prairie, AB	Skid No. 15197
Facility: Valhalla Oil & Gas Gathering	Location (LSD): 06-21-75-11 W6M
Vessel Name Equipment Number: Fuel Gas Scrubber	
Orientation: Vertical	
Status: In Service	Regulatory Inspection: Yes

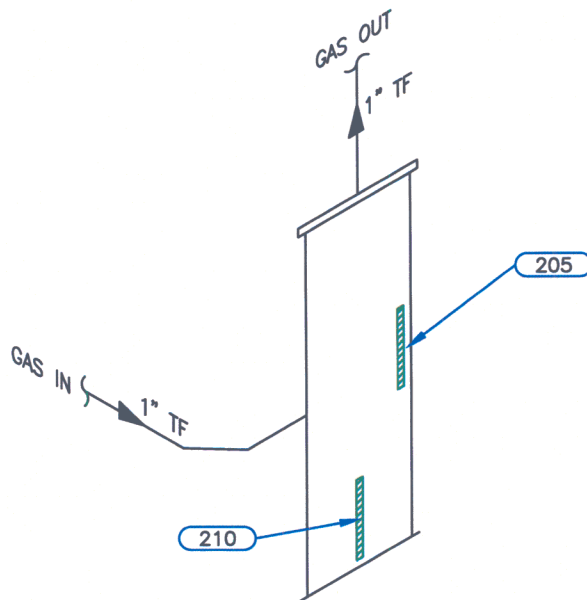
PSV DATA

MFG: FARRIS
 MODEL: 27DA23-M20
 SERIAL: 456869-60-KE
 SET PRES: 862 kPa
 CAPACITY: 306 scfm
 SERVICED BY: IPV
 SERVICE DATE: MAY, 2005
 SIZE: 0.75in x 1in
 CODE STAMP: UV
 BLOCK VALVE: NO
 CRN: OGO386.9C
 LOCATION: INLET PIPING
 TAG: 350

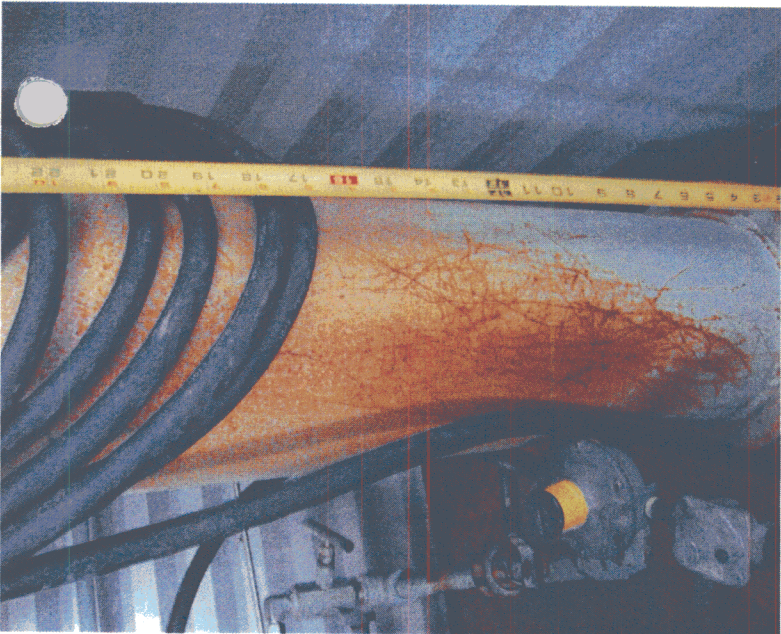
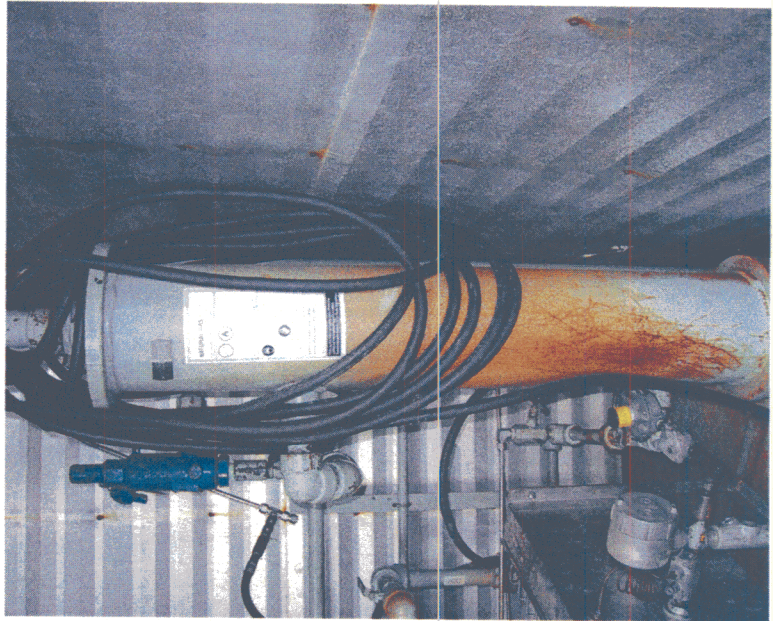
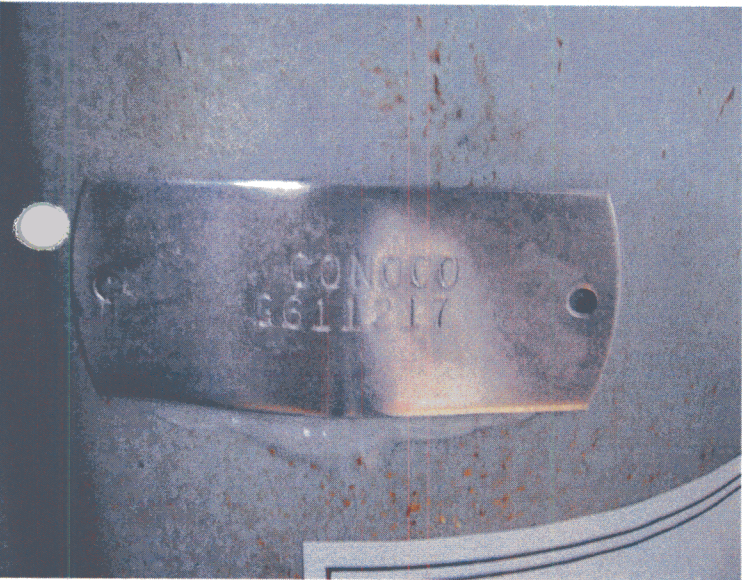
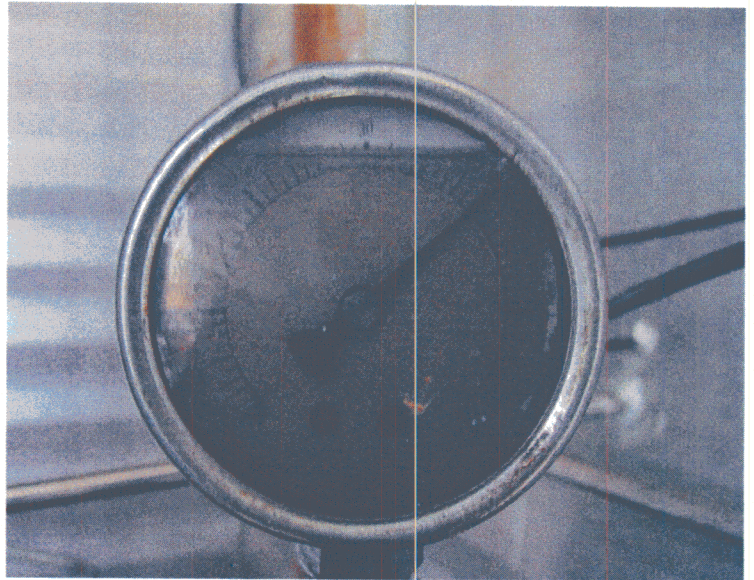
External Inspection Items	G	F	P	N/A	Comments
Insulation -Verify sealed around manways, nozzles, no damage present, and there is no egress of moisture.				X	
External Condition -Assess paint condition, areas peeling, record any corrosion, damage, etc (record location, size and depth of corrosion or damage)			X		...Oxidization occurring to approx. 60% of vessel. Light surface corrosion beginning to form where vessel paint is chipped or scratched (less than % of area)
Leakage -Record any leakage at flanges, threaded joints, weep holes on repads, etc.	X				...No leaks found.
Skirt/ Saddle -Assess condition of paint, fire protection, concrete. Look for corrosion, buckling, dents, etc. Look at vessel surface area near supports. Verify no signs of leakage at attachment to vessel and attachment welds are acceptable. Ground wire attached?		X			...Paint is in fair condition oxidization is occurring to approx. 10% of area. No dents or buckling.

Anchor Bolts -Hammer tap to ensure secure. Look for cracking in treads or signs of deformation.	X				...Welded to floor.
Concrete foundation -Check for cracks, spalling, etc.				X	
Ladder / Platform -Describe general condition, ensure support is secure to vessel, and describe any hazards.				X	
Nozzle -Assess paint, look for leakage, and ensure stud threads are fully engaged. Record any damage, deflection, etc. Are nozzles gusseted?	X				...Threads fully engaged.
Gauges -Ensure gauges are visible, working, no leakage, and suitable for range of MAWP/ Temp.			X		...Pressure gauge fluid is dark and cloudy with range from 0 to 60 psi.
External Piping -Ensure pipe is well supported. All clamps, supports, shoes, etc. in place. Look for evidence of structural overload, deflection, etc. Paint condition, external corrosion?		X			...Piping well supported with light brown oxidization occurring to approx. 10% of piping. Minor paint chips to approx. 5% of piping.

Valving -Ensure no leaks are visible. Valves are properly supported and chained if necessary.	X				...Thread engaged no leaks found.
PSV -Ensure PSV is set at pressure at or below that of vessel. Discharge piping is same size as inlet to valve and is properly supported and routed. Ensure no block valves between psv and vessel or if there are they are locked open.		X			...Assumed set at MAWP of vessel.
NDE methods -Was UT/ MPI done on vessel (MI coordinator to review results)	X				...Ultrasonic thickness survey carried out-No metal thickness detected below nominal minus corrosion allowance.
Other-					
Recommendations or corrective actions : Vessel is Fit for Service or describe corrective actions required) (MIC to review corrective actions with Operations, discuss with Chief Inspector where necessary, and get remedial action implemented) Recommend sandblasting and painting vessel. Vessel is fit for service.
