**Canadian Natural Resources Limited
GENERAL PRESSURE VESSEL INFORMATION**

District: Grande Prairie AB	Skid No.
Facility: Wembley Gas Gathering	Location (LSD): 14-31-73-09-W6M
Vessel Name Equipment Number: Line Heater	
Orientation: Horizontal	
Status: Not In service	Regulatory Inspection

Photo Table

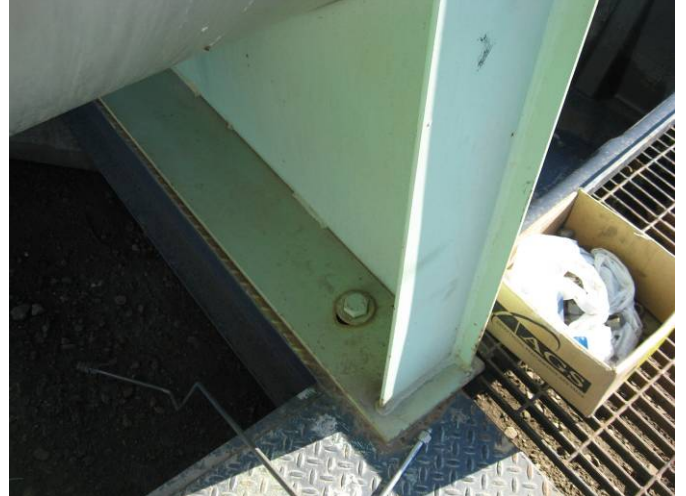
Saddle bolting to skid

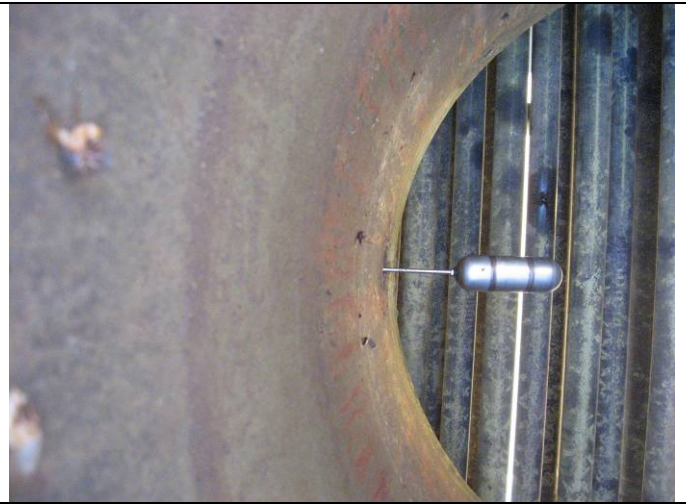
Expansion tank over view and top side of tubes

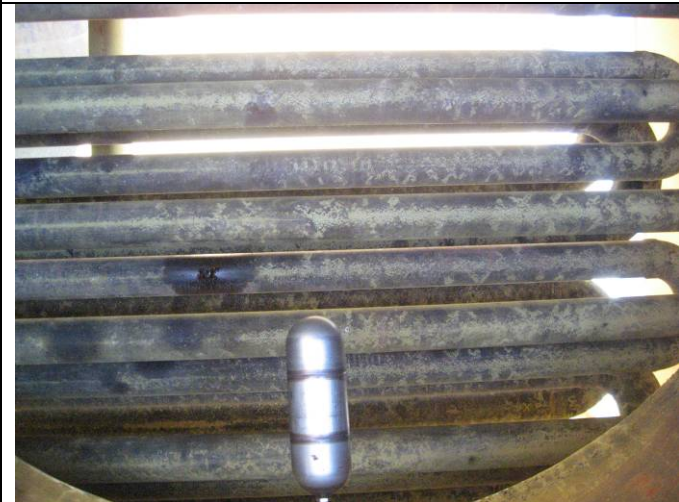
Glycol low level float inside expansion tank

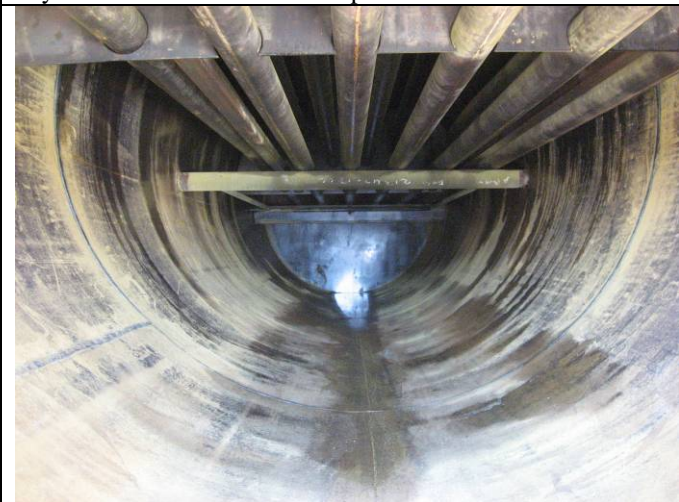
Over view of internals

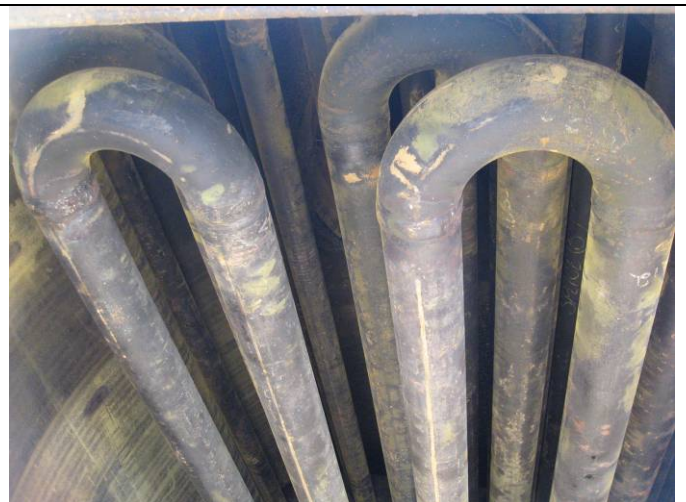
Gas coil return bends

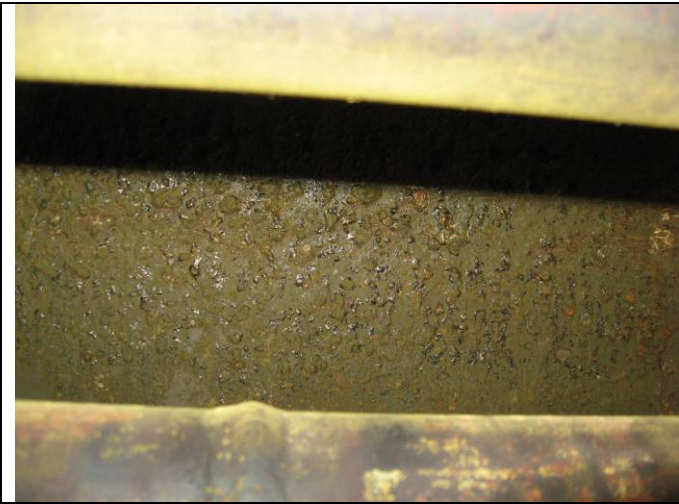
Shell at 12:00 position – light scaling in vapor space – no measureable pitting.

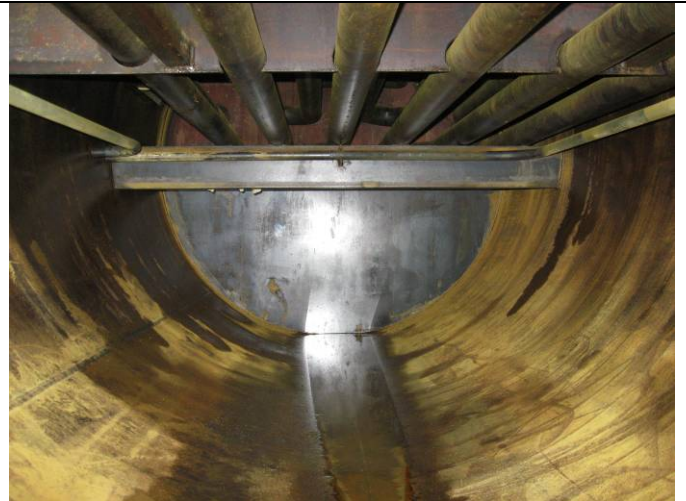
Over view of head and gas coil supports

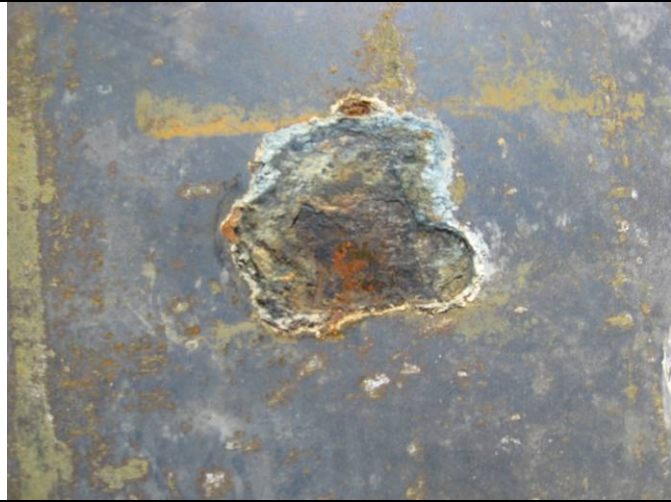
Fire Tube Identify and pitting or corrosion on external.	X				<ul style="list-style-type: none"> ▪ There are 2 small corroded areas at the ends of both fire and stack side at the 12:00 position from discharge to sled during operation – these areas are shallow – max depth is .020 inches.
<p>Recommendations or corrective actions: (MIC to review corrective actions with Operations, discuss with Chief Inspector where necessary, and get remedial action implemented) See internal inspection report for summary and recommendations.</p>

Fire tube – stack side – corroded patch near mitered joints – max depth .020 inches.

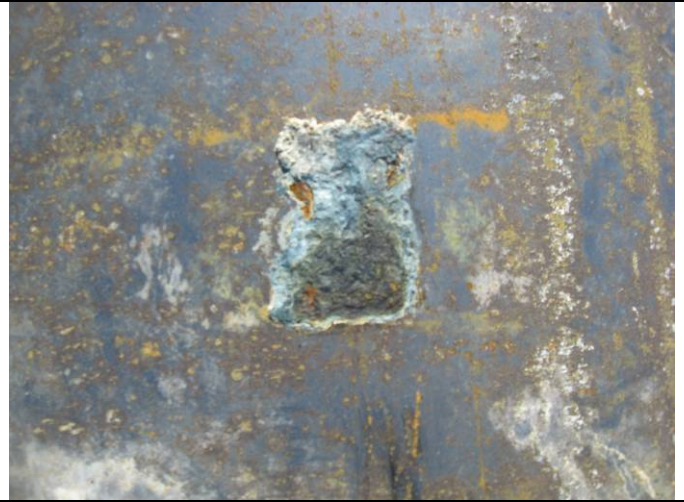
Fire tube – burner side – corroded patch near mitered joints – max depth .020 inches.
