**TANK INSPECTION  
CHECKLIST AND  
SUMMARY**

Report #: **137865-SM-36**  
 Inspect Date: 05/14/2009  
 Page: 1 of 3  
 IRISNDT #: 137865

Client: <u>CNRL</u>	District: <u>Slave Lake</u>	Field: <u>Springburn</u>
Facility: <u>04-11-079-17W5</u>	Unit: <u>N/A</u>	LSD: <u>04-11-079-17W5</u>
Owner ID #: <u>SN8298</u>	Equip Tag #: <u>TK-104</u>	Serial #: <u>8298</u>
Foundation: <u>Gravel</u>	AST / UST: <u>AST</u>	Year Built: <u>2002</u>
Manufacturer: <u>Argo Sales Ltd.</u>		Equipment Description: <u>Crude Oil Tank</u>
Status: <u>In Service</u>	Date Removed From Service: _____	Service: <u>Sweet</u>
Des. Fill Height: _____ @ _____	Roof Height: <u>16</u> Feet	Code <input type="checkbox"/> Y <input checked="" type="checkbox"/> N
Fire Tube: <input type="checkbox"/> Y <input checked="" type="checkbox"/> N	Diameter: <u>21.5</u> Ft. O.D.	Insulated: <input type="checkbox"/> Y <input checked="" type="checkbox"/> N
Secondary Containment Type: <u>Dyke</u>	Volume: <u>1000</u> bbl	Cladding: <input type="checkbox"/> Y <input checked="" type="checkbox"/> N

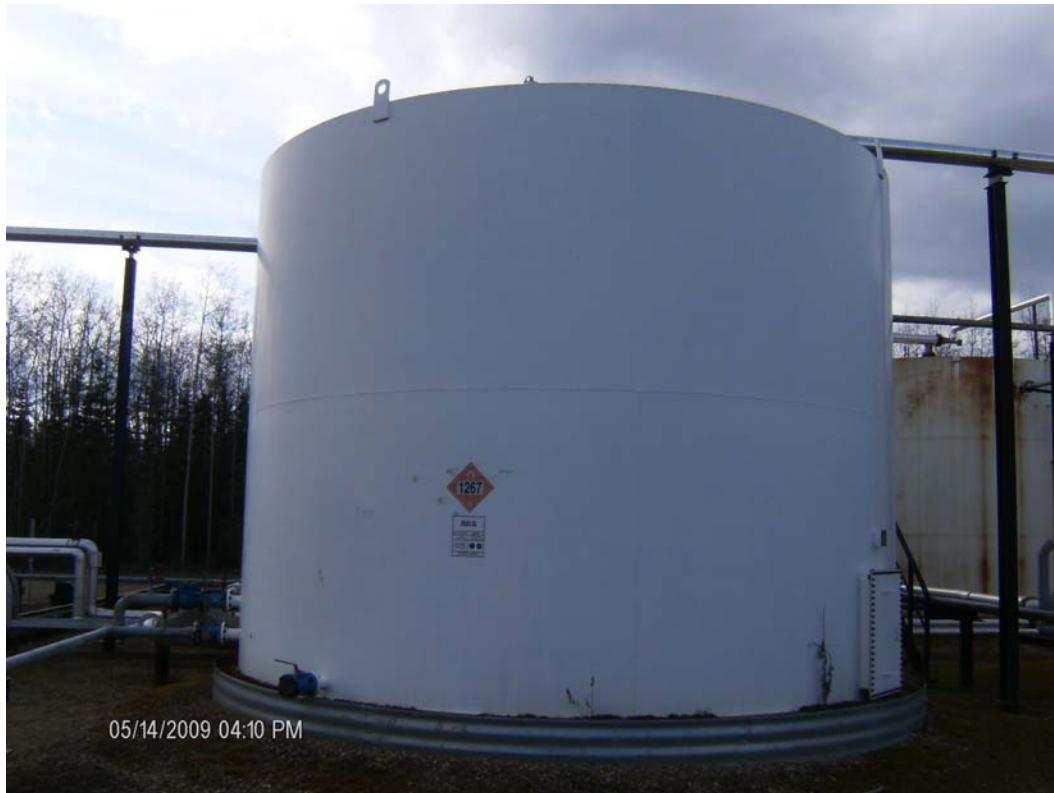
Figure 2\_Crude Oil Tank\_14May09

- Vegetation is present around the base of the tank and is in contact with bottom chime and shell.
The paint is intact on the shell.
The ladder is secure and level.
The tank is properly grounded.
The level gauge is clear and visible.
The PVRV is in good condition.
Refer to the attached photos for inspection findings.

- Vegetation is present around the base of the tank and is in contact with bottom chime and shell.

- Remove the vegetation from the area to prevent a corrosive environment from developing.
