**Canadian Natural Resources Limited
GENERAL PRESSURE VESSEL INFORMATION**

Job # 10.110056

District: Grande Prairie AB.	Skid No.
Facility: Knopcik Gas Gathering	Location (LSD): 102 / 06-02-74-11W6M
Vessel Name Equipment Number: Separator	
Orientation: Vertical	
Status: In Service	Regulatory Inspection

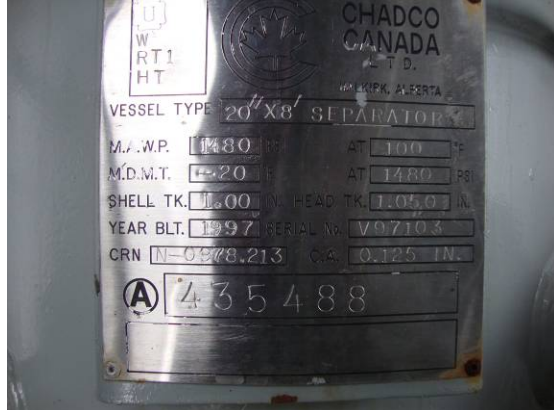
<p>LSD</p>	<p>Vessel data plate</p>

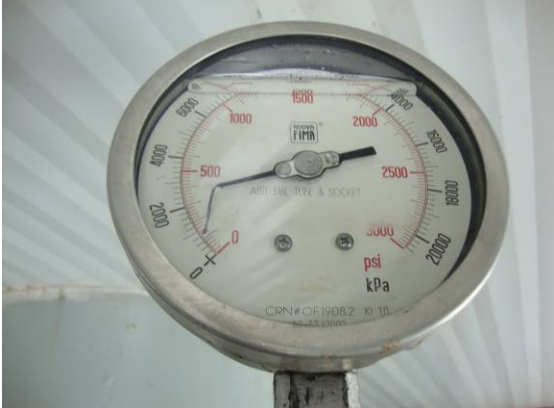
<p>Vessel pressure gauge</p>	<p>Vessel temperature gauge</p>

Recommendations: 1) Replace leaking gasket at PSV nozzle. 2) Replace pressure gauge.

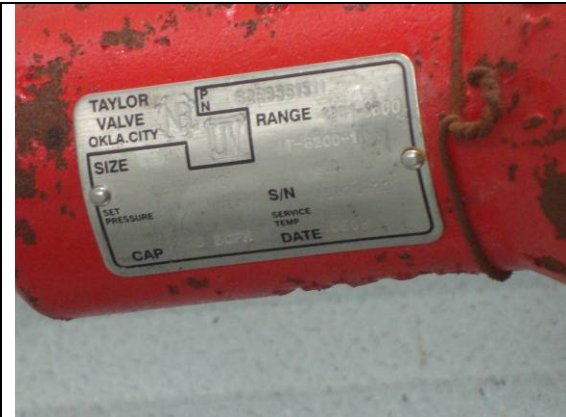
PSV data plate

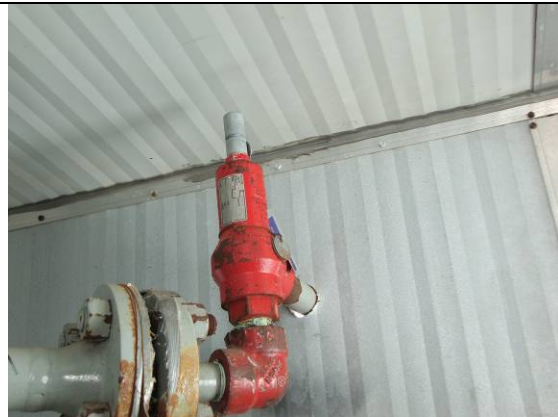
Valve: Ensure no leaks are visible. Valves are properly supported and chained if necessary.	X				Valves are supported properly – no leaks.
PSV Ensure PSV is set at pressure at or below that of vessel.	X				Location: Upper shell of vessel – set below MAWP of vessel. No block valve between vessel and PSV. Discharge piping is same size as valve out let. Seal in place.

Vessel PSV

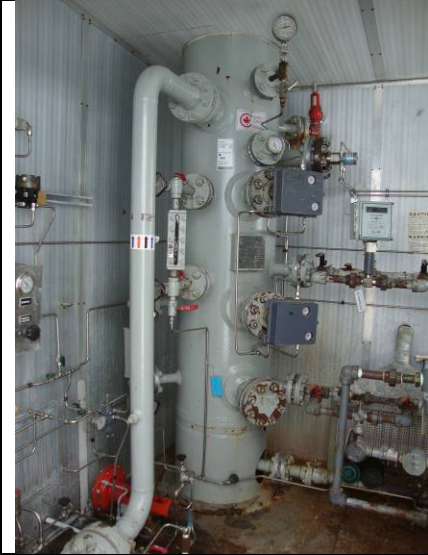
Summary: Vessel is in overall good condition, visual external inspection and ultrasonic corrosion survey performed – pipe metal thickness detected below nominal minus corrosion allowance. Thickness calculations carried out to ensure sufficient metal exists for safe operation.

Vessel overview

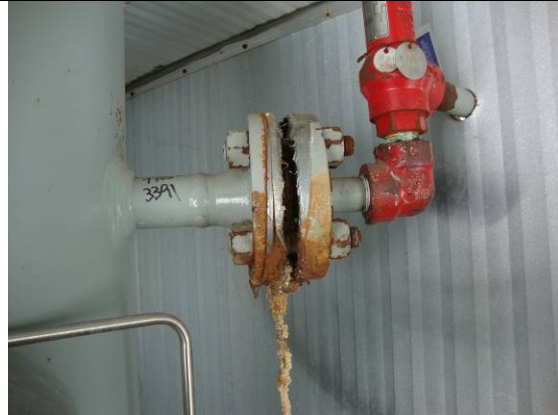
Leak at PSV nozzle
