**Canadian Natural Resources Limited
GENERAL PRESSURE VESSEL INFORMATION**

Job # 10.110056

District: Grande Prairie AB.	Skid No.
Facility: Knopcik Gas Gathering	Location (LSD): 16-06-73-10W6M
Vessel Name Equipment Number: Line Heater	
Orientation: Horizontal	
Status: In Service	Regulatory Inspection

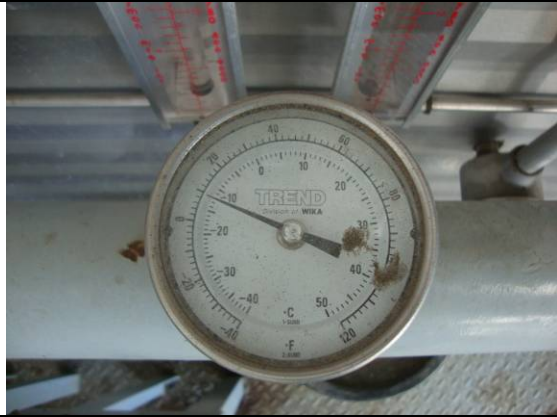
Vessel tube temperature gauge

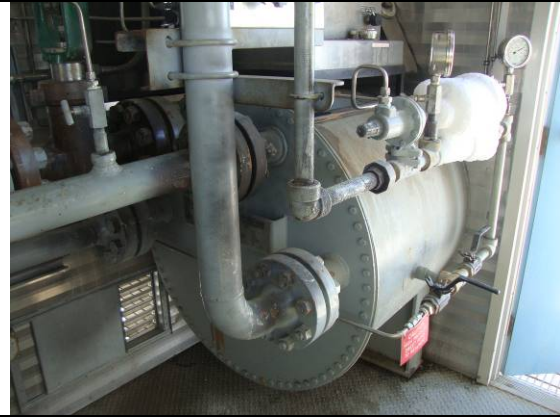
Vessel inlet overview

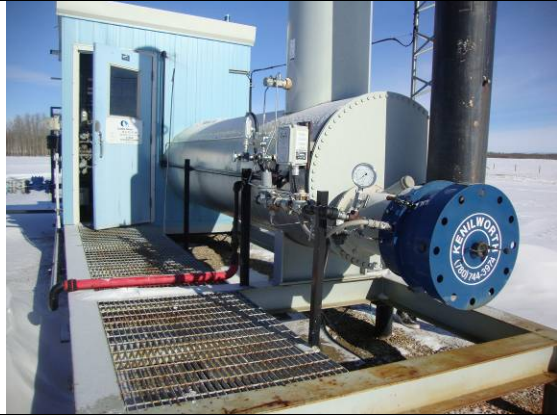
Vessel overview
