**TANK INSPECTION  
CHECKLIST AND  
SUMMARY**

Report #: **137865-SM-35**  
 Inspect Date: 05/14/2009  
 Page: 1 of 3  
 IRISNDT #: 137865

Client: <u>CNRL</u>	District: <u>Slave Lake</u>	Field: <u>Springburn</u>
Facility: <u>04-11-079-17W5</u>	Unit: <u>N/A</u>	LSD: <u>04-11-079-17W5</u>
Owner ID #: <u>SN8297</u>	Equip Tag #: <u>TK-103</u>	Serial #: <u>8297</u>
Foundation: <u>Gravel</u>	AST / UST: <u>AST</u>	Year Built: <u>2002</u>
Manufacturer: <u>Argo Sales Ltd.</u>		Equipment Description: <u>Crude Oil Tank</u>
Status: <u>In Service</u>	Date Removed From Service: _____	Service: <u>Sweet</u>
Des. Fill Height: _____ @ _____	Roof Height: <u>16</u> Feet	Code <input type="checkbox"/> Y <input checked="" type="checkbox"/> N
Fire Tube: <input type="checkbox"/> Y <input checked="" type="checkbox"/> N	Diameter: <u>21.5</u> Ft. O.D.	Insulated: <input type="checkbox"/> Y <input checked="" type="checkbox"/> N
Secondary Containment Type: <u>Dyke</u>	Volume: <u>1000</u> bbl	Cladding: <input type="checkbox"/> Y <input checked="" type="checkbox"/> N

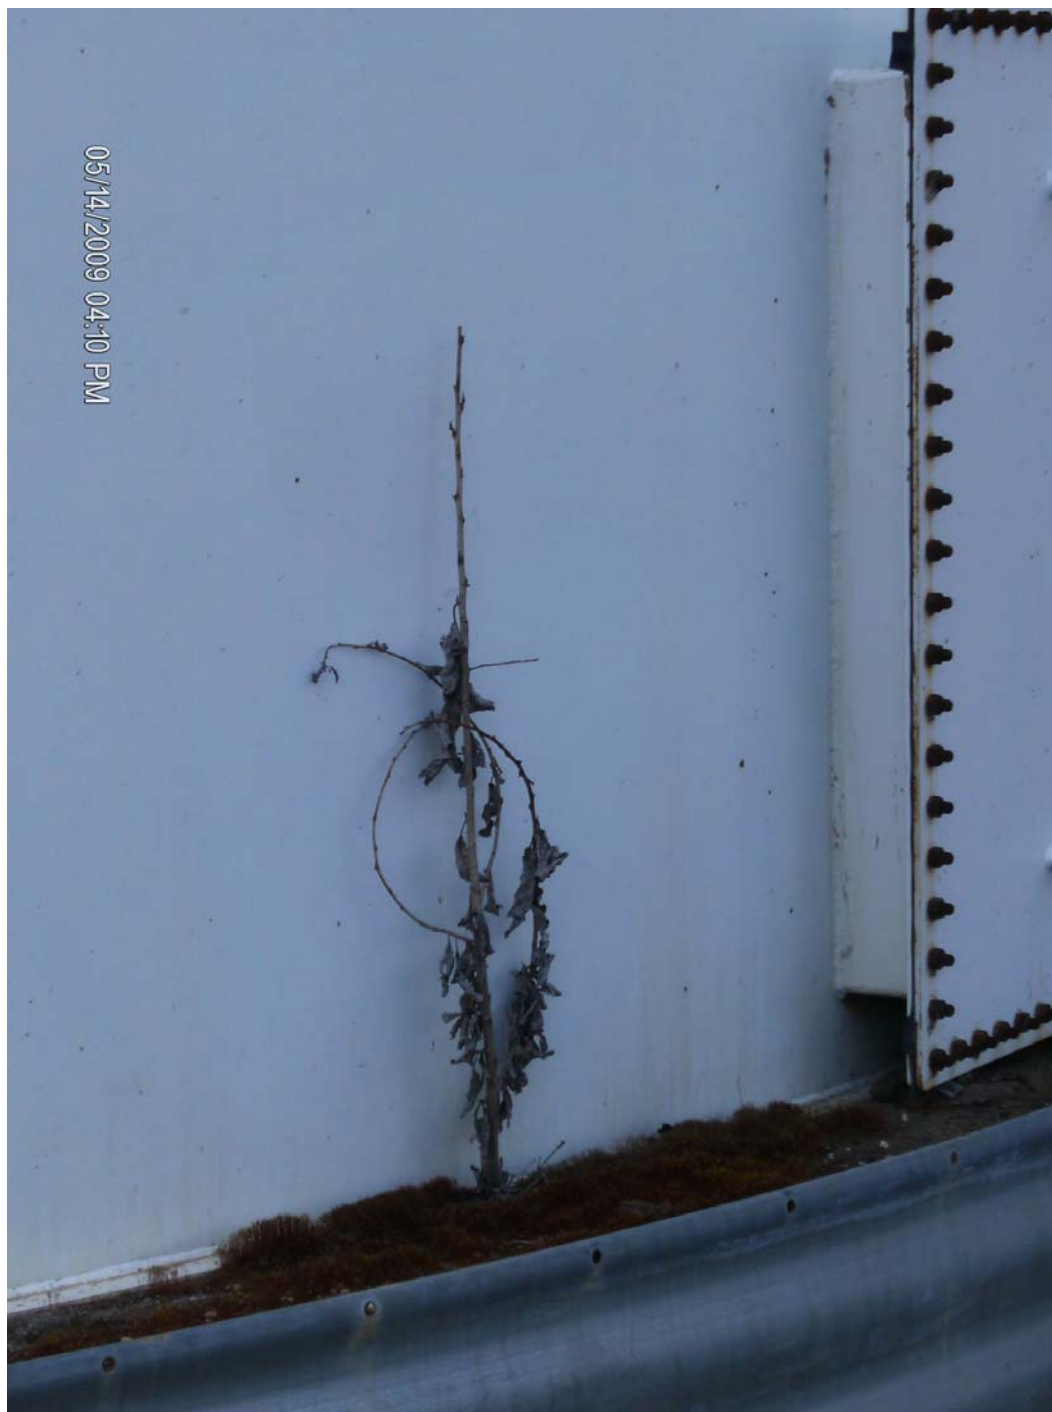
- Vegetation is present around the base of the tank and is in contact with bottom chime and shell.

Figure 3\_Vegetation Present Around Tank Base\_14May09

- Remove the vegetation from the area to prevent a corrosive environment from developing.
