**Canadian Natural Resources Limited
GENERAL PRESSURE VESSEL INFORMATION**

Job # 10.110056

District: Grande Prairie AB.	Skid No.
Facility: Knopcik Gas Gathering	Location (LSD): 09-34-73-10W6M
Vessel Name Equipment Number: Line Heater	
Orientation: Horizontal	
Status: In Service	Regulatory Inspection

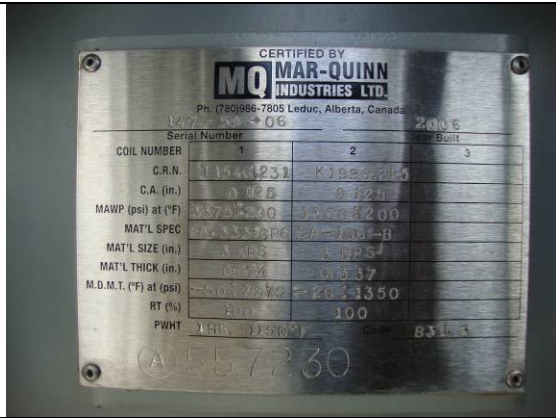
Vessel data plate

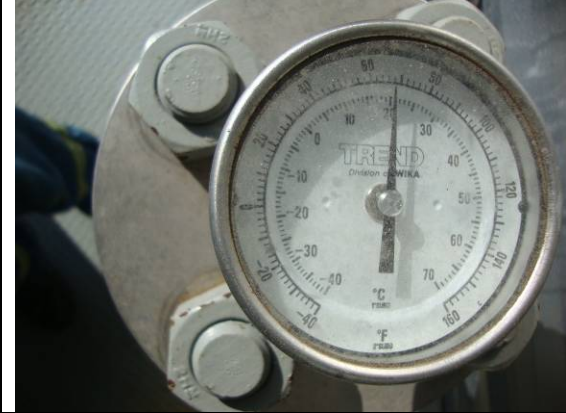
Vessel temperature gauge

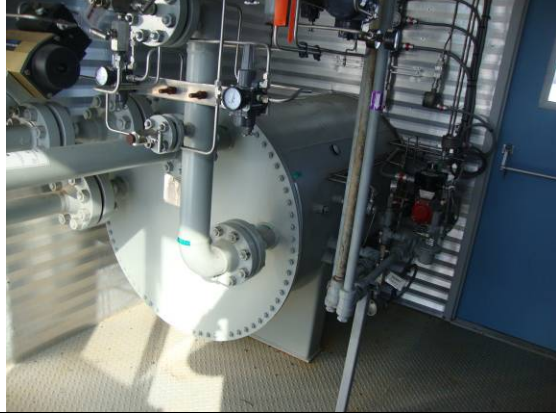
Vessel front view

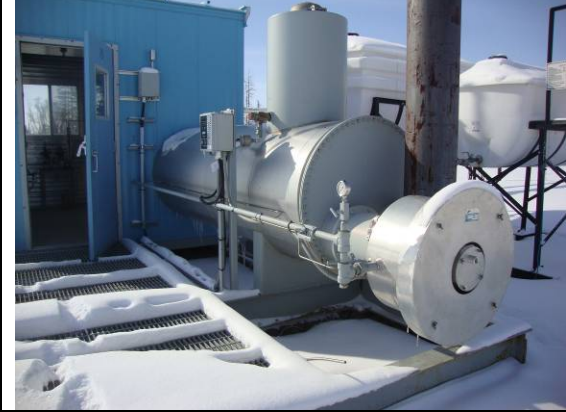
Vessel overview
