INSPECTION DEFICIENCY REPORT

FACILITY: Hussar Field DATE: August 8, 2012 REPORT #: IDR 120808AFb

Prov. Reg. #	<u>A0547598</u>	CRN:	<u>P-3515.213</u>	Serial #	<u>14532</u>
Equipment Location(LSD):	<u>07-09-25-21 W4M</u>	Equipment ID #:	<u>66100501</u>	<input checked="" type="checkbox"/> Sweet	<input type="checkbox"/> Sour
Equipment Description:	<u>Flodrip Separator</u>	Service:	<u>Natural Gas</u>		
Manufacturer:	<u>Crimtech Services Ltd.</u>	Year Built:	<u>2005</u>		
MAWP	<u>1480</u> psi	@	<u>100</u> °F	MDMT:	<u>- 29</u> °C Capacity: <u> </u> m3

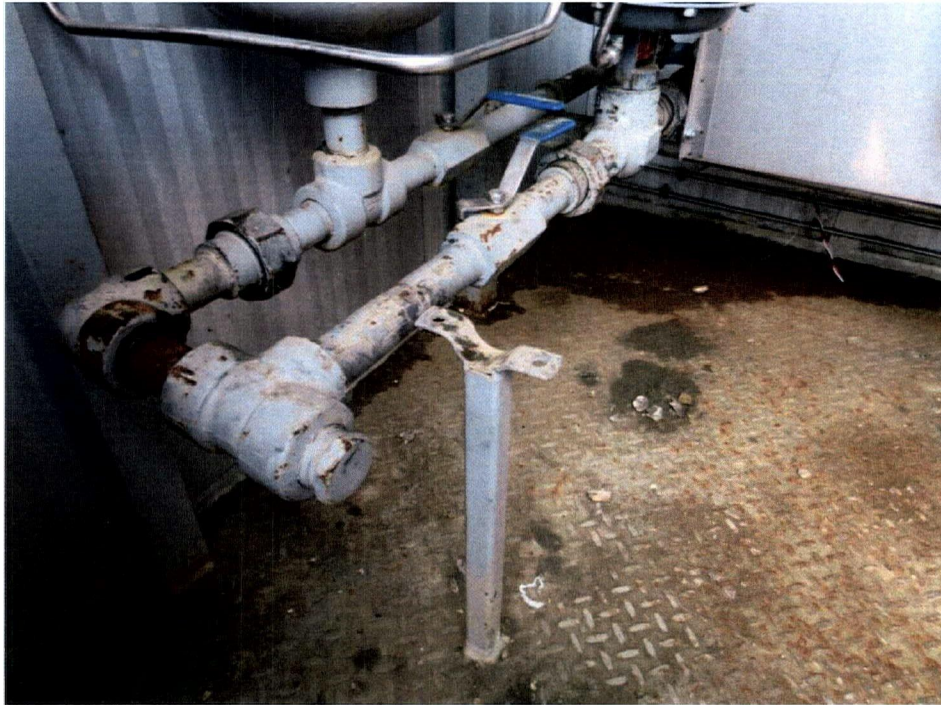
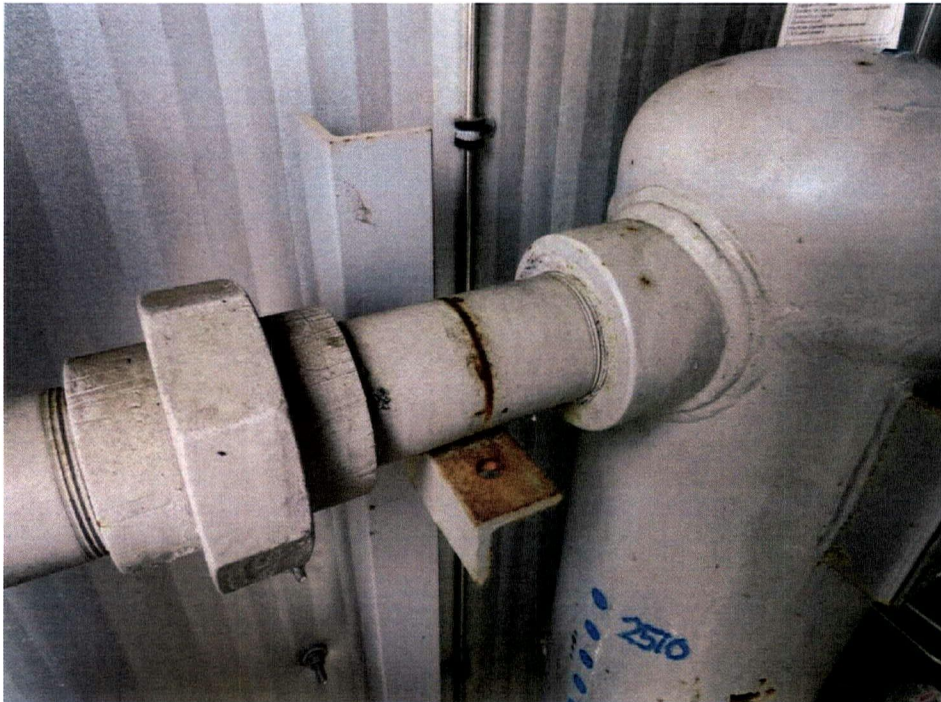
-The piping support for the 1" drain piping was not aligned with the piping.
-The inlet piping support is missing the U-bolt clamp.

Comments: *Ensure piping is supported & u-clamps installed.*
