**Canadian Natural Resources Limited  
GENERAL PRESSURE VESSEL INFORMATION**

**Job 10.113377**

| Facility: <b>La Glace Gas Gathering</b> | | Location (LSD): <b>14-09-75-09W6M</b> | | | | | |
| Vessel Name Equipment Number: <b>Separator</b> | | | | | | | |

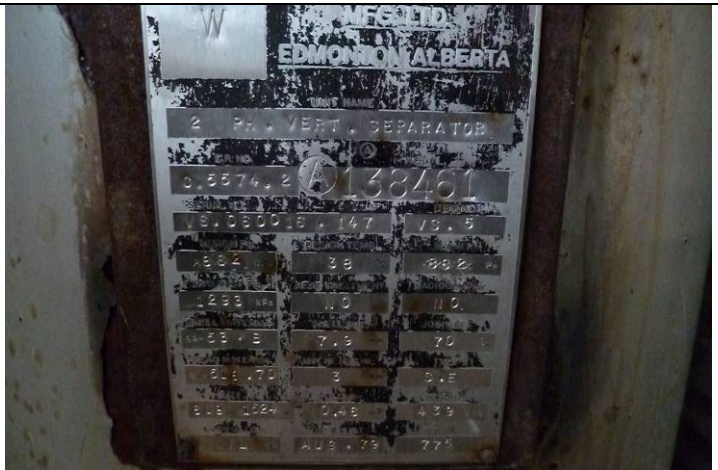
Vessel data plate

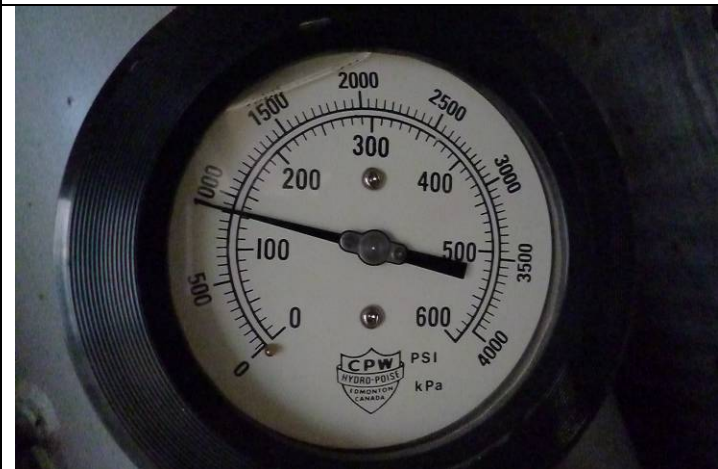
| External Inspection Items | G | F | P | N/A | Comments |
|---|---|---|---|---|---|
| <b>Gauges</b> Ensure gauges are visible, working, no leakage, and suitable for range of MAWP/ Temp. | X | | | | Clear and clean – no leakage.<br>Within operational range for service.<br>Pressure gauge 0 – 600 PSI. |

Pressure gauge

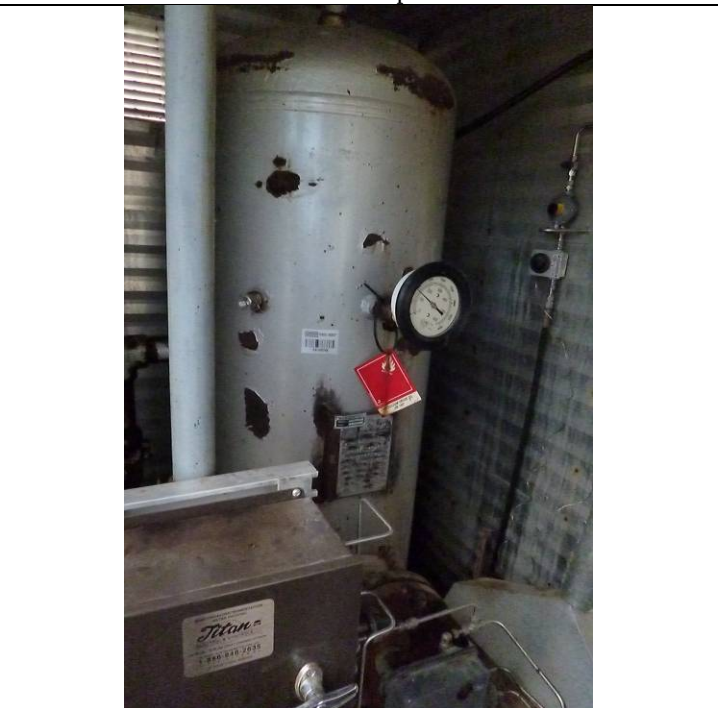
| External Inspection Items | G | F | P | N/A | Comments |
|---|---|---|---|---|---|
| <b>External Condition</b> Assess paint condition, areas peeling, record any corrosion, damage, etc (record location, size and depth of corrosion or damage) | | X | | | Paint peeling to 60% of area – scale corrosion on exposed metal. Pitting less than .005” |

Vessel overview

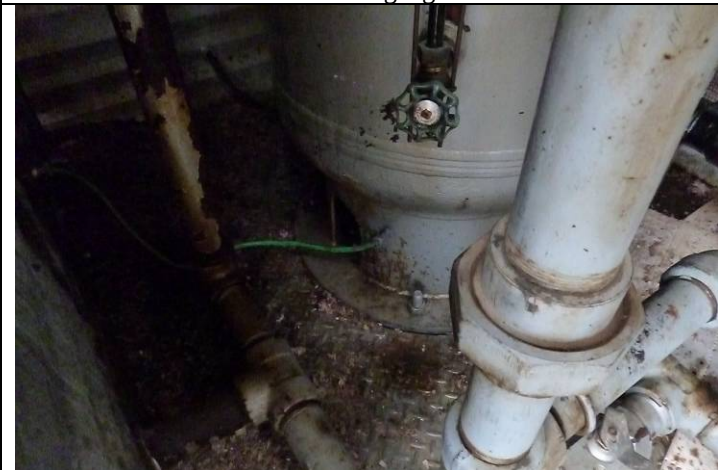
| External Inspection Items | G | F | P | N/A | Comments |
|---|---|---|---|---|---|
| <b>Saddle/skirt</b> Assess condition of paint, fire protection, and concrete. Look for corrosion, buckling, dents, etc. Look at vessel surface area near supports. Verify no signs of leakage at attachment to vessel and attachment welds are acceptable. Ground wire attached? | X | | | | Skirt: Bolted directly to skid floor.<br>No buckling or dents.<br>No corrosion at attachment welds to vessel.<br>Ground wire attached to vessel. |

Vessel skirt and ground wire attached

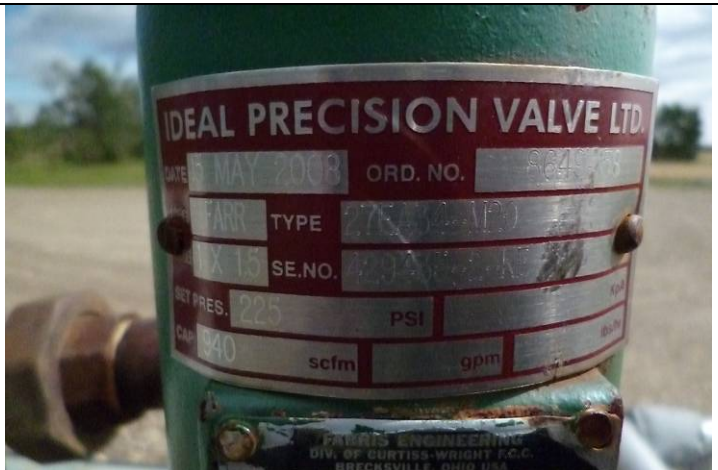
PSV data plate

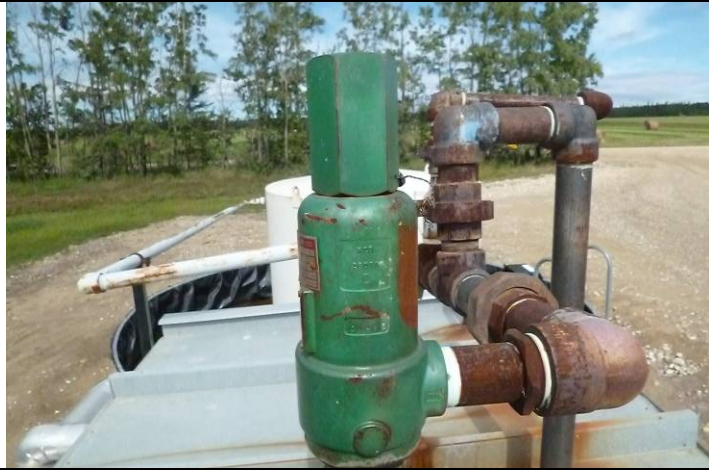
| External Inspection Items | G | F | P | N/A | Comments |
|---|---|---|---|---|---|
| <b>PSV</b> Ensure PSV is set at pressure at or below that of vessel. | | X | | | Location: Top head – Set above MAWP<br>No block valve between vessel and PSV.<br>Discharge piping is same size as valve out let.<br>PSV seal broken. |

Vessel PSV

| External Inspection Items | G | F | P | N/A | Comments |
|---|---|---|---|---|---|
| <b>Recommendations or corrective actions : Vessel is Fit for Service or describe corrective actions required)</b><br>(MIC to review corrective actions with Operations, discuss with Chief Inspector where necessary, and get remedial action implemented)<br><b>Recommendations:</b> Service PSV<br>Repair leakage at pipe threads.<br>Re-paint vessel and piping.<br><b>Summary: This vessel is in good condition, visual external and ultrasonic thickness inspection carried out – no metal thickness detected below nominal minus corrosion allowance.</b><br><b>Corrosion rate based on greatest thickness loss (shell) 0.026mm per year. Retirement Date to “T”min is year 2032.</b><br><b>Vessel is fit for service.</b> | | | | | |
