**Canadian Natural Resources Limited**  
**GENERAL PRESSURE VESSEL INFORMATION**

**Job # 10.111019**

| Facility: <b>Knopcik Oil Battery</b> | | Location (LSD): <b>08-34-73-10 w6m</b> | | | | | |
| Vessel Name Equipment Number: <b>Test Separator</b> | | | | | | | |

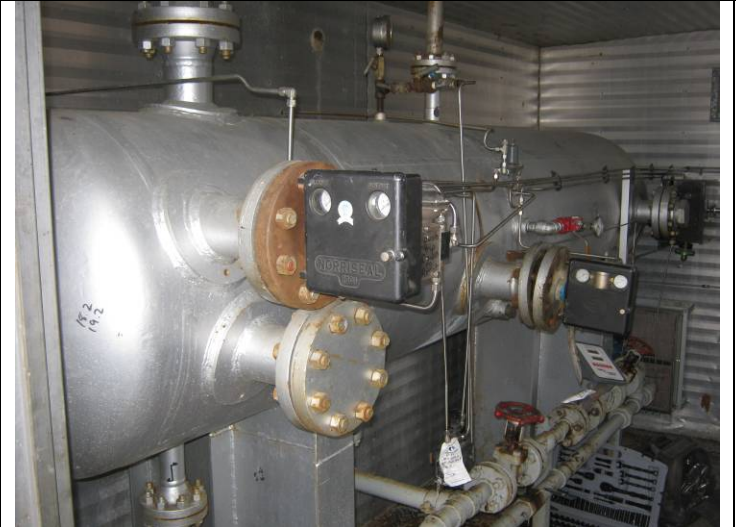
Overview - Vessel

| External Inspection Items | G | F | P | N/A | Comments |
|---|---|---|---|---|---|
| <b>External Condition</b> Assess paint condition, areas peeling, record any corrosion, damage, etc (record location, size and depth of corrosion or damage) | X | | | | Paint chipping and abrasion to 5% exposed metal with minor surface corrosion.<br>No damage. |

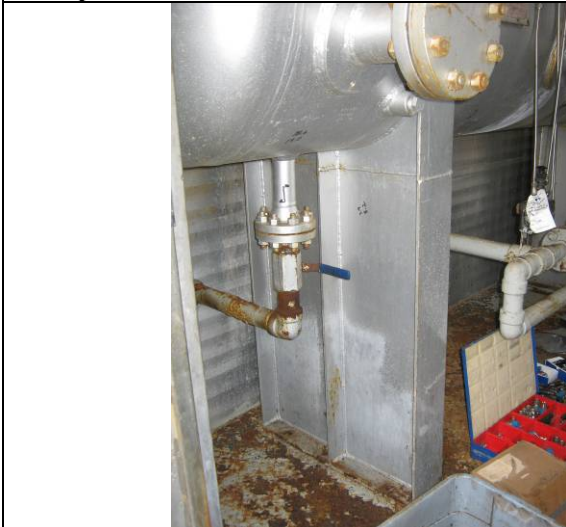
Saddle

| External Inspection Items | G | F | P | N/A | Comments |
|---|---|---|---|---|---|
| <b>Saddle/Skirt</b> Assess condition of paint, fire protection, concrete. Look for corrosion, buckling, dents, etc. Look at vessel surface area near supports. Verify no signs of leakage at attachment to vessel and attachment welds are acceptable. Ground wire attached? | X | | | | Vessel saddle is welded to skid floor.<br>No evidence of corrosion at shell to saddle weld – no leaks.<br>Paint chipped to 5% exposed metal with minor surface corrosion.<br>No distortion. No buckles.<br>No ground wire attached. Vessel is grounded through pilings. |

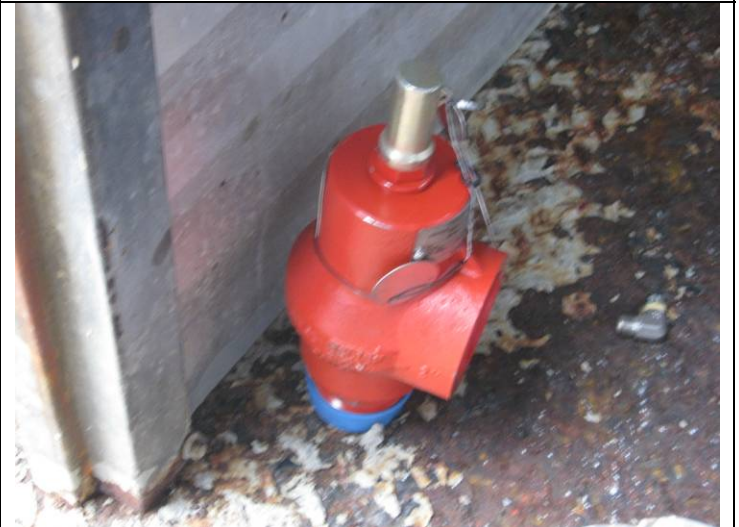
| External Inspection Items | G | F | P | N/A | Comments |
|---|---|---|---|---|---|
| <b>PSV</b> Ensure PSV is set at pressure at or below that of vessel. Seal is intact? Supported properly? Discharges to closed header or atmosphere? | X | | | | PSV not installed at time of inspection – set below MAWP of vessel.<br>Discharge piping is same size as valve outlet.<br>Valve is properly supported and routed.<br>PSV seal in place.<br>No block valve between vessel and PSV inlet. |

PSV not installed at time of inspection

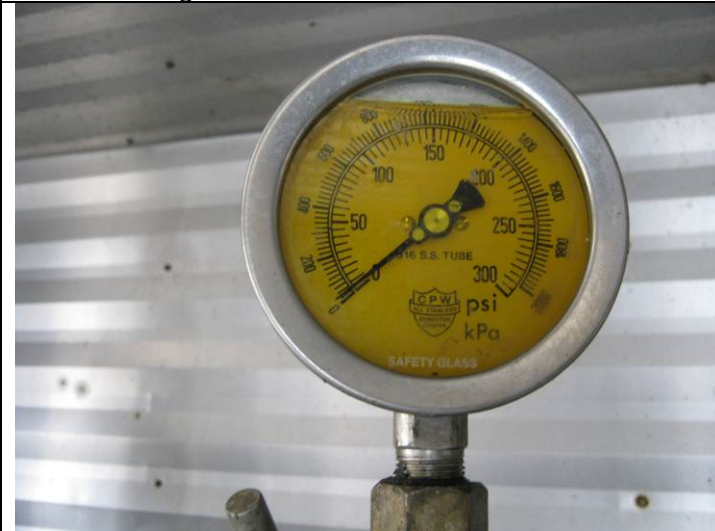
Pressure gauge

| External Inspection Items | G | F | P | N/A | Comments |
|---|---|---|---|---|---|
| <b>Gauges</b> Ensure gauges are visible, working, no leakage, and suitable for range of MAWP/Temp. | | X | | | Pressure and temperature gauges attached.<br><b>Pressure gauge: 0 to 2068 kPa. Not within range of MAWP.</b><br>Temperature gauge: -40 to 70°C. Within range of MAWT.<br>Clean, clear and in working condition. No leaks. |

| External Inspection Items | G | F | P | N/A | Comments |
|---|---|---|---|---|---|
| <b>Recommendations or corrective actions : Vessel is Fit for Service or describe corrective actions required)</b><br>(MIC to review corrective actions with Operations, discuss with Chief Inspector where necessary, and get remedial action implemented)<br><b>Recommendations: 1. Install pressure gauge with range at or above MAWP of vessel.</b><br><b>Summary:</b> Vessel is in overall good condition, visual external inspection and ultrasonic corrosion survey performed – no metal thickness detected below nominal minus corrosion allowance.<br>Long term corrosion rate based on greatest thickness loss (shell) 0.016mm per year. Retirement Date to “T”min is year 2284.<br><b>Vessel is fit for service.</b> | | | | | |
