Canadian	latural	PRESSURE VISUAL INS REPORT		Inspect	Date: Page:	56960-MD-09 10/16/2012 1 of 15 156960	
Criticality Designation		Yelle	W	_			
Insp. Comp: Matrix_Ins Location: 01-24-096 Jurisdiction #: A0146 CRN #: D 319	Grande Prairie - No N/A V-301A N/A	V-301A S		Field: Chincaga LSD: 01-24-096-05V Serial #: 79-087-05A Year Built: 1980			
Manufacturer: KML Manufact	X	quipment Description	n: Other: Gas De				
Status:Out of ServiceMAWP Shell:8619kPaMAWP Tube:MDMT:-20 °FSupportSkirt	ⓐ <u>@ 343 °C</u>	Equip. Type: Vessel: Tower Volume: N/A Height/Length: 8992 mm Size/Diameter.: 1677 mm I.D. on Original CNRL Inventory List: X Y					
			J.E.: <u>1.00</u> Re	,	ube Side	Chall Cida	
Component 1 Main - Shell 2 Top - Head 3 Bottom - Head 4 -	Material SA-516-70 SA-516-70 SA-516-70	Nominal Thk 88.500 mm 69.270 mm 69.270 mm	Diameter 1677.000 mm 1677.000 mm 1677.000 mm 1677.000 mm	OD/ID ID ID ID		Shell Side	
5 -

PRESSURE VESSEL VISUAL INSPECTION REPORT

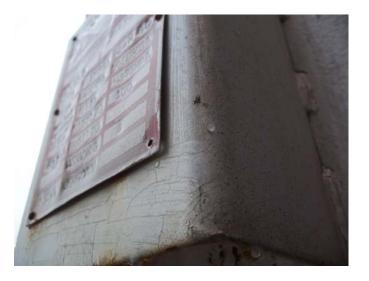
There is a broken rivet on the nameplate

02 broken rivet

Remove/ replace insulation on piping Replace broken rivet Replace temperature gauges as necessary Replace cladding and remove moss and treat area Clean and touch up the coating to aid in the protection against corrosion

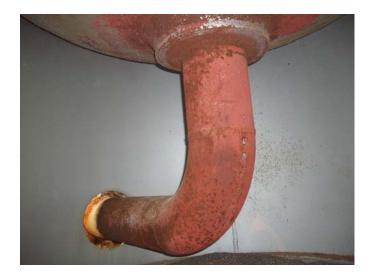
The coating is flaking and chipped throughout exposing the base metal to very minor surface corrosion with no evidence of pitting.

04 flash corrosion

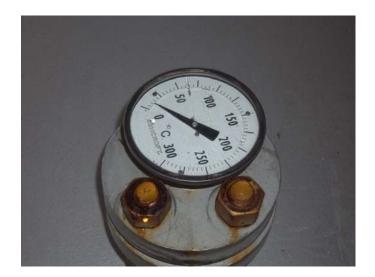
The 0-300 C temperature gauges are not within design temp range and the 0-500 C gauge needle is at the 500 C mark

05 not within range

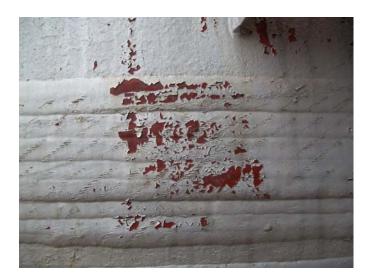
05 paint deterioration

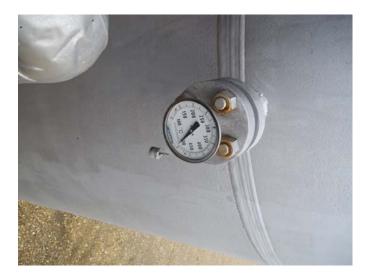
06 needle @ 500

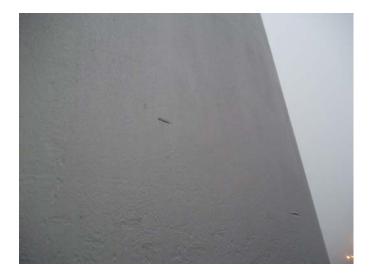
There is mechanical damage noted thru out the surfaces on the shells, (it appears as a tooling marks from erection) There is also mechanical damage on the top head below the paint

07 mechanical damage

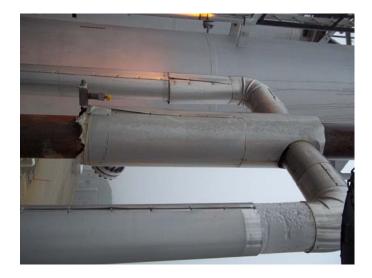
The top 8" inlet piping cladding is damaged and punctured with moss growth at the cladding interface that may result in MIC The outlet/inlet piping has a small section of cladding/insulation removed, the insulation is exposed, discolored and deteriorating which may result in CUI to the piping system

08 damaged insulation

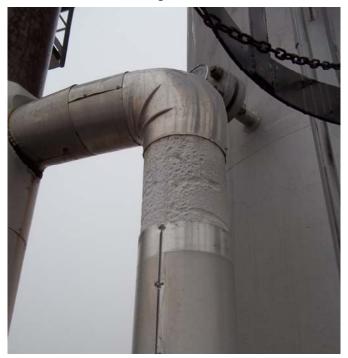
09 exposed insulation

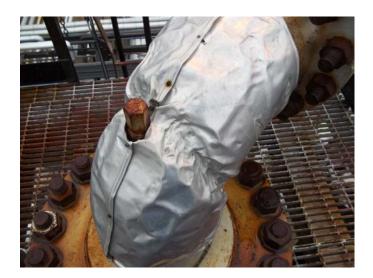
10 damaged cladding

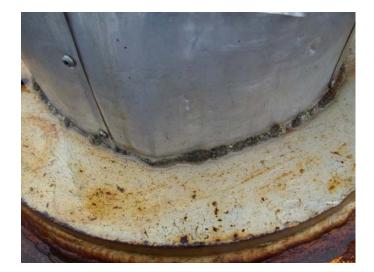
11 moss growth

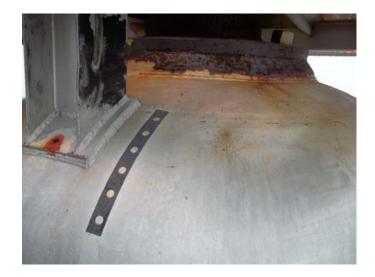
The top platform support beam is bent on the West side

12 mechanical damage on support
