| Canadian Natural Resources Limited GENERAL PRESSURE VESSEL INFORMATION RTD Job # 10.110181 | | | | | | |
| Facility: Ladyfern (a-84-G) | | | Location (LSD): a-84-G/ 94-H-1 | | | |
| Vessel Name & Equipment Number: Glycol Contactor | | | | | | |

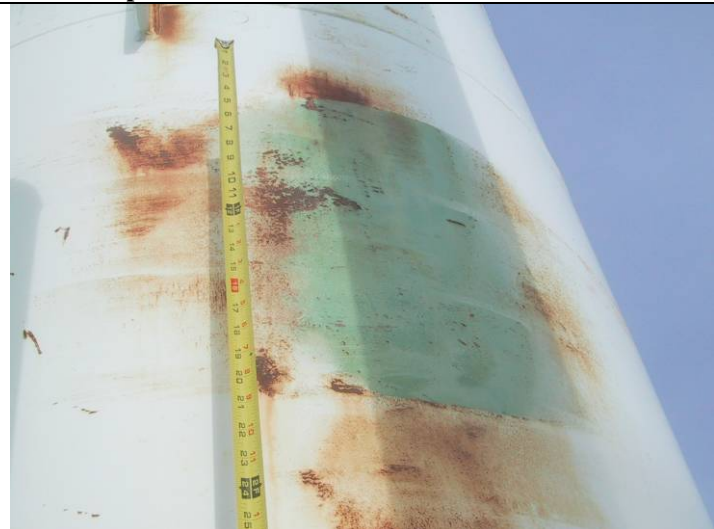
South Side of Shell Above Roof

| External Inspection Items | G | F | P | N/A | Comments |
|---|---|---|---|---|--|
| External Condition Assess paint condition, areas peeling, record any corrosion, damage, etc (record location, size and depth of corrosion or damage) | | X | | | Minor chips and scratches to approximately 5% of vessel. 1 area 1 ½' x 2 ½' paint is peeling, light brown oxidization is occurring. Staining present and paint faded. |
