**Canadian Natural Resources Limited
GENERAL PRESSURE VESSEL INFORMATION**

Job 10.112837

District: Fort St. John North	Skid No.
Facility: Chowade Gas Gathering	Location (LSD): b-49-L/94-B-09
Vessel Name Equipment Number: Test Separator	
Orientation: Vertical	
Status: In Service	Regulatory Inspection

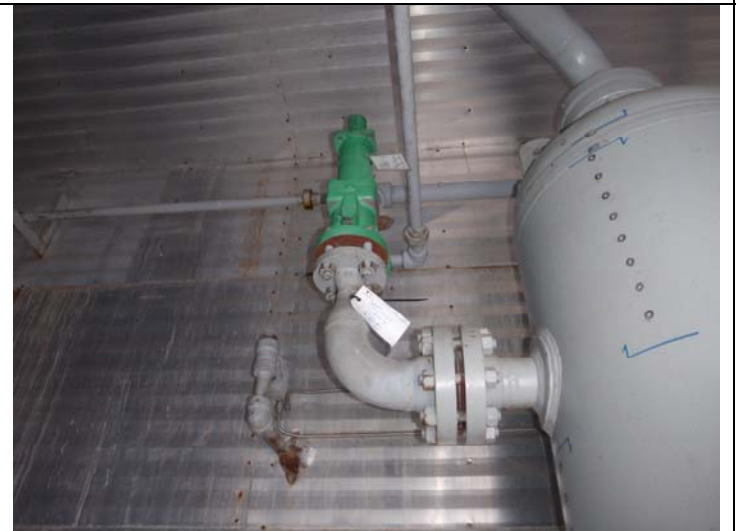
Valving Ensure no leaks are visible. Valves are properly supported and chained if necessary.	X				Valves properly supported – no sign of leaking
PSV Ensure PSV is set at pressure at or below that of vessel.	X				PSV is set at MAWP – seal intact – no block valve – outlet piping does not reduce form PSV discharge orifice size
NDE methods Was UT/ MPI done on vessel (MI coordinator to review results)	X				Ultrasonic corrosion survey carried out, no metal thickness detected below nominal minus corrosion allowance.
Other					
<p>Recommendations or corrective actions : Vessel is Fit for Service or describe corrective actions required) (MIC to review corrective actions with Operations, discuss with Chief Inspector where necessary, and get remedial action implemented) Recommendations: Summary: This vessel is in good condition, visual external and ultrasonic thickness inspection carried out – no metal thickness detected below nominal minus corrosion allowance. Short term corrosion rate based on greatest thickness loss (head) 0.263mm per year. Retirement Date to “T”min is year 2033. Vessel is fit for service.</p>
