**Canadian Natural Resources Limited
GENERAL PRESSURE VESSEL INFORMATION**

Job 10.112837

District: Fort St. John North	Skid No.
Facility: Chowade Compressor Station	Location (LSD): c-29-L/94-B-09
Vessel Name Equipment Number: Flare Knock Out Drum	
Orientation: Horizontal	
Status: In Service	Regulatory Inspection

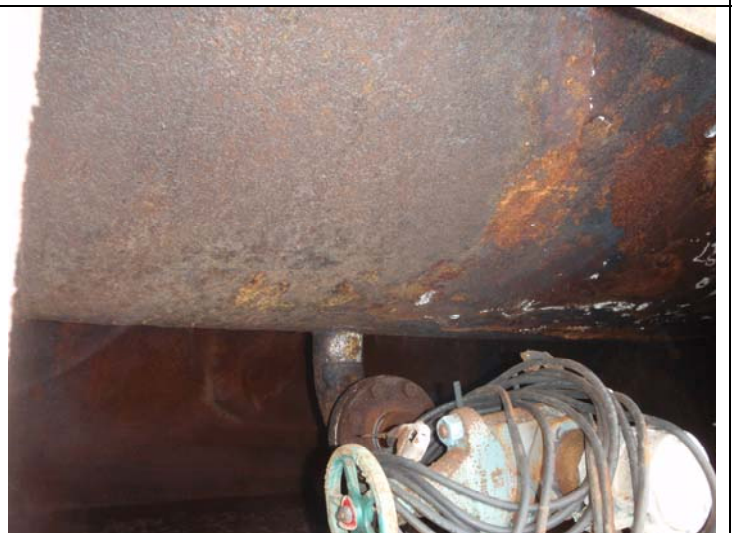
Under belly overview – Paint loss and surface corrosion to 100%
