**Canadian Natural Resources Limited
GENERAL PRESSURE VESSEL INFORMATION**

Job #4016571

District: Fort St. John, B.C	Skid No.
Facility: Gutah Compressor Station	Location (LSD): a-98-L/94-H-10
Vessel Name Equipment Number: Inlet Separator	
Orientation: Horizontal	
Status: In Service	Regulatory Inspection

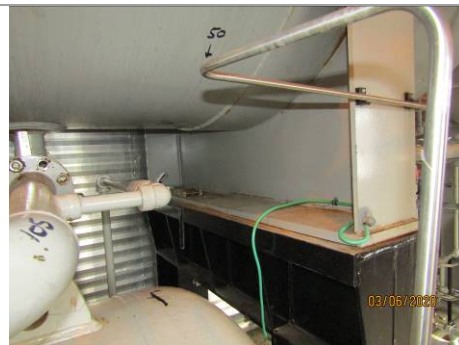
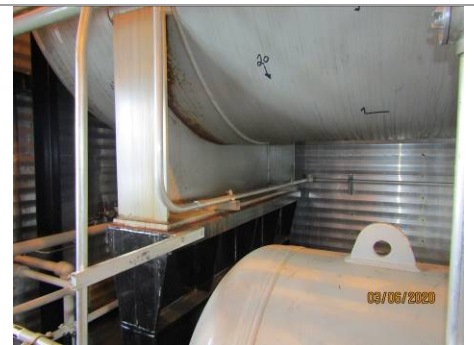
Mounting

External Inspection Items	G	F	P	N/A	Comments
Insulation Verify sealed around manways, nozzles, no damage present, and there is no egress of moisture.				X	Vessel is not insulated
External Condition Assess paint condition, areas peeling, record any corrosion, damage, etc (record location, size and depth of corrosion or damage)	X				Paint in good condition – no corrosion or damage – slight surface staining
Leakage Record any leakage at flanges, threaded joints, weep holes on repads, etc.	X				No leakage.
Saddle/Skirt Assess condition of paint, fire protection, concrete. Look for corrosion, buckling, dents, etc. Look at vessel surface area near supports. Verify no signs of leakage at attachment to vessel and attachment welds are acceptable. Ground wire attached?	X				Saddle: No buckling or dents. No corrosion at saddle to shell area – no leaks. Ground wire attached to skid
Anchor Bolts Hammer tap to ensure secure. Look for cracking in treads or signs of deformation.	X				All bolts in place – secure – no cracking or deformation noted

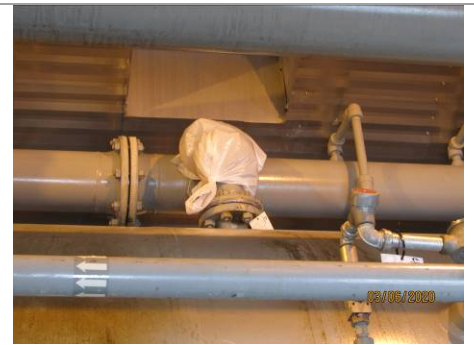
PSV location

Valving Ensure no leaks are visible. Valves are properly supported and chained if necessary.	X				Valves are properly supported and chained if necessary No leaks
PSV Ensure PSV is set at pressure at or below that of vessel.				X	PSV is out for service
NDE methods Was UT/ MPI done on vessel (MI coordinator to review results)	X				Ultrasonic corrosion survey carried out – no metal thickness detected below nominal minus corrosion allowance.
Recommendations or corrective actions: (Vessel is Fit for Service or describe corrective actions required) (MIC to review corrective actions with Operations, discuss with Chief Inspector where necessary, and get remedial action implemented)					
See internal portion of report for summary and recommendations.

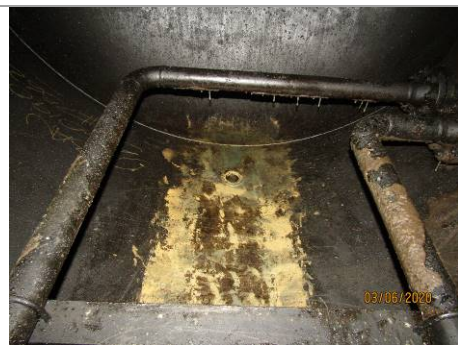
Bottom shell

Internal Inspection Items	G	F	P	N/A	Comments
Coating Assess coating. Describe area coated, general condition of coating.				X	Vessel is not coated
Anodes. How many, type, condition. % consumed. Are they being replaced?				X	No anodes
Internal Piping Is there any? If so, carbon or stainless steel. Describe condition, dents, corrosion, erosion, etc. Ensure supports are secure and any bolts are suitable for future use.	X				2 inch heat medium piping located in vessel – good condition with no dents or corrosion All supports are secure – mounting hardware in good condition
Trays How many? Type of material. Are valves in place? Check for erosion/ corrosion; wear on tray valve legs. Cleanliness?				X	No trays
Baffles, deflector plates, etc. If present, describe condition. Look closely at welds attached to vessel wall.	X				Inlet deflector located on the top shell – good condition – welds in good condition with no cracking noted – Baffle in good condition - welds to shell acceptable - Demister pad housing on the top shell - welds in good condition with no cracking noted

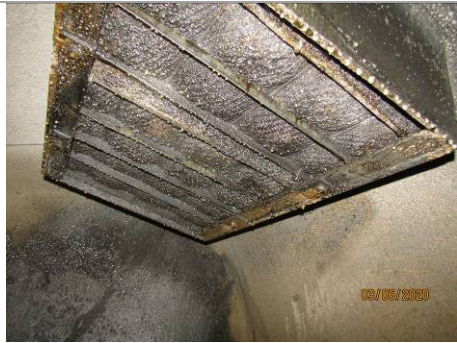
West Head Note all corrosion, erosion or mechanical damage. (If vessel is horizontal identify direction of this head)	X				No corrosion or erosion – no mechanical damage Head is in good condition
East Head Note all corrosion, erosion or mechanical damage. (If vessel is horizontal identify direction of this head)	X				No corrosion or erosion – no mechanical damage Head is in good condition
Shell Sections Record number of shell sections. Record location, size and depth of all erosion, corrosion or mechanical damage. Describe general condition. If any corrosion greater than corrosion allowance is observed in either shell or head, discuss with Chief Inspector before closing vessel.	X				2 shell sections No corrosion or erosion – no mechanical damage Shell is in good condition
Demister pad Is it in place? Is it clean? If any corrosion is apparent in vessel, lift pad and check top head for corrosion.	X				Demister pad in good overall condition – not lifted – slightly dirty due to vessel cleaning

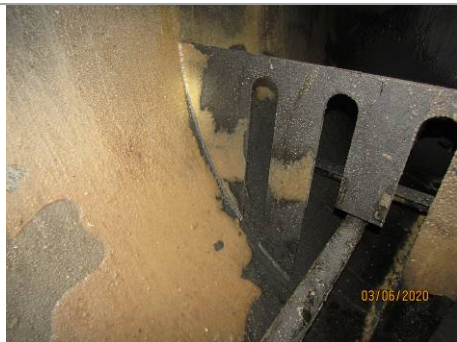
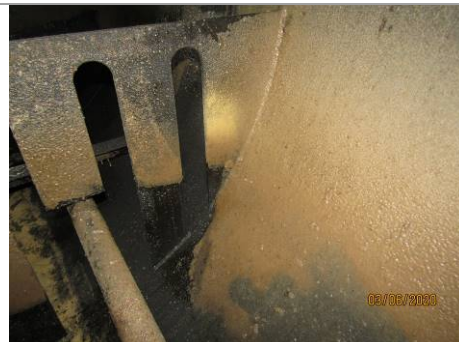
Baffle weld

Welds Inspect all welds, including attachment welds. Record all service-related damages and if there is any discuss with Chief Inspector before closing.	X				All welds in good condition – no service related damage
Repairs Required. If yes, ensure procedure and copy of AB 40 is on file, and one sent to local ABSA, and Chief Inspector	X				No repairs required
NDE Was any NDE done. (MI coordinator to review results)	X				MT examination performed on nozzles and T intersections – no cracking detected
Other					
<p>Recommendations or corrective actions: (Vessel is Fit for Service or describe corrective actions required) (MIC to review corrective actions with Operations, discuss with Chief Inspector where necessary, and get remedial action implemented)</p> <p>Recommendations: No recommendations at this time.</p> <p>Summary: This vessel is in good condition, visual external, internal and ultrasonic thickness inspection carried out – no metal thickness detected below nominal minus corrosion allowance. Corrosion rate based on greatest thickness loss (nozzle) 0.064mm per year. Retirement Date to “T” min is year 2204. Vessel is fit for service.</p>
