GENERAL INSPECTION FORM						
District: Fort St. John BC			Skid No. 16539			
Facility: Ring Border Gutah Header			Location (LSD): ^A A -98-L-94-H-10			
Vessel Name & Equipment Number: Inlet Separator						
Orientation: Horizontal						
Status: In Service			Regulatory Inspection			
PRESSURE VESSEL NAMEPLATE DATA						
"A" or "G" or "S" (Sask.) or BC Registration Number. A538747 A0536747			CRN Number R 0733.21			
Vessel serial number: 05.328HS			Size: 72 in. x 24 ft.			
Shell thickness: 31.8mm			Shell material: SA 516-70N			
Head thickness: 31.8mm			Head material: SA 516-70N			
Tube wall thickness:			Tube material:			
Tube diameter:			Tube length:			
Channel thickness:			Channel material:			
MAWP	Shell: 655 PSI		Operating pressure	Shell:		
	Tubes:			Tubes:		
Design Temp.	Shell: 150 Deg F		Operating temperature	Shell:		
	Tubes:			Tubes:		
X-ray: RT 2			Heat treatment: no			
Code parameters: ASME Section VIII Div 1			Joint efficiency (if on nameplate):

Photo Table

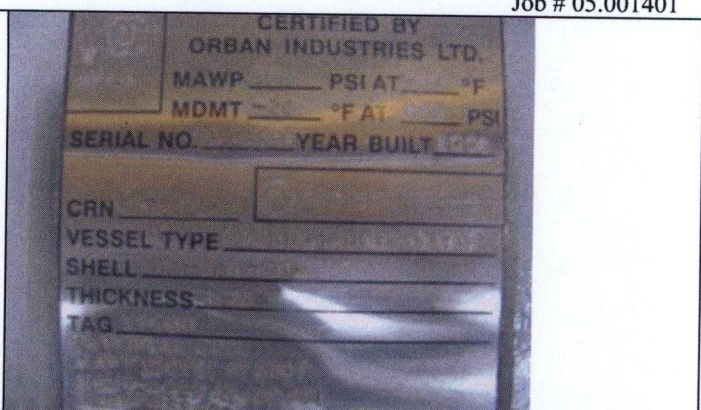
vessel data plate

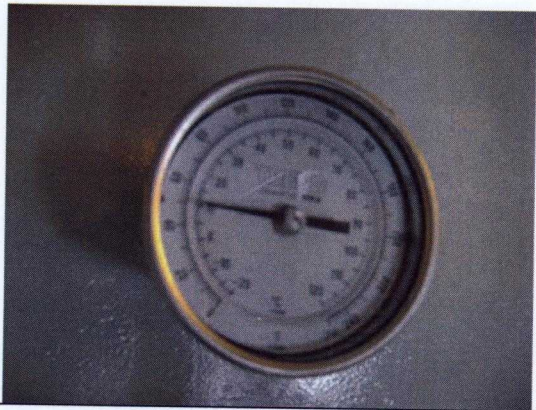
temperature gauge

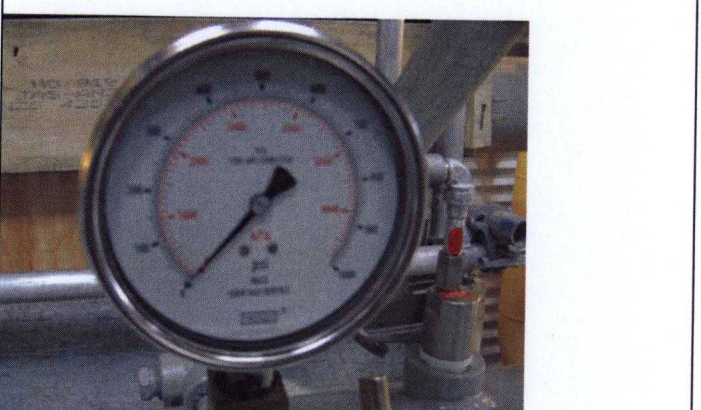
pressure gauge

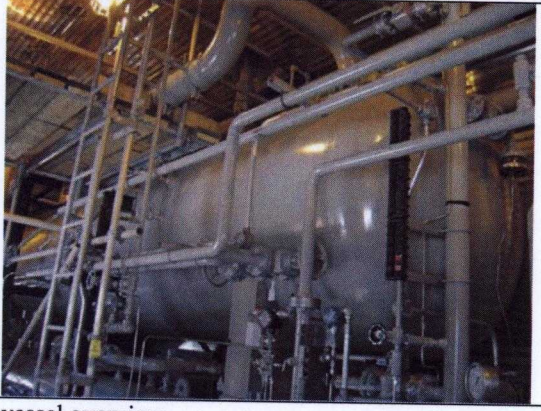
vessel overview

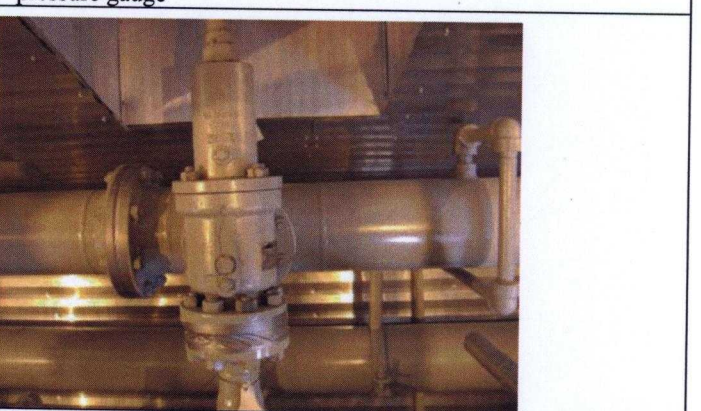
vessel PSV

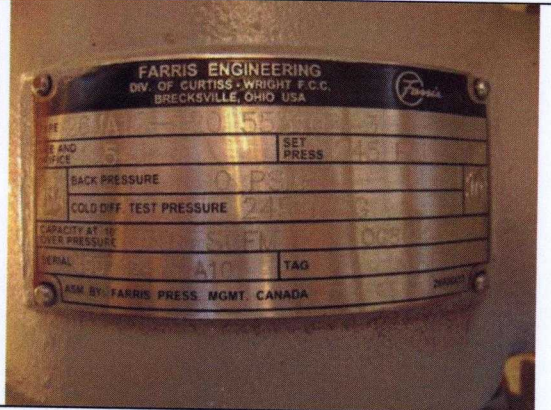
vessel PSV data plate

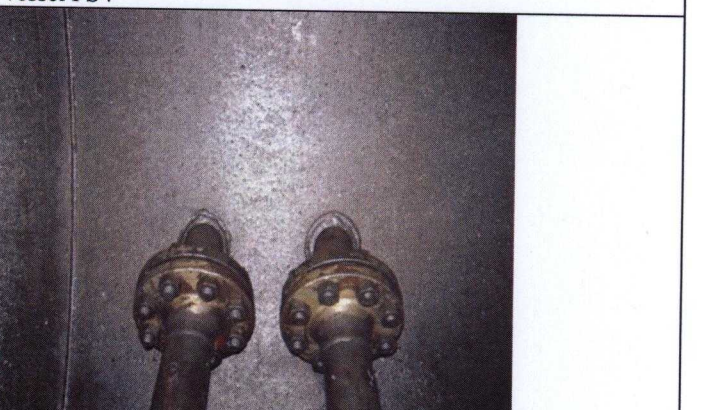
Welds Inspect all welds, including attachment welds. Record all service-related damages and if there is any discuss with Chief Inspector before closing.	X				attachment welds to shell are in good condition – no erosion or corrosion noted – Shell welds are in good condition No service related damages
Repairs Required. If yes, ensure procedure and copy of AB 40 is on file, and one sent to local ABSA, and Chief Inspector				X	No repairs are required
NDE Was any NDE done. (MI coordinator to review results)				X	No NDE was performed at this inspection
Recommendations or corrective actions : Vessel is Fit for Service or describe corrective actions required) (MIC to review corrective actions with Operations, discuss with Chief Inspector where necessary, and get remedial action implemented) Other Observations: Recommendations: No recommendations at this time. Summary: This vessel is in good condition, visual external and internal carried out – no pitting detected – all internals well supported

nozzle attachment welds to shell

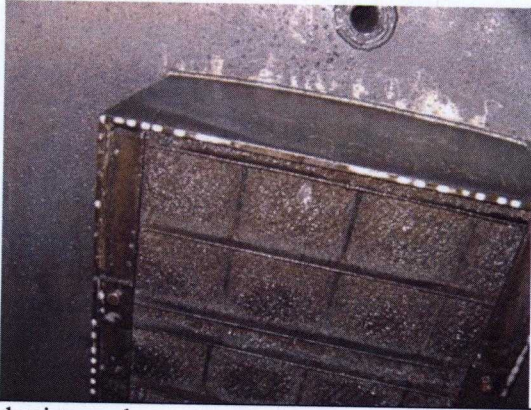
Top Head Note all corrosion, erosion or mechanical damage. (If vessel is horizontal identify direction of this head)	X				West head – man way access – no mechanical damages- no corrosion or erosion
Bottom Head Note all corrosion, erosion or mechanical damage. (If vessel is horizontal identify direction of this head)	X				East head – no mechanical damage –no erosion or corrosion-head attachment weld in good condition
Shell Sections Record number of shell sections. Record location, size and depth of all erosion, corrosion or mechanical damage. Describe general condition. If any corrosion greater than corrosion allowance is observed in either shell or head, discuss with Chief Inspector before closing vessel.	X				3 shell sections- no mechanical damage or erosion – no dents – attachment welds in good condition no erosion no corrosion or erosion noted
Demister pad Is it in place? Is it clean? If any corrosion is apparent in vessel, lift pad and check top head for corrosion.	X				Pad is dirty – no corrosion behind pad on shell- bolts are securely fastened

demister pad

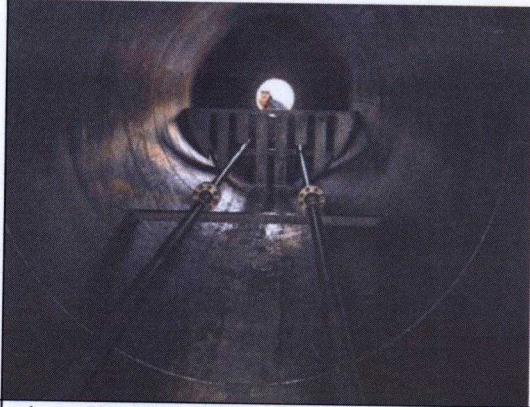
view of internal

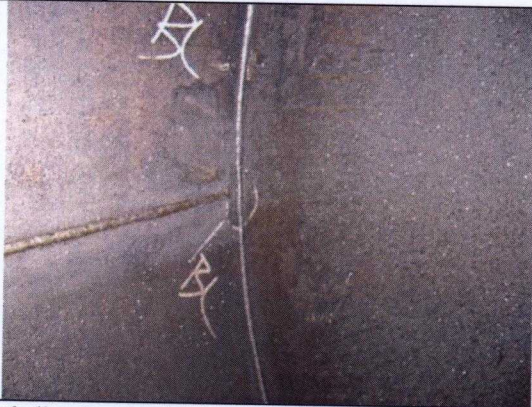
shell to head weld

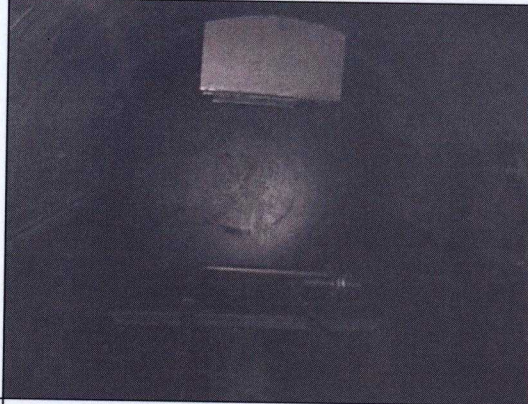
view of east head and supports

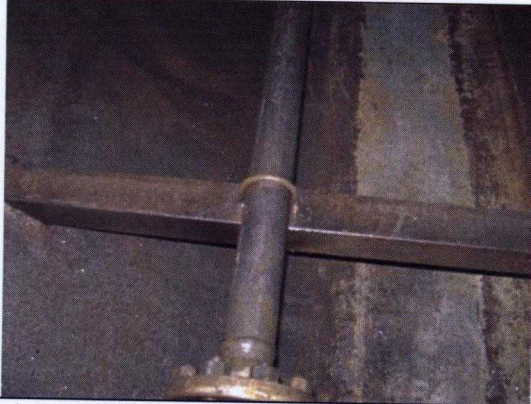
piping support and clamp

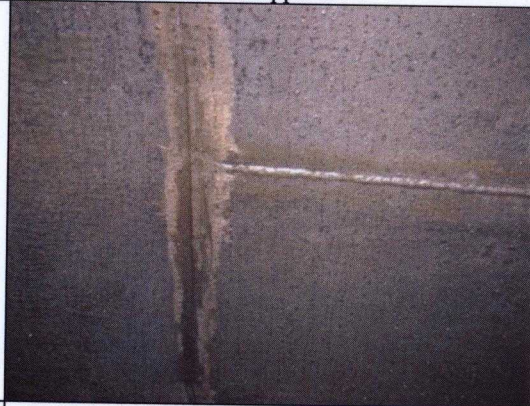
shell tee weld

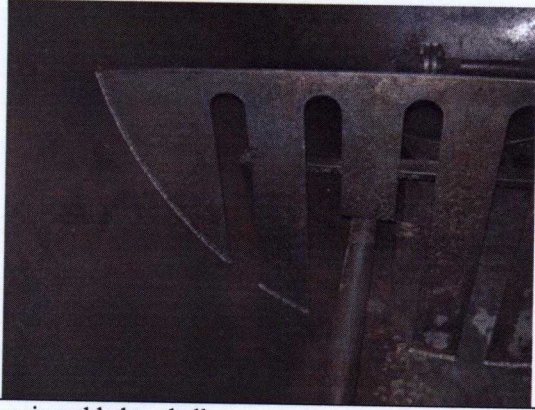
Internal Inspection Items	G	F	P	N/A	Comments
Coating Assess coating. Describe area coated, general condition of coating.				X	vessel not coated
Anodes. How many, type, condition. % consumed. Are they being replaced?				X	No anodes in vessel
Internal Piping Is there any? If so, carbon or stainless steel. Describe condition, dents, corrosion, erosion, etc. Ensure supports are secure and any bolts are suitable for future use.	X				Heat medium piping-no corrosion or erosion noted Attachment welds are in good condition – no dents – no structural overloads or deflection – piping is carbon steel All clamps and supports are in place
Trays How many? Type of material. Are valves in place. Check for erosion/ corrosion; wear on tray valve legs. Cleanliness?				X	No trays in vessel
Baffles, deflector plates, etc. If present, describe condition. Look closely at welds attached to vessel wall.	X				Deflector plate is welded directly to top shell of vessel – no service related damages- no erosion or corrosion noted weir – attachment weld in good condition – no dents or deflections

weir welded to shell

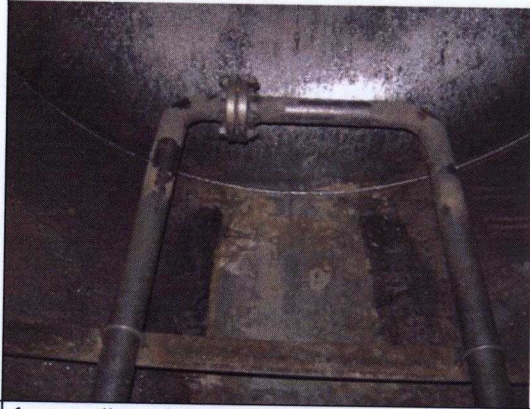
heat medium piping and east head

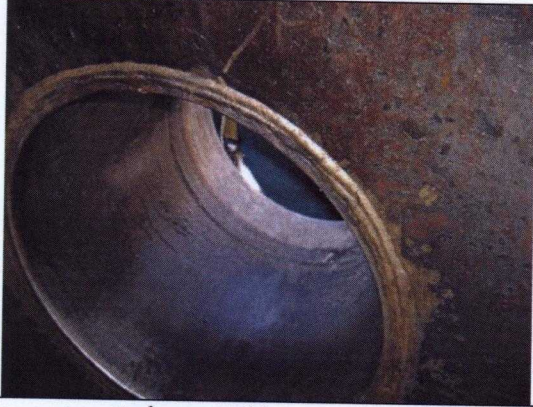
man way attachment weld

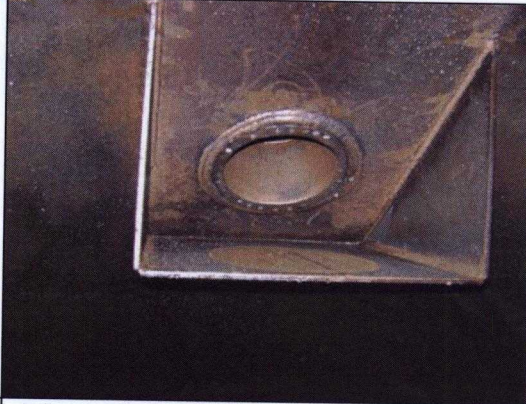
deflector plate and nozzle

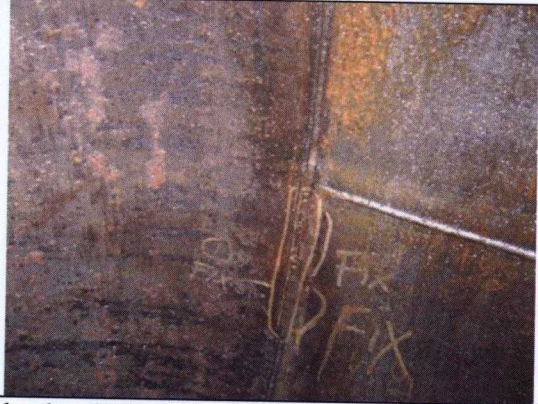
head to shell weld
