**Canadian Natural Resources Limited
GENERAL PRESSURE VESSEL INFORMATION**

Job # 10.112596

District: Fort St. John BC.	Skid No.
Facility: Cypress Gas Plant	Location (LSD): b-99-C/94-B-16
Vessel Name Equipment Number: Acid Gas Scrubber	
Orientation: Vertical	
Status: In Service	Regulatory Inspection

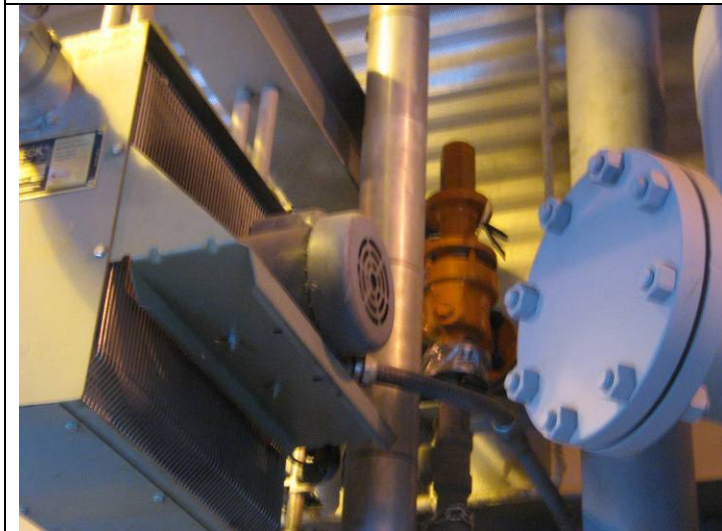
vessel PSV

Valving Ensure no leaks are visible. Valves are properly supported and chained if necessary.	X				No leaks are visible- valves are supported properly.
PSV Ensure PSV is set at pressure at or below that of vessel.	X				Location: Outlet piping - set at MAWP of vessel. Block valve between vessel and PSV- valve locked in open position. PSV seal in place. Discharge piping is same size as valve outlet.
