**Field Inspection Report - CNRL**

**Internal Inspection**

**STORAGE TANK SURVEY DRAWING**

**MAGNETIC FLUX LEAKAGE (MFL) REPORT**

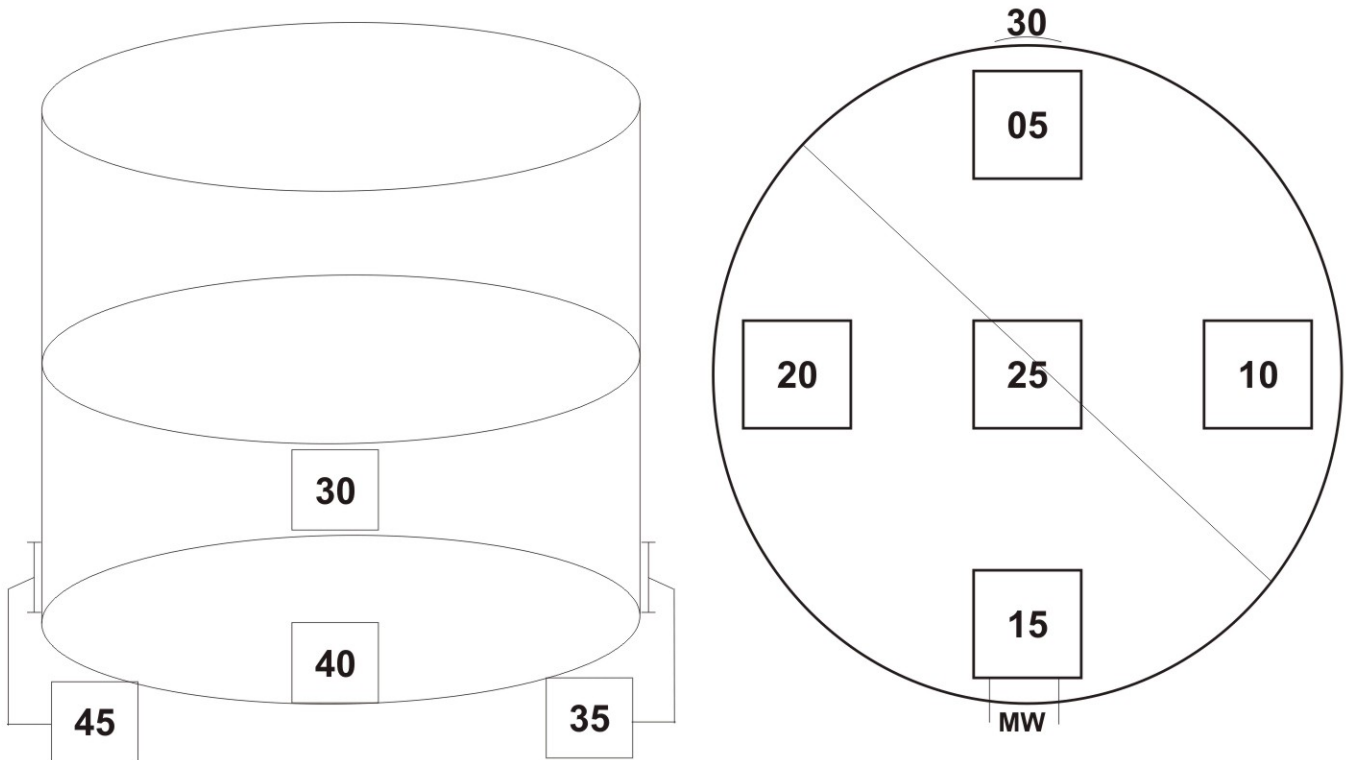
#	LOW	AVG	#	LOW	AVG
05	0.252	0.260	35	0.252	0.260
10	0.254	0.265	40	0.253	0.265
15	0.251	0.260	45	0.247	0.260
20	0.244	0.260			
25	0.247	0.260			
30	0.248	0.255

NOTE: EACH TML REPRESENTS A 12" x 12" SCANNING AREA

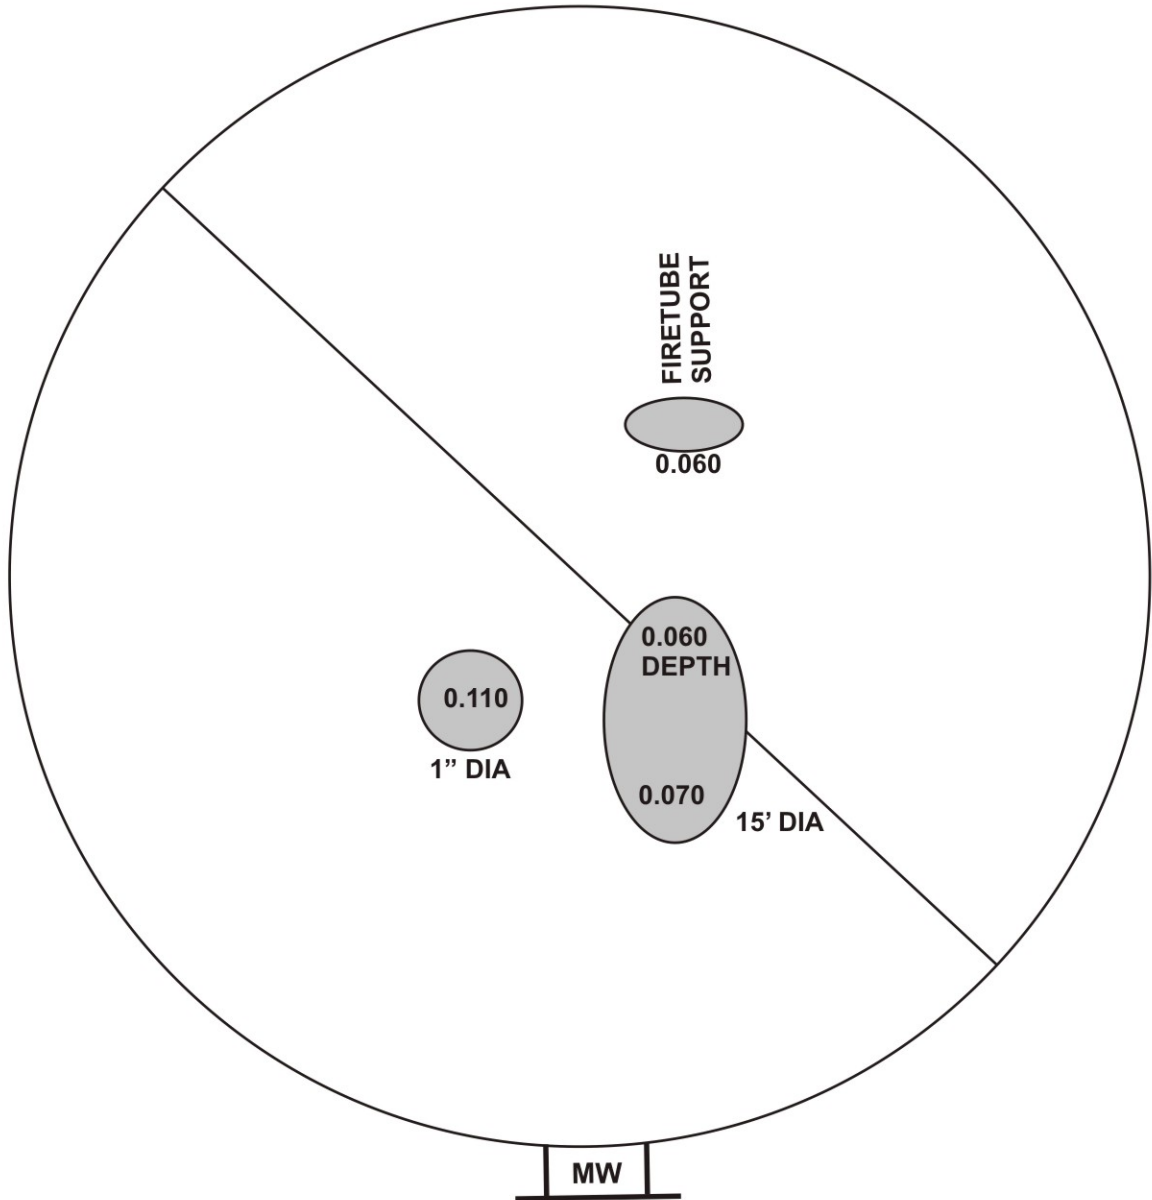
MAGNETIC FLUX LEAKAGE FLOOR SCAN PERFORMED ON TANK FLOOR. ANY AREAS OF NOTABLE UNDERSIDE CORROSION THAT ARE LOCATED SHALL BE PROVED WITH UT THICKNESS VERIFICATION.

NO SIGNS OF UNDERSIDE CORROSION WERE FOUND USING THE MFL AND UT SCANS. INTERNAL PITTING FOUND.

RECOMMEND TO MONITOR CORROSION ON FLOOR.
