Registration #:
 C81071
 Equipment Name:
 AST
 Province:
 Alberta

Internal Inspection

STORAGE TANK SURVEY DRAWING

MAGNETIC FLUX LEAKAGE (MFL) REPORT

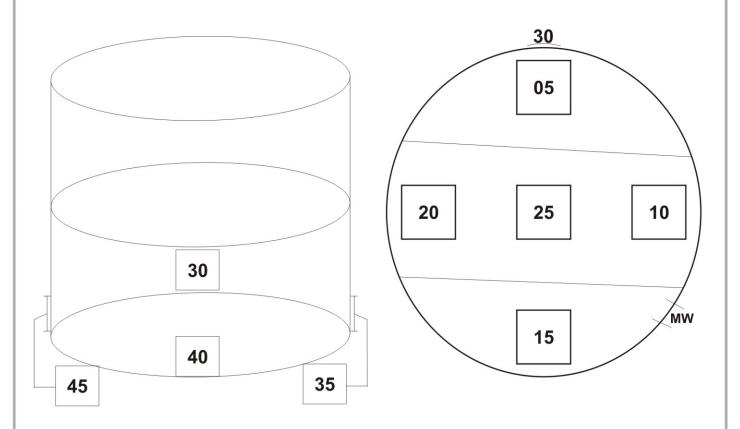
#	LOW	AVG	#	LOW	AVG
05	0.212	0.235	35	0.188	0.195
10	0.245	0.255	40	0.189	0.195
15	0.233	0.250	45	0.190	0.200
20	0.236	0.250			
25	0.248	0.255			
30	0.187	0.200

NOTE: EACH TML REPRESENTS A 12" x 12" SCANNING AREA

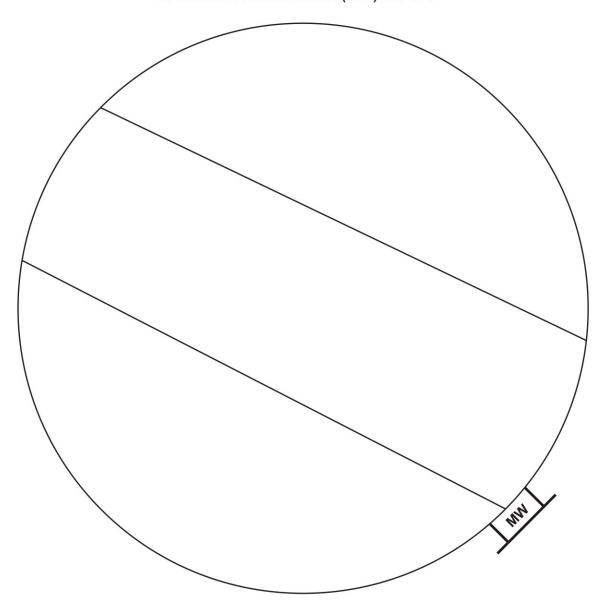
MAGNETIC FLUX LEAKAGE FLOOR SCAN PERFORMED ON TANK FLOOR.
ANY AREAS OF NOTABLE UNDERSIDE CORROSION THAT ARE LOCATED SHALL BE PROVED WITH UT THICKNESS VERIFICATION.

NO SIGNS OF UNDERSIDE CORROSION WERE FOUND USING THE MFL AND UT SCAN.
