G	ENERA	L TANK	INFORMATIO	ON				
District: Slave Lake			Skid No.: CB33						
Facility: Central Pads			Location (LSD): 01-07-081-20W4						
Name & Equip No: AST - C81068			Orientation:	Vertical					
Company: CNRL				Cost Code:					
Status: Operating				Operating Prov	rince:	Alberta			
Unit:	W.O/P.O No.:			Unique ID:				ONCOR ID: 65	5412
		TANK	NAME	PLATE DATA					
Registration Number: C8:	1068			Registration Number (Other):					
Serial Number: G-97-338-9	90			Tank Height: 288.00 (In) 7315.20 (mn			(mm)		
Manufacturer: G.L.M. TAN	NKS			Tank Diameter	:	207.00	(In)	5257.80	(mm)
Year Built: 1998				Tank Volume:		1000.00			
Type:				Floor Material:					
Secondary Containment:	Yes			Floor Thicknes	s:	0.25	(In)	6.35	(mm)
External Cathodic Protection:	Yes			Roof Material:					
Corrosion Allowance: (In) (mm)			Roof Thickness	s:	0.25	(In)	6.35	(mm)	
Internally Coated:			Containment L	ength:		(In)		(mm)	
Skid Mounted: No			Containment Width: (In)			(mm)

## **Internal Inspection**

## STORAGE TANK SURVEY DRAWING

MAGNETIC FLUX LEAKAGE (MFL) REPORT

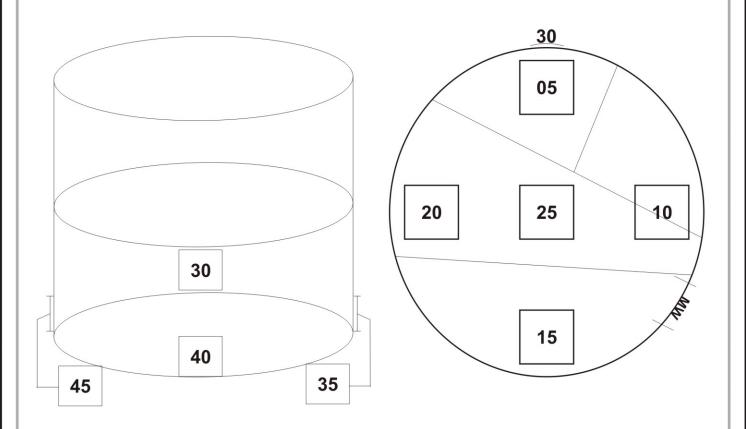
#	LOW	AVG	#	LOW	AVG
05	0.230	0.245	35	0.246	0.255
10	0.233	0.245	40	0.244	0.260
15	0.240	0.250	45	0.250	0.260
20	0.239	0.250			
25	0.241	0.250			
30	0.248	0.255

NOTE: EACH TML REPRESENTS A 12" x 12" SCANNING AREA

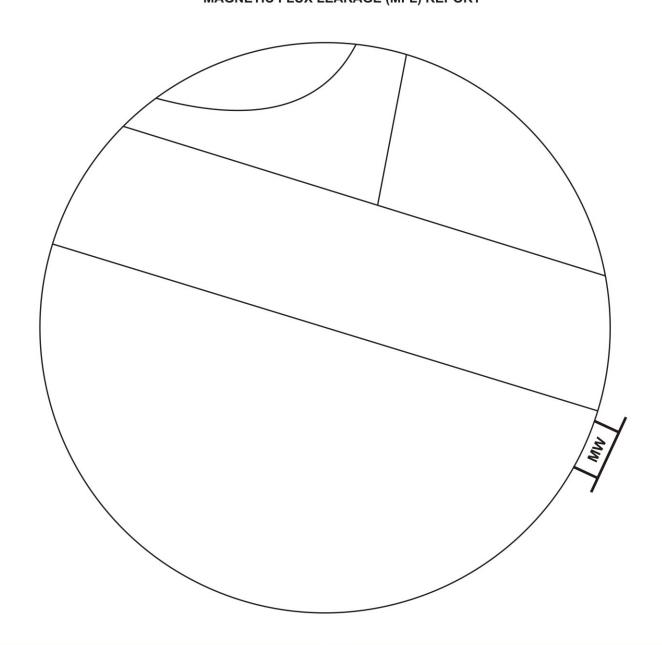
MAGNETIC FLUX LEAKAGE FLOOR SCAN PERFORMED ON TANK FLOOR.
ANY AREAS OF NOTABLE UNDERSIDE CORROSION THAT ARE LOCATED SHALL BE PROVED WITH UT
THICKNESS VERIFICATION.

NO SIGNS OF UNDERSIDE CORROSION WERE FOUND USING THE MFL AND UT SCAN.
