GENERA	L TANK	INFORMATIO	ON				
District: Slave L	ake			Skid No.:	BAR1				
Facility: Barney Pads			Location (LSD): 09-13-080-21W4						
Name & Equip No: AST - C81055			Orientation: Vertical						
Company: CNRL				Cost Code:					
Status: Shut-Ir	1			Operating Province: Alberta					
Unit:	W.O/P.O No	u:		Unique ID: ONCOR ID: 64856					
		TANK	NAME	PLATE DATA					
			Registration Nu	ımber (0	Other):				
Serial Number: F-9	7-019-12			Tank Height:		288.00	(In)	7315.20	(mm)
Manufacturer: GLI	M TANKS & EQUIPMENT LTD			Tank Diameter	:	183.00	(In)	4648.20	(mm)
Year Built: 1997				Tank Volume: 750.00					
Туре:				Floor Material:					
Secondary Containme	nt: Yes			Floor Thickness: 0.25 (In)		6.35	(mm)		
External Cathodic Protection: Yes			Roof Material:						
Corrosion Allowance: (In) (mm)			Roof Thickness	i:	0.19	(In)	4.78	(mm)	
Internally Coated: No			Containment L	ength:		(In)		(mm)	
Skid Mounted: No			Containment Width: (In)			(mm)

Internal Inspection

STORAGE TANK SURVEY DRAWING

MAGNETIC FLUX LEAKAGE (MFL) REPORT

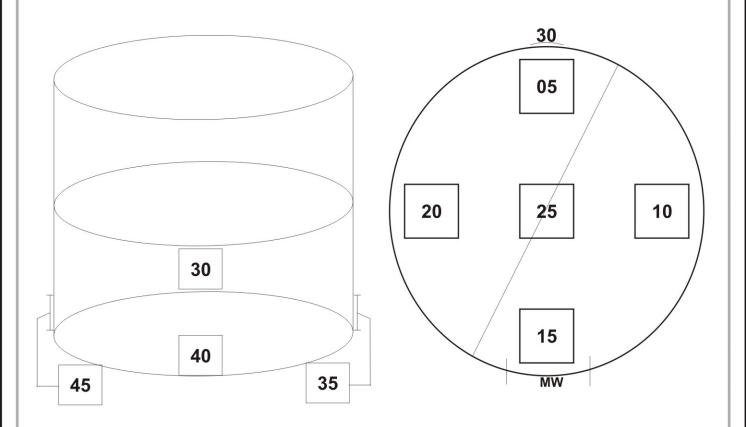
#	LOW	AVG	#	LOW	AVG
05	0.232	0.250	35	0.184	0.195
10	0.236	0.250	40	0.182	0.190
15	0.246	0.260	45	0.182	0.190
20	0.225	0.240			
25	0.239	0.250			
30	0.184	0.195

NOTE: EACH TML REPRESENTS A 12" x 12" SCANNING AREA

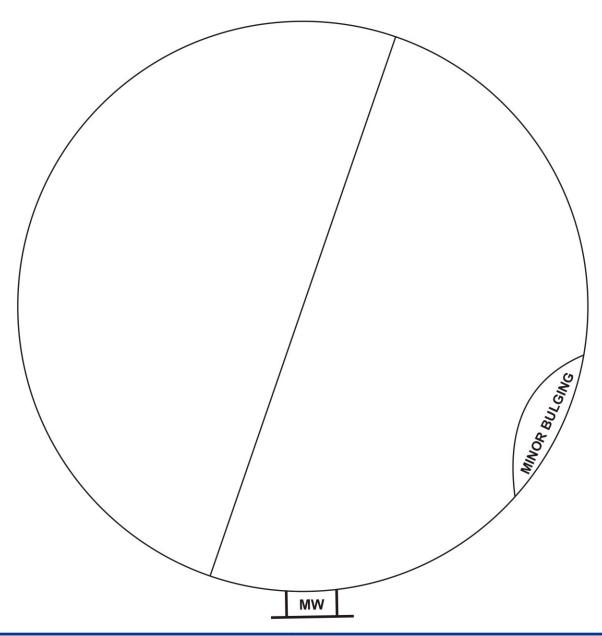
MAGNETIC FLUX LEAKAGE FLOOR SCAN PERFORMED ON TANK FLOOR.
ANY AREAS OF NOTABLE UNDERSIDE CORROSION THAT ARE LOCATED SHALL BE PROVED WITH UT
THICKNESS VERIFICATION.

NO SIGNS OF UNDERSIDE CORROSION WERE FOUND USING THE MFL AND UT SCAN.
