Canadian Natural Resources Limited GENERAL PRESSURE VESSEL INFORMATION Job 10.113250										
District: Fort St	. John		Skid No.							
Facility: Millig	an Battery	Location (LSD): b-63-G/94-H-02								
Vassal Nama Equ	uipmont Numbor:									
vessei Name Equ										
Orientation: Hor	rizontal									
Status: In S	Service	Regulatory Inspection								
	I	PRESSURE VES	SSEL NA	AME	PLATE DATA	L				
"A" or "G	" or "S" (Sask.) or BC Regi	CRN Number:								
	A0225408		F 5480 21							
Vessel serial nun	nber: 85C-3422-01	Size: 12 ft. x 24ft.								
Shell thickness:	19 mm	Shell material: SA 516 70								
Head thickness:	17.2 mm		Head material: SA 516 70							
Tube wall thickne	ess:		Tube material:							
Tube diameter:			Tube length:							
Channel thicknes	s:		Ch	annel material:		r				
Design pressure	Shell: 862 kPa			Operating pressure			Shell:			
	Tubes:						Tubes:			
Design Temp.	Shell: 66° C			Operating temperature		Shell:

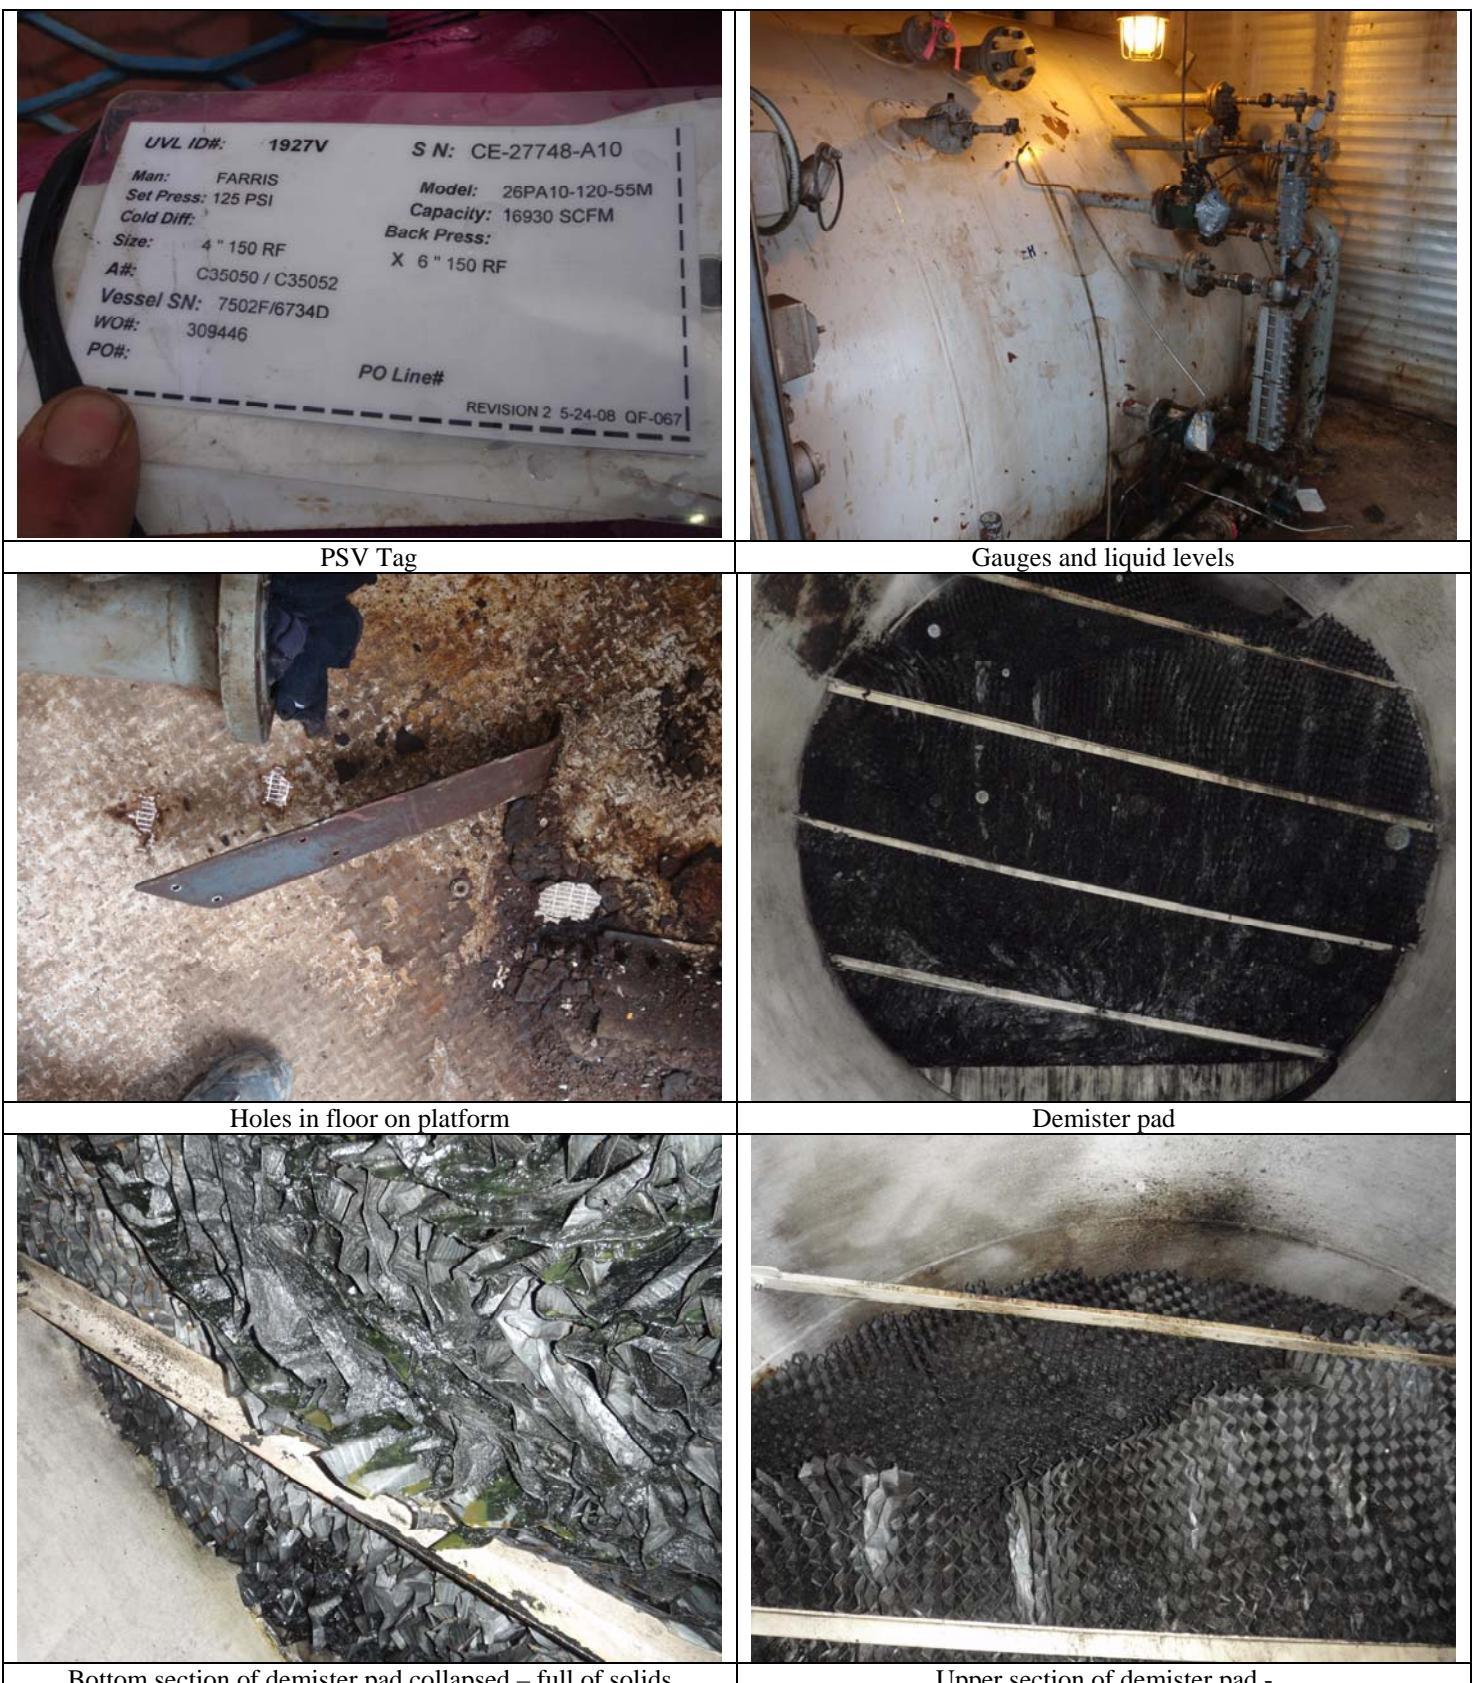
Bottom section of demister pad collapsed - full of solids

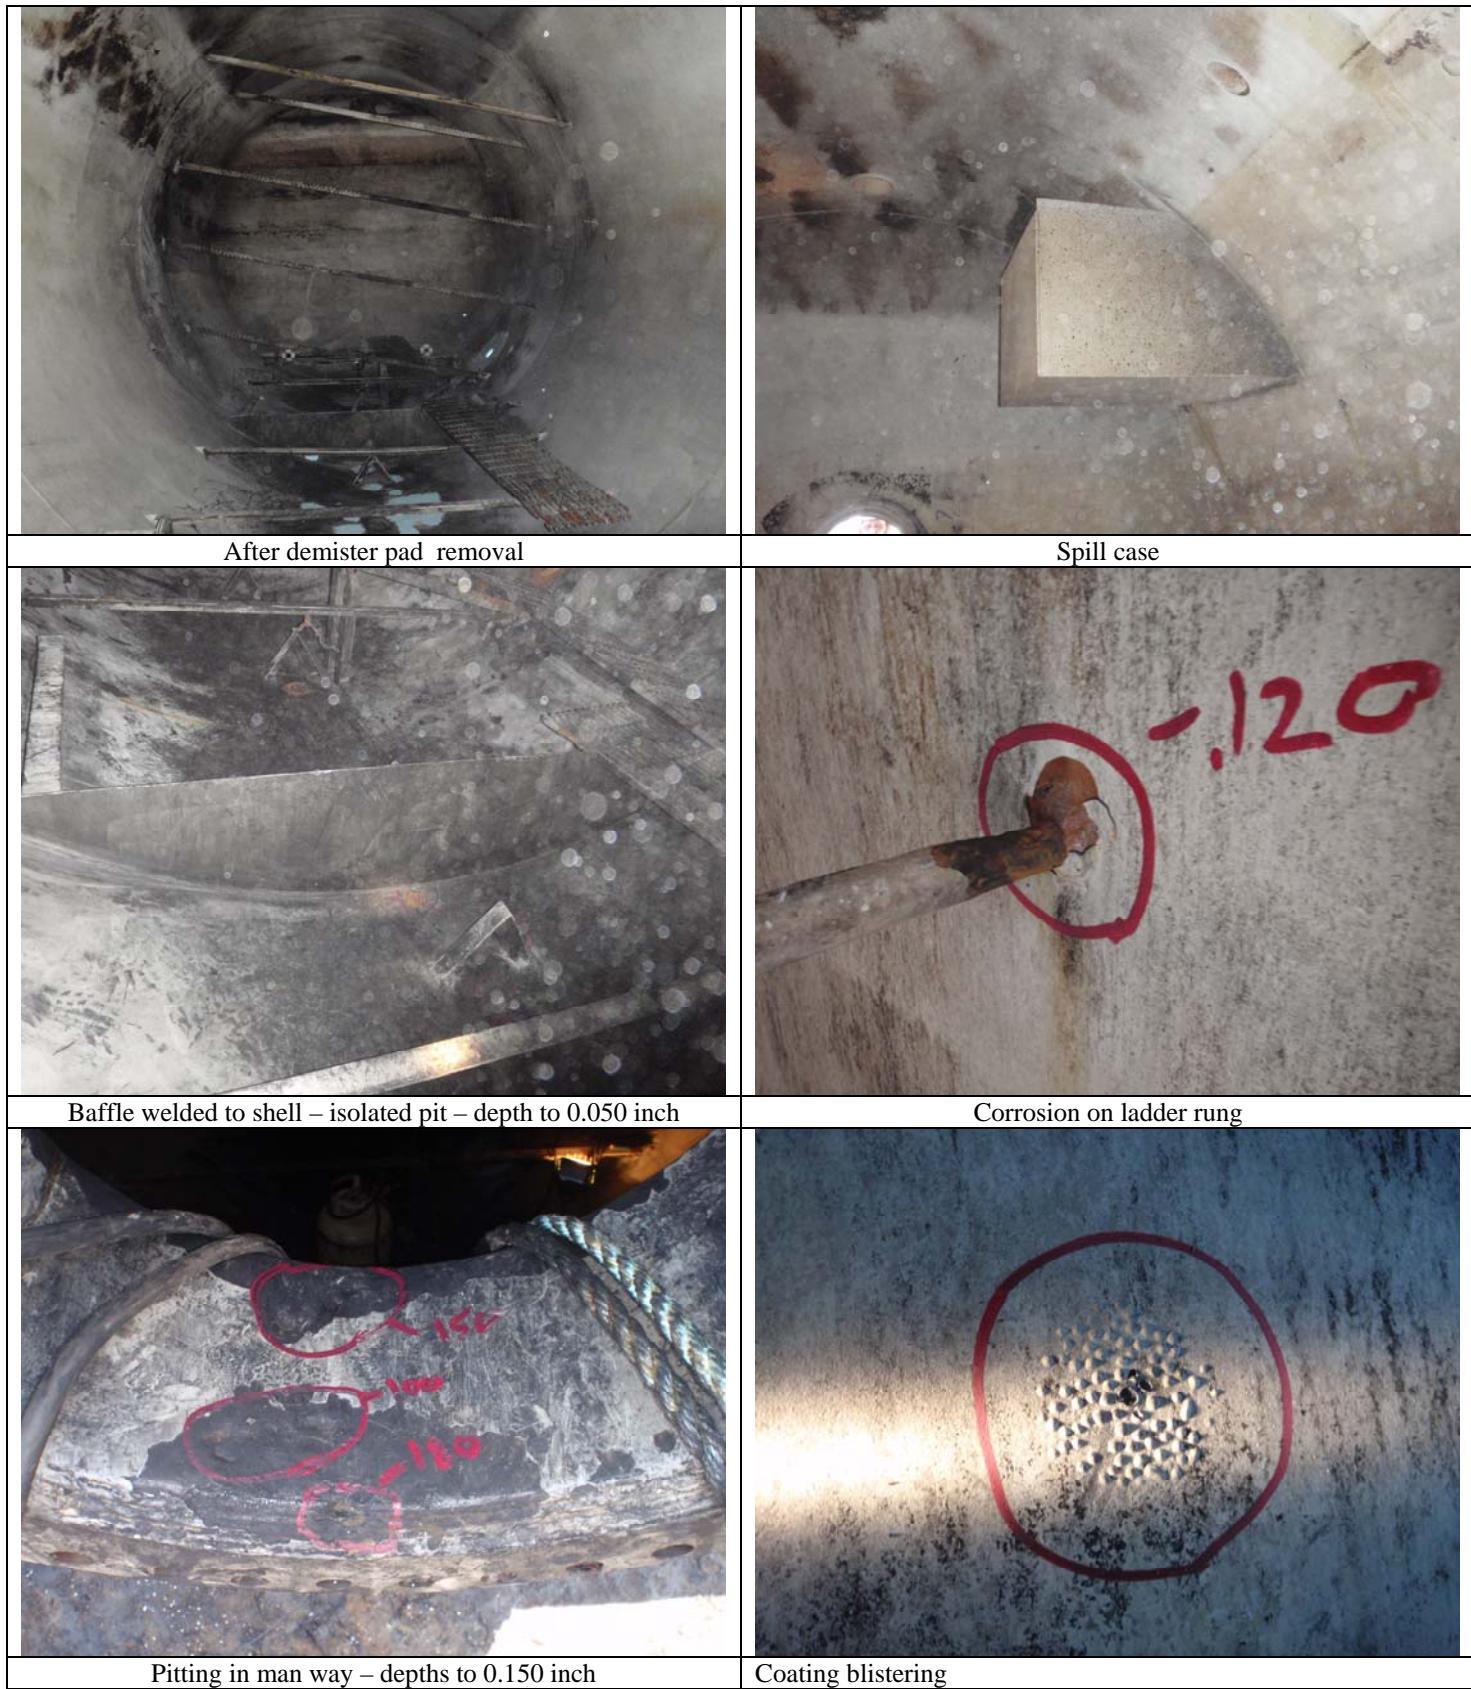
Internal Inspection Items		F	P	N/A	Comments
Coating Assess coating. Describe area coated,		Χ			Internal surface is 100% coated with epoxy – coating
general condition of coating.					failure to 5% of total area - three 3 inch nozzles with total
					coating loss – blistering and failed coating along 6 o'clock
					region
Anodes. How many, type, condition. %			Х		Two anode removed from vessel – in poor condition - over
consumed. Are they being replaced?					60% consumed
Internal Piping Is there any? If so, carbon or			Х		Internal piping removed for inspection – poor condition –
stainless steel. Describe condition, dents,					through wall corrosion – Internal piping has no use and
corrosion, erosion, etc. Ensure supports are					will not be reinstalled after inspection
secure and any bolts are suitable for future					
use.				N 7	N
Trays How many? Type of material. Are				Х	None
valves in place. Check for erosion/ corrosion;

Coating blistering

Recommendations: 1. Cut out and replace corroded nozzles #2 and #3 - Weld build-up on corroded nozzle #1. Grit blast failed epoxy coating on bottom shell from 5 – 7 o'clock position for entire length of shell and inside repaired nozzles. Re coat epoxy to bottom shell. Repair minor coating damage around man way, internal supports and ladder with Devoe 142 Summerry Vascal is in overall good condition visual external inspection and ultrasonic corrosion survey performed – no metal
