**Canadian Natural Resources Limited
GENERAL PRESSURE VESSEL INFORMATION**

Job# 05.001890

District: Fort St. John BC	Skid No.
Facility: Dahl West Compressor Station	Location (LSD): b-89-H/94-H-7
Vessel Name Equipment Number: Inlet Separator	
Orientation: Horizontal	
Status: In Service	Regulatory Inspection

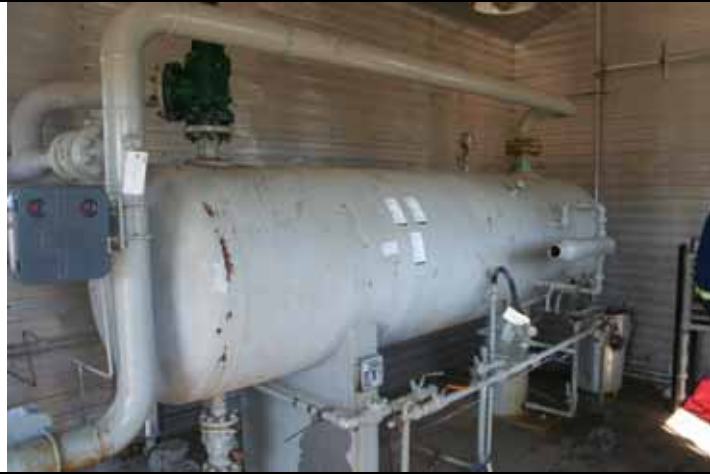
Vessel overview

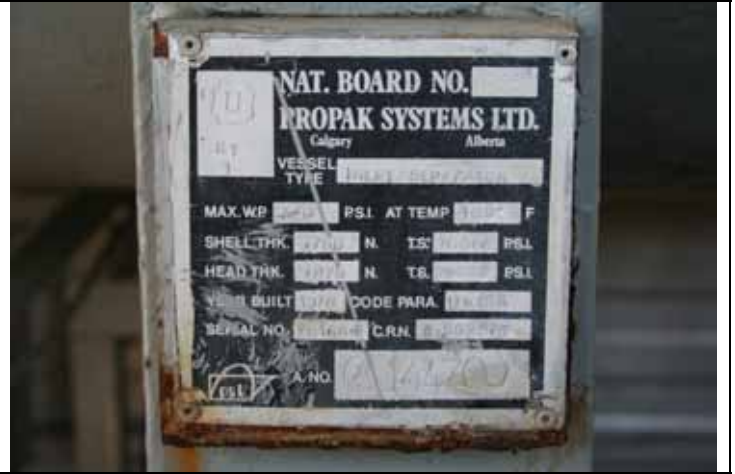
Data plate

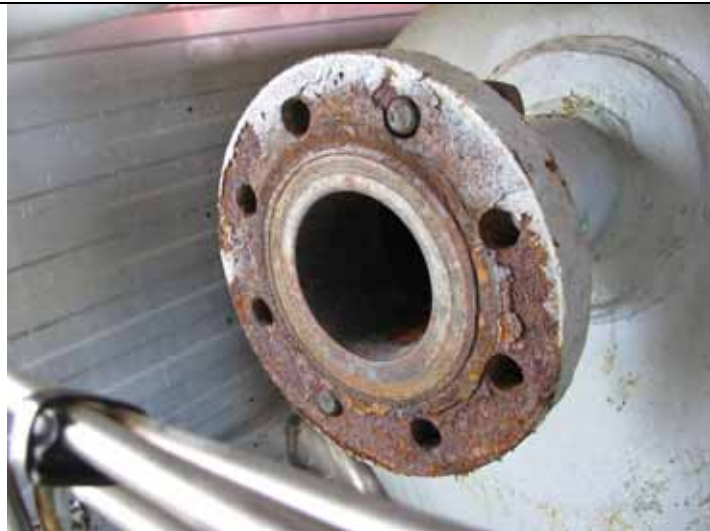
Pitting and corrosion to flange face.

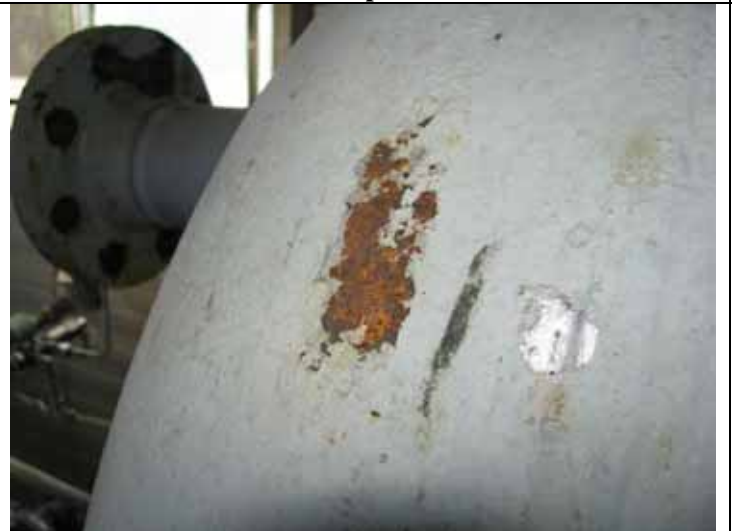
Minor pitting in areas of paint failure on shell and head.

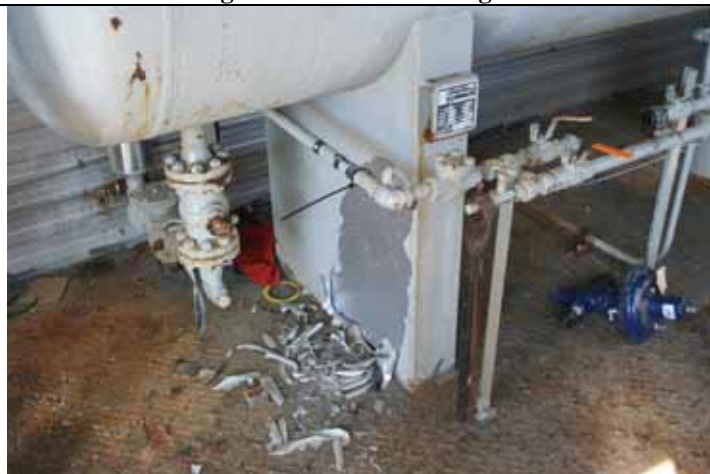
Saddle is in good condition and well supporting

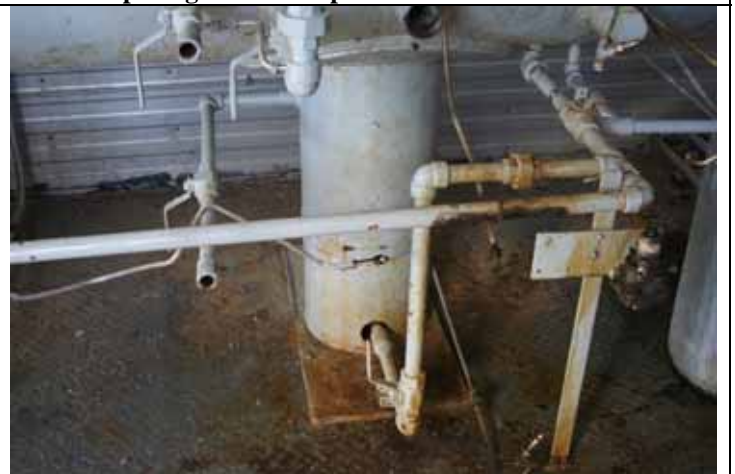
No internal or external corrosion on boot.

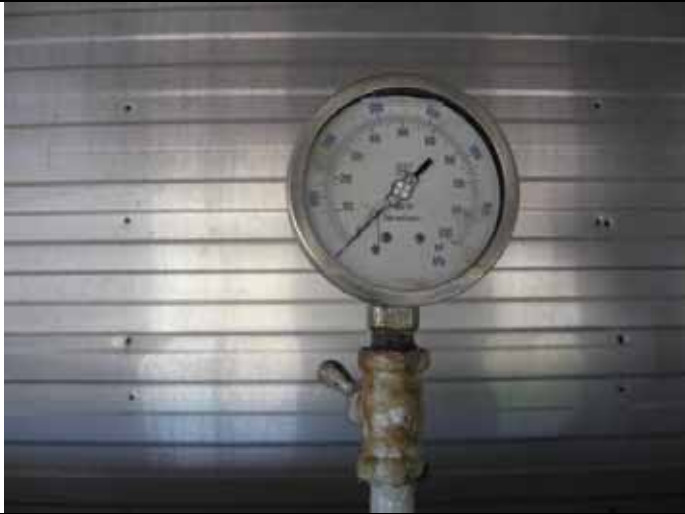
Pressure gauge

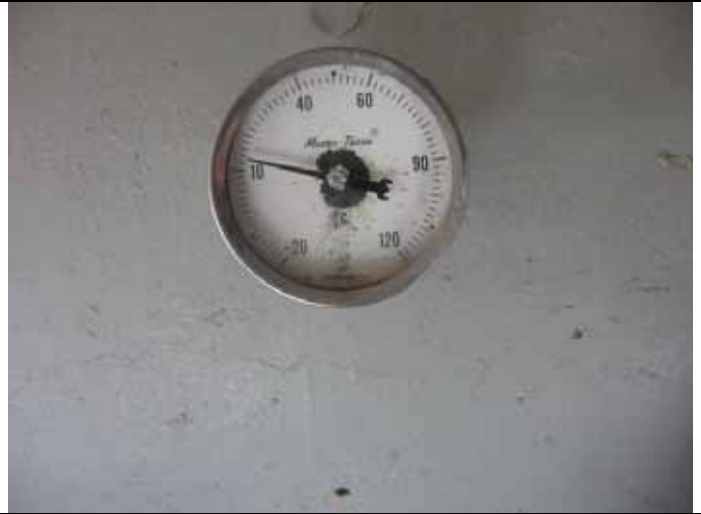
Temp gauge

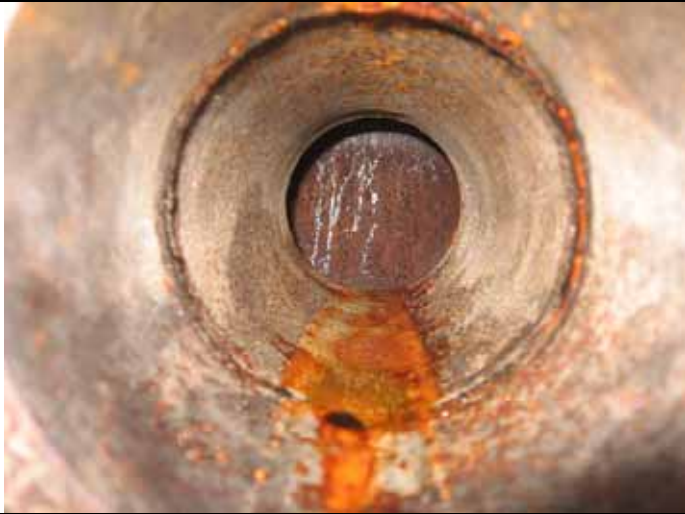
Outlet nozzle with diffuser in place

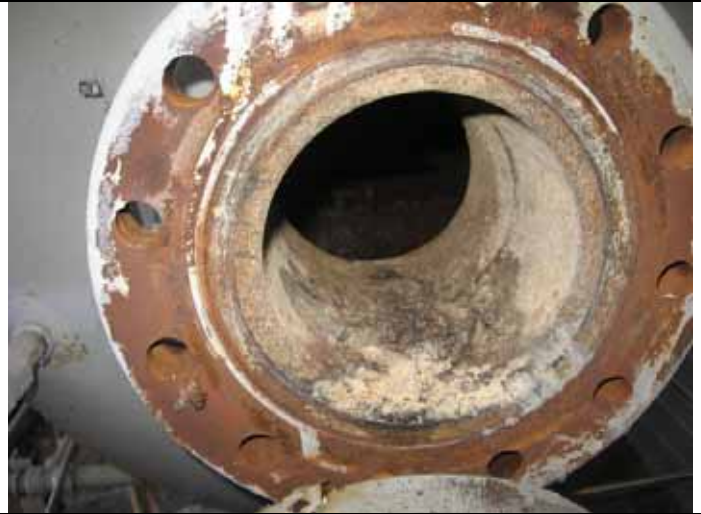
Inlet nozzle

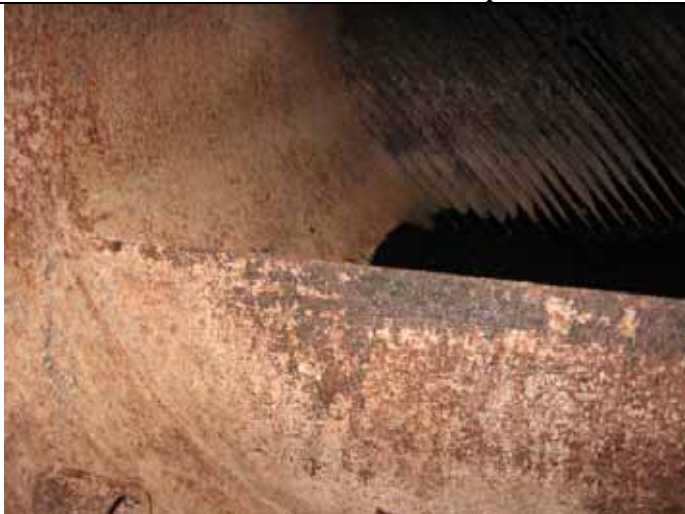
Weir and vain pack

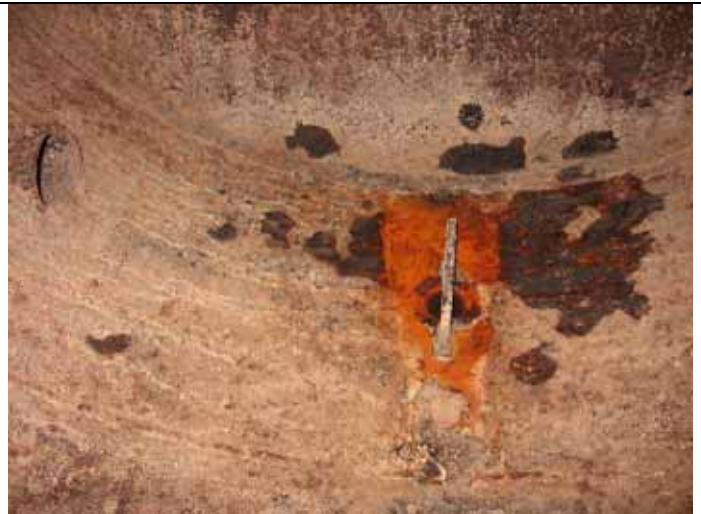
Water dump nozzle
