PR VIS	ESSURE '	VESSEL	Re Inspec	eport #:	156835-MD-01 07/06/2012
Canadian Na	atural	RE	PORT	Lonon	Insp. Co.	Page: Job #:	1 of 14 156835
Criticality Designation:		1	Yellow	<u>//</u>			
Insp. Comp: Matrix Inspe	ection District:	Grande	Prairie - No	rth	Fiel	d: Sout	h Hamburg
Location: 12-29-096-1	1W6 Unit / Skid #:		N/A		LSI	D: 12-29	9-096-11W6
Jurisdiction #: A020138	Equip Tag #:		V-13A		Serial	#: 8	2-609-1
CRN #: E5298.2	2 Nat'l Bd #:		N/A		Year Bui	lt:	1982
Manufacturer: Dacro Industries	E	quipment	Description	: Other: Storage	Tank (bi	ullet)	
Status: In Service - Stan MAWP Shell: 155 Psi	1009 Equ	Ip. Type: Volum	Vessel: Bull	let m ³		Service	
MAWP Tube:	<u>@ 150 1</u> @ Hei	aht/l enat	e. <u> </u>	 Ft.		Insulated	
MDMT: -29 °F	RT: RT-2 Size	/Diameter	r.: 144	in. O.D.		PWHT	
Support Saddle	Vessel on Orig	inal CNRI	Inventory L	ist: 🛛 Y 🗌 N	1	Manway	/: ⊠Y □N
C.A.: 1.6 mm	Coated: No	Clad: No	J	.E.: <u>N/A</u> Re	mote Acc	cess: 🗌

PRESSURE VESSEL VISUAL INSPECTION REPORT

156835-MD-01 07/06/2012 2 of 14

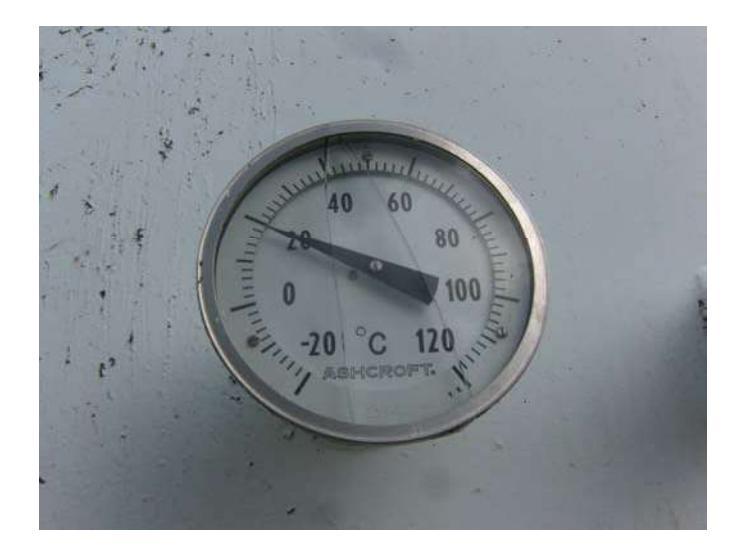
The temperature gauge sight lense is cracked

03 cracked temperature gauge

Clean the vessel and touch up the coating to aid in corrosion protection. Consider replacing the temperature gauge sight lense Ensure the saddle anchors are secure prior to fireproofing Secure npt plug Ensure all flange connections are secure and tight

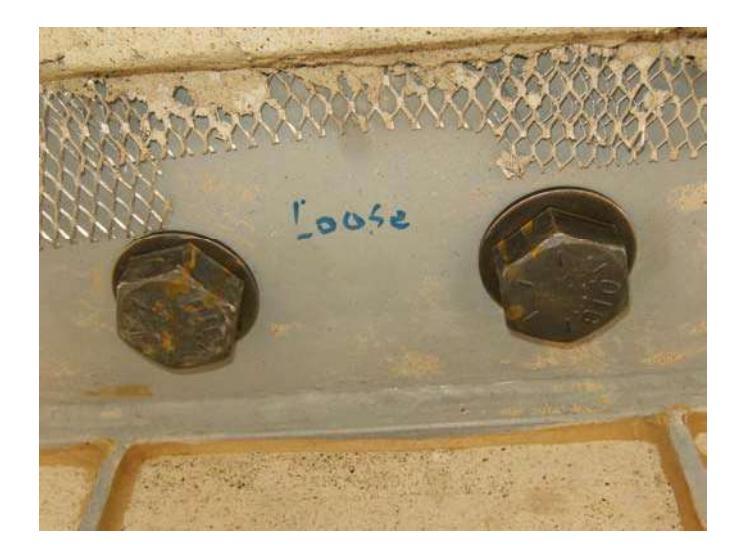
The saddles and supports are partially fireproofed, exposed for inspections on the anchor bolts There are loose anchor bolts on the saddles There is a loose npt plug on the top of the bullet ball valve

05 loose anchor bolts

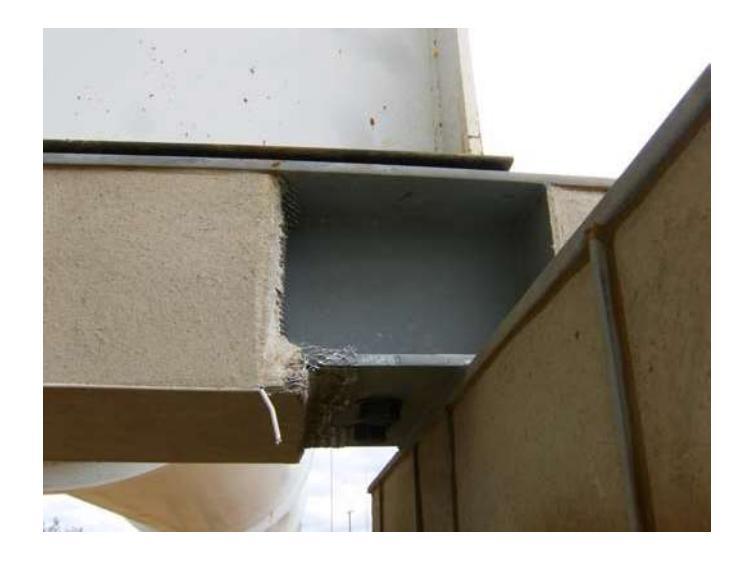
06 exposed fireproofing

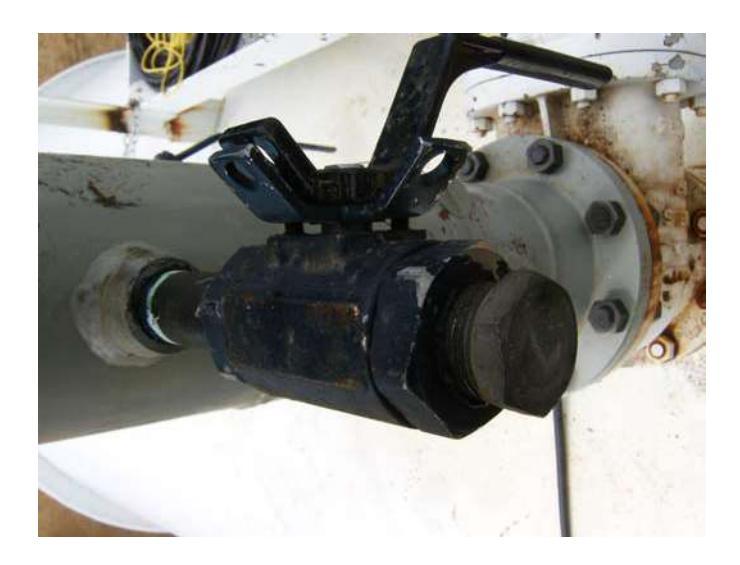
08 loose npt plug

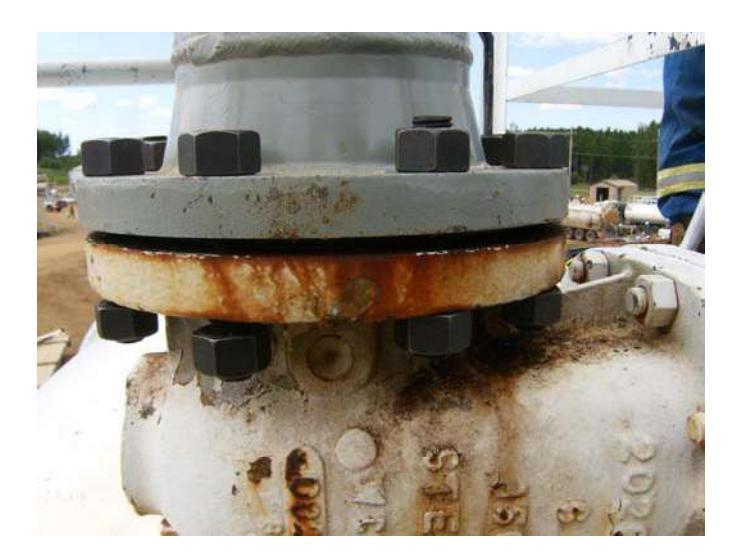
There are loose nuts to stud assembly on the 6" valve to flange connection on the top of the bullet

09 loose hardware

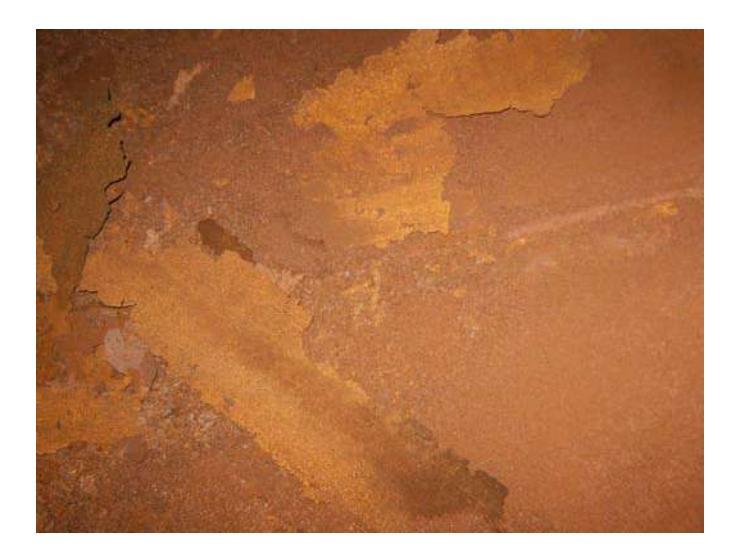
The entire internal surface of the bullet has a thin scale film with no significant evidence of mechanical damage or service damage

11 film scale throughout bullet

Clean and remove scale film from the bullet

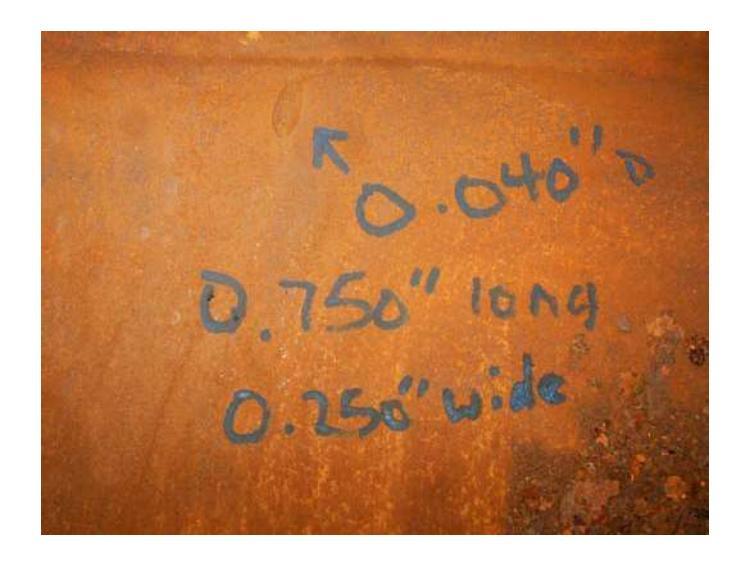
There is a pit on the 3rd shell from the North head (6 o'clock position) 0.040" deep, 0.75" long by 0.25" wide - acceptable to API 510

12 pit
