## Pressure Vessel Static Information

| <b>Manufacturer:</b> Western Rock Bit Co. Ltd. | | <b>Equipment Description:</b> LPG STORAGE BULLET |

External Inspection Complete: 2014-08-18

| <b>Report ID:</b> CNR-PVI-14-00014-32 | | <b>Inspector Job Number:</b> | |

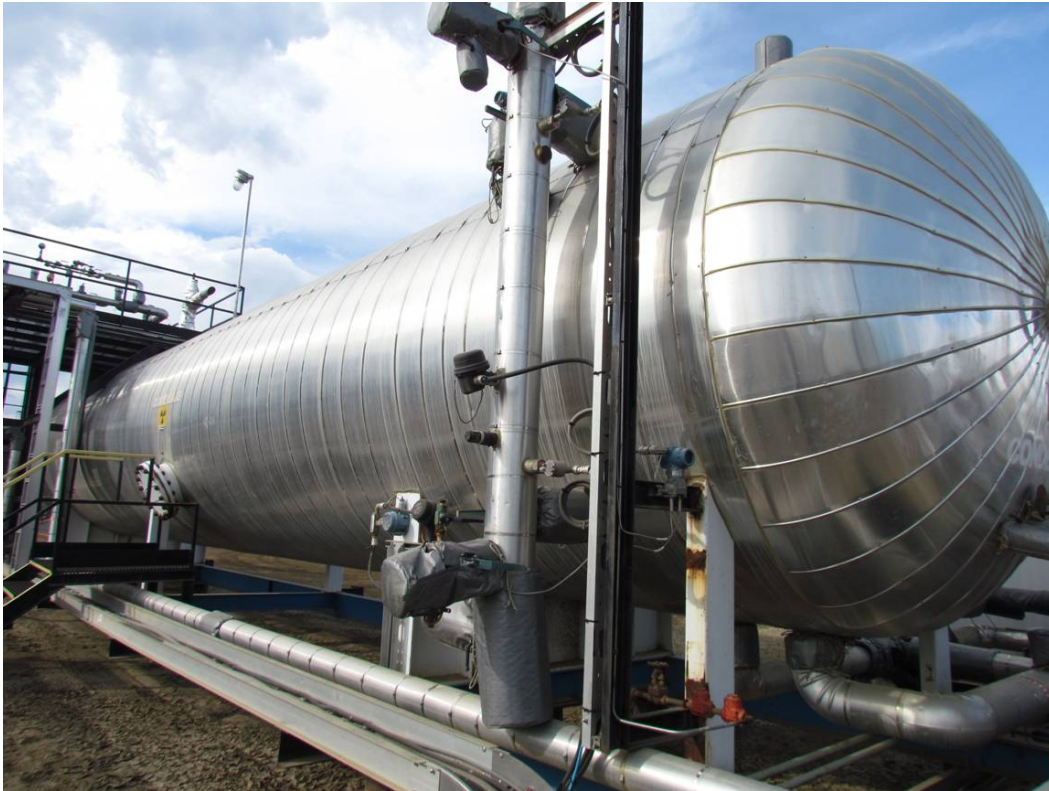
**Description:** General view of vessel

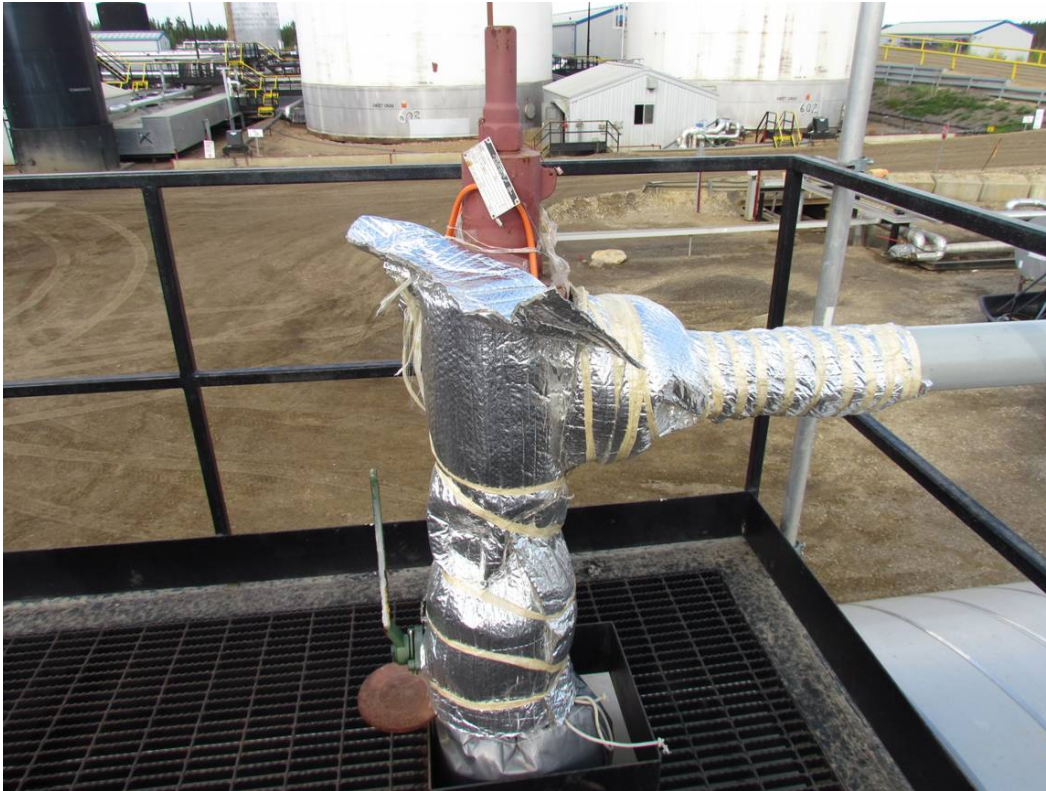
**Description:** General view of PSV
