**PRESSURE VESSEL  
VISUAL INSPECTION  
REPORT**

Report #: **141168-SS-116**  
 Inspect Date: 04/21/2010  
 Page: 1 of 10  
 Insp. Co. Job #: 141168

Insp. Comp: Matrix\_Inspection District: Medicine Hat - West Field: Taber  
 Location: 10-17-011-16W4 Unit / Skid #: N/A LSD: 09-17-011-16W4  
 Jurisdiction #: A0426433 Equip Tag #: N/A Serial #: 66759  
 CRN #: M5100.23 Nat'l Bd #: N/A Year Built: 1997  
 Manufacturer: Bromley Mechanical Equipment Description: Other: Separator  
 Status: In Service - Equip. Type: Vessel: Separator Service: Sour  
 MAWP Shell: 4964 kPa @ 38 °C Volume: N/A Code Stamp:  Y  N  
 MAWP Tube: N/A @ N/A Height/Length: N/A Insulated:  Y  N  
 MDMT: -20 °F RT: RT-1 Size/Diameter.: N/A PWHT:  Y  N  
 Support: Skirt Vessel on Original CNRL Inventory List:  Y  N Manway:  Y  N  
 C.A.: \_\_\_\_\_ Coated: No Clad: No J.E.: \_\_\_\_\_ Remote Access:  - \_\_\_\_\_

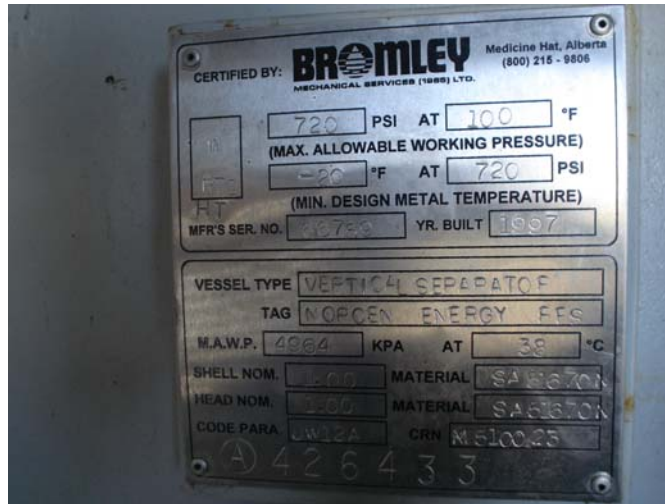
Figure 1\_Nameplate\_21April2010

Nameplate secure & legible.

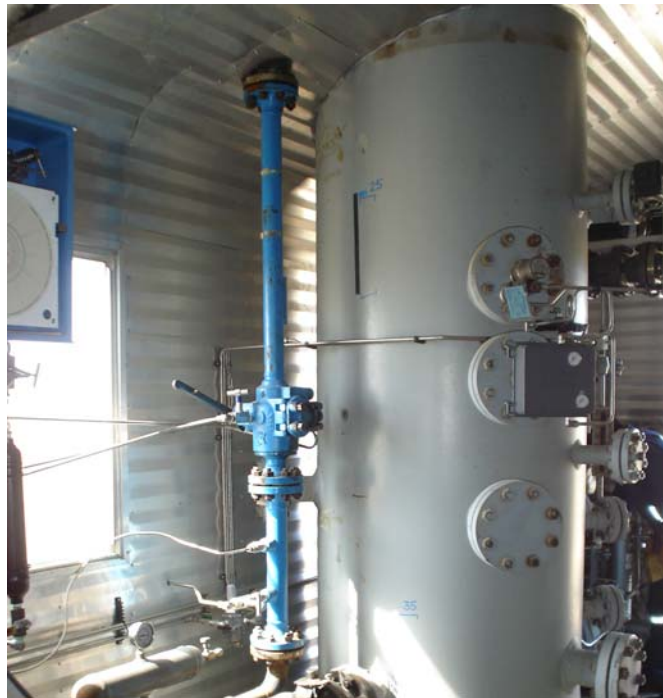
Figure 2\_Sideview\_21April2010

Vessel not in service at time of inspection due to a power failure.  
 Separator is uninsulated and painted.  
 Nameplate secure & legible.  
 Shell, skirt and both heads in good condition with minor paint chips and scratches. Negligible corrosion at exposed areas.  
 Skirt welded to building floor. All stitch welds have no visible defects.  
 Vessel is ground through building on SW corner. Ground wire is securely attached with no damage visible.  
 Pressure gauge has no damage or defects visible. Reading 140 psi.  
 Sight glass also in good condition with no damage or defects visible.  
 No misalignment noted.  
 No leaks noted at time of inspection.  
 No service date found on PSV.
