**PRESSURE VESSEL  
VISUAL INSPECTION  
REPORT**

Report #: **156828-MD-30**  
 Inspect Date: 06/01/2012  
 Page: 1 of 14  
 Insp. Co. Job #: 156828

Insp. Comp: Matrix\_Inspection District: St Albert - South Field: Nevis  
 Location: 05-11-039-22W4 Unit / Skid #: N/A LSD: 05-11-039-22W4  
 Jurisdiction #: A0058221 Equip Tag #: N/A Serial #: C 9173  
 CRN #: 8591.2 Nat'l Bd #: N/A Year Built: 1959  
 Manufacturer: B.S. & B Equipment Description: Other: Horizontal Inlet Separator  
 Status: In Service - Standby Equip. Type: Vessel: Separator Service: Sour  
 MAWP Shell: 1200 Psi @ 100 °F Volume: N/A Code Stamp:  Y  N  
 MAWP Tube: @ Height/Length: 20 Ft. Insulated:  Y  N  
 MDMT: N/A RT: N/A Size/Diameter.: 45 in. I.D. PWHT:  Y  N  
 Support Saddle Vessel on Original CNRL Inventory List:  Y  N Manway:  Y  N  
 C.A.: Coated: N/A Clad: N/A J.E.: N/A Remote Access:  -

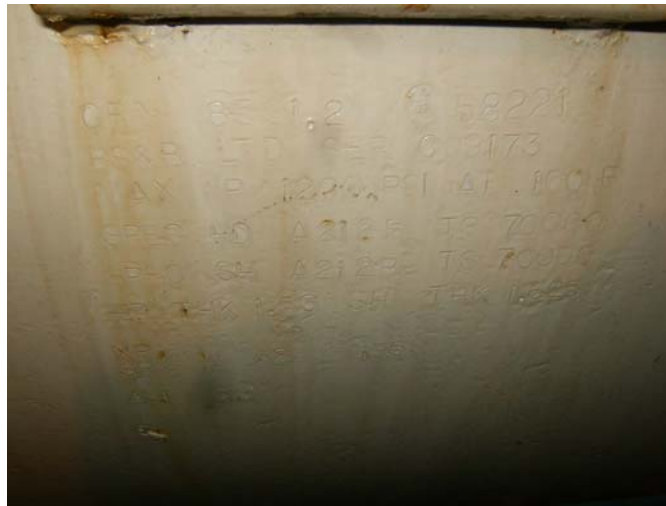
01.5 stamped static data

Stamped XR & 70 ksi Tensile

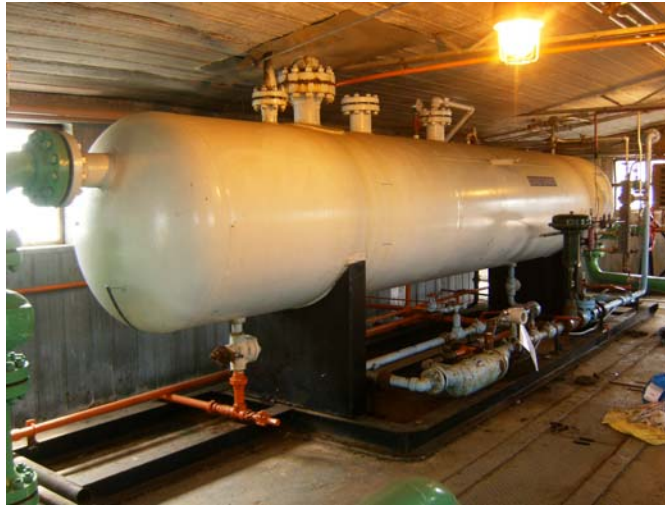
02 overview

The separator was not in operation at the time of inspection

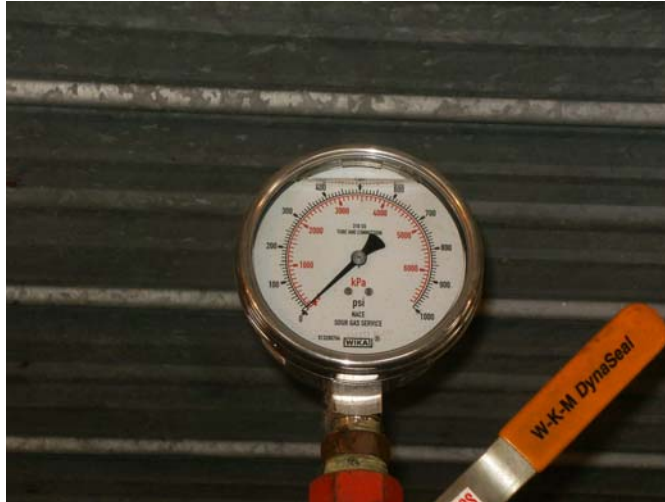
03 not within range

The pressure gauge is not within range of the MAWP

Clean and touch up the coating to aid in the protection against corrosion  
 Install missing studs on instrumentation flange  
 Confirm with operations that the vessel does not exceed gauge pressure, replace as required  
 Open block valve and install a lock  
 Reseal thru wall caulking

Clean and touch up the coating to aid in the protection against corrosion  
Install missing studs in flange Seal thru wall caulking  
Replace pressure gauge as required  
Open and lock block valve

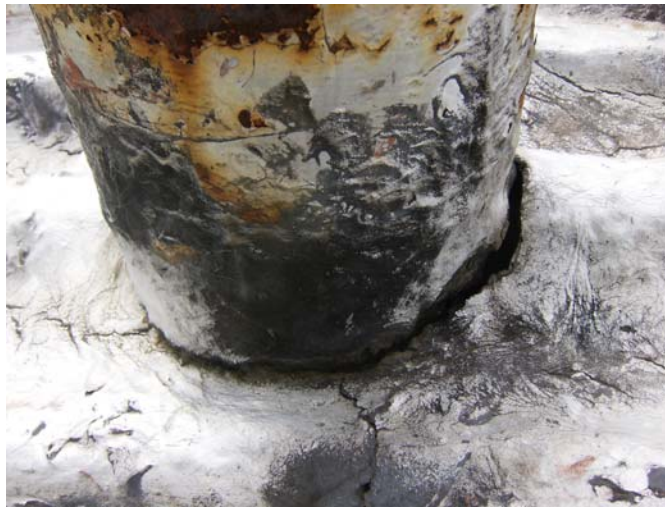
**04 deteriorated caulking**

Dust and bird turds noted on top shell and head sections of the separator  
 The thru wall caulking seal is deteriorated allowing for moisture ingress

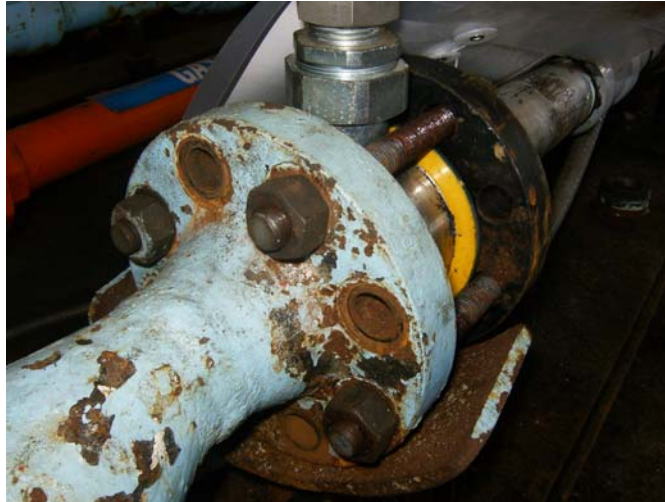
**05 missing hardware on flange**

There are studs and nuts missing from the 2" sour water drains instrumentation flange connection

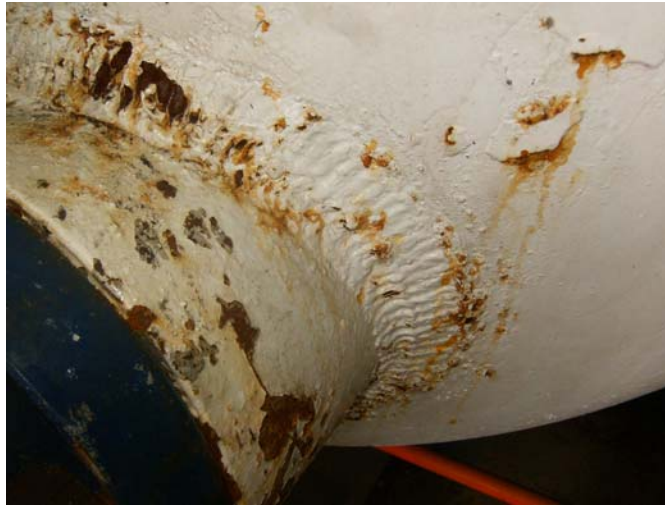
**06 deteriorated coating**

The coating is chipped and flaking on the heads and shells as well as between the flanges exposing the base metal to mild surface corrosion with evidence of near surface pitting.

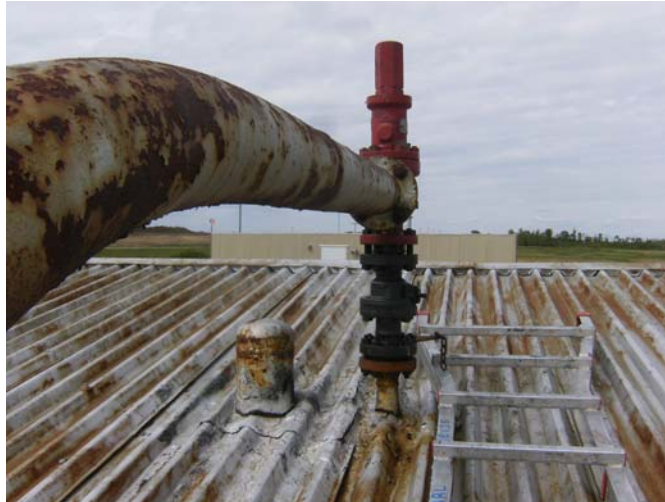
09 PSV overview

PSV -1 Tag #: 21 Serial #: 77C5605 CRN: 01832.568312  
 Model #: 1912HC XSG Capacity: 19028 SCFM Set Pressure: 1200 psi  
 Manufacturer: Consolidated Service Company: Powell  
 Inlet Size & Type: 2.00 in. - Flanged Last Service Date: May 29 2012  
 Outlet Size & Type: 3.00 in. - Flanged Block Valve: Upstream - Lock Missing - Closed  
 Carseal Intact: Yes Code Stamp: Yes  
 Shell Side / Tube Side: Shell Side Out for Service During Insp.: N Location of PSV: On Vessel

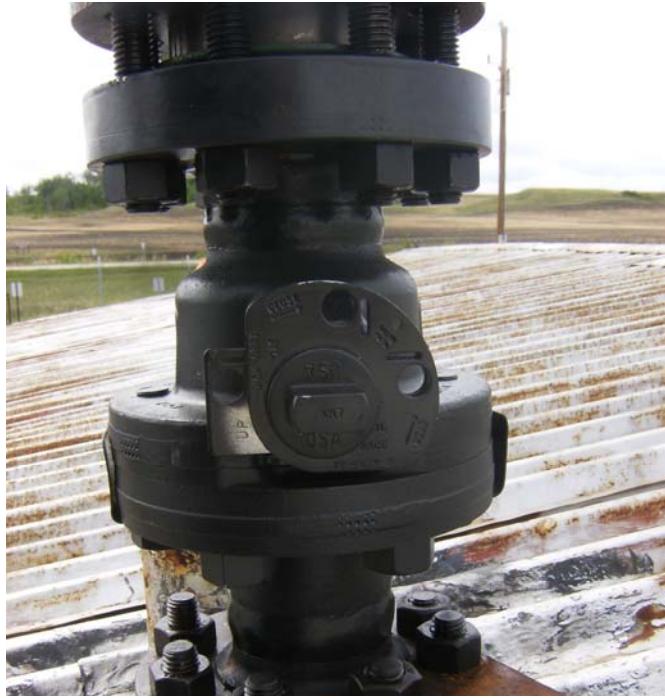
10 missing lock

Block valve is missing lock and in closed position

The PSV block valve is missing a lock and in the closed position
