**PRESSURE VESSEL
VISUAL INSPECTION
REPORT**

Report #: **156828-MD-31**
 Inspect Date: 06/01/2012
 Page: 1 of 13
 Insp. Co. Job #: 156828

Insp. Comp: Matrix_Inspection District: St Albert - South Field: Nevis
 Location: 05-11-039-22W4 Unit / Skid #: N/A LSD: 05-11-039-22W4
 Jurisdiction #: A0083030 Equip Tag #: 4439 Serial #: C 4439
 CRN #: A5739.2 Nat'l Bd #: N/A Year Built: 1966
 Manufacturer: CESSCO Equipment Description: Other: Horizontal Inlet Separator
 Status: Out of Service - 888 - Standby Equip. Type: Vessel: Separator Service: Sour
 MAWP Shell: 1200 Psi @ 150 °F Volume: 235 ft³ Code Stamp: Y N
 MAWP Tube: @ Height/Length: 20 Ft. Insulated: Y N
 MDMT: N/A RT: N/A Size/Diameter.: 48 in. O.D. PWHT: Y N
 Support: Saddle Vessel on Original CNRL Inventory List: Y N Manway: Y N
 C.A.: _____ Coated: N/A Clad: N/A J.E.: 1.00 Remote Access: - _____

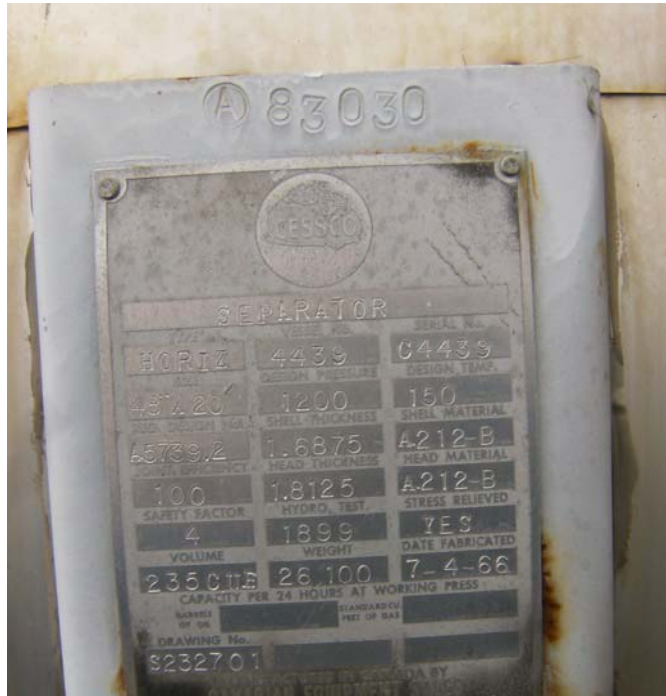
01 nameplate

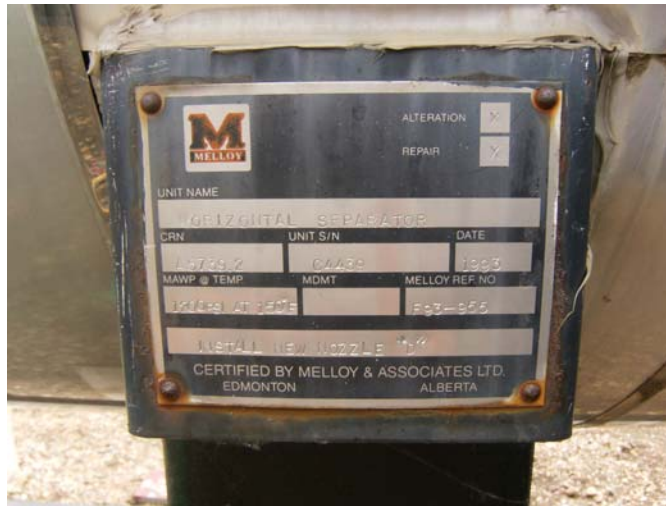
Repair/ Alteration made 1993 by Melloy & Associates Ltd.
 Install new nozzle 'D'
 Note: no reference to a hydrostatic test performed

02 repair nameplate

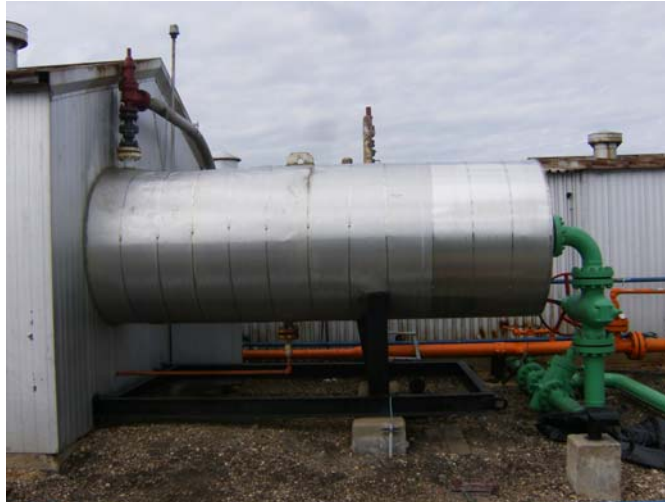
The separator is approximately 50% outdoors and insulated
 The cladding is bent and damaged with loose banding

04 overview outdoors

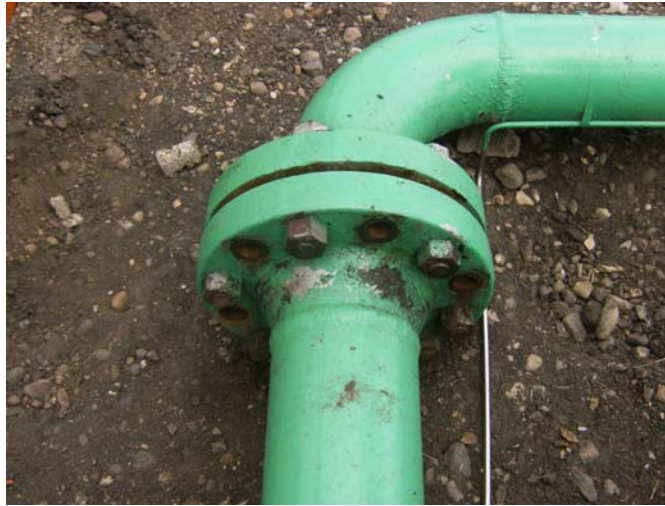
There are studs and nuts missing from the 6" sour gas inlet flange connection

05 missing hardware inlet piping

Clean and touch up the coating to aid in the protection against corrosion
 Install missing studs on the 6" flange
 Open block valve and install a lock
 Anchor the East saddle

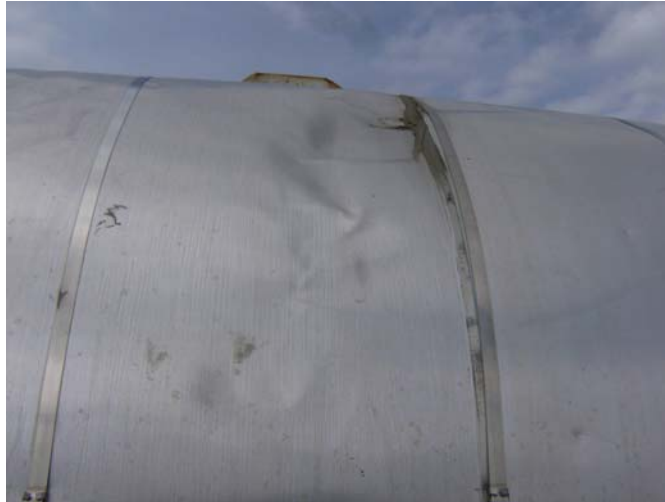
06 damaged cladding

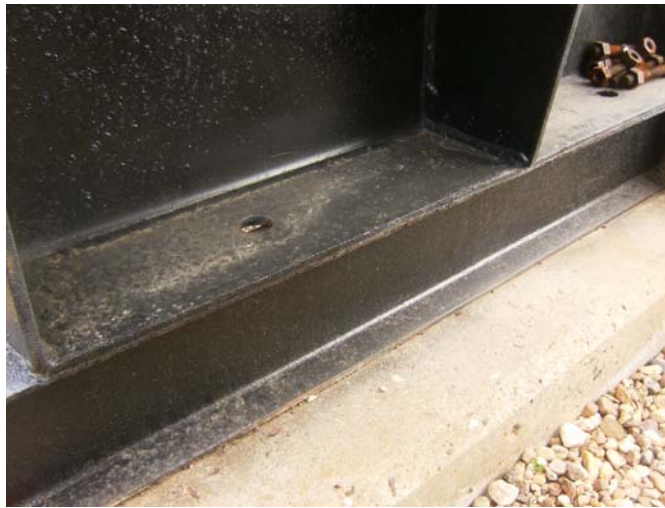
The East saddle support is missing the anchor bolts

07 missing anchor bolts

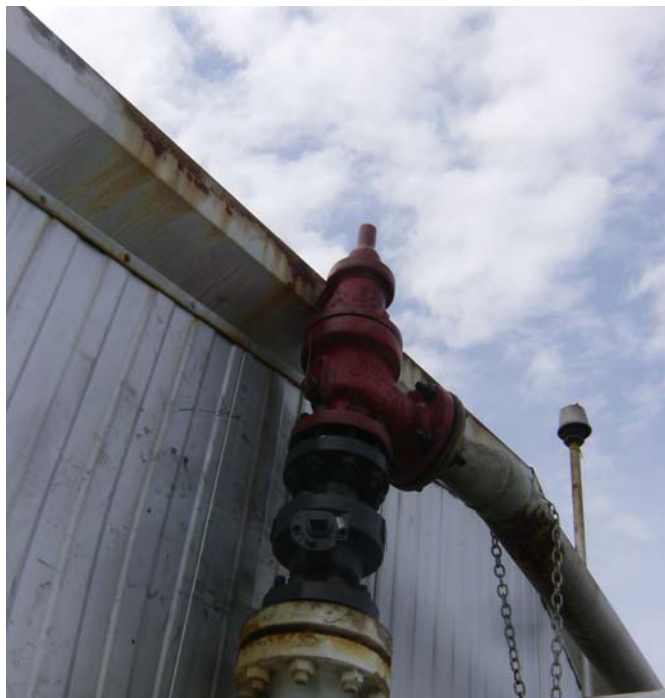
PSV -1 Tag #: 22 Serial #: 66C2082 CRN: 01832.568312
 Model #: 1912HC/SI Capacity: 19028 SCFM Set Pressure: 1200 psi
 Manufacturer: Consolidated Service Company: Powell
 Inlet Size & Type: 2.00 in. - Flanged Last Service Date: May 2012
 Outlet Size & Type: 3.00 in. - Flanged Block Valve: Upstream - Lock Missing - Closed
 Carseal Intact: Yes Code Stamp: Yes
 Shell Side / Tube Side: Shell Side Out for Service During Insp.: N Location of PSV: On Vessel

08 PSV overview

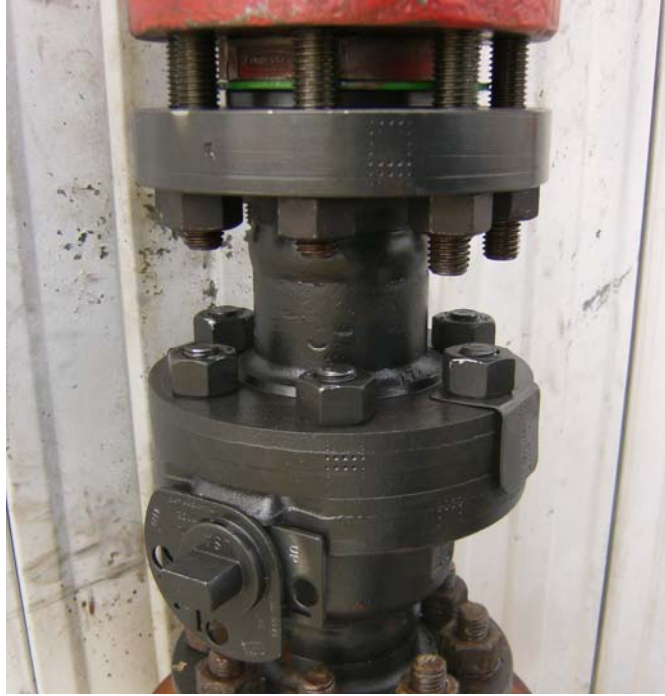
Block valve is missing lock and in closed position

The PSV block valve is missing a lock and in the closed position

09 missing lock
