GENERAL INSPECTION FORM						
District: <b>Ft St John, B.C.</b>			Skid No.			
Facility: <b>South Buick Battery</b>			Location (LSD): <b>d-78-I / 94-A-11</b>			
Vessel Name & Equipment Number: <b>Group Separator</b>						
Orientation: <b>Horizontal</b>						
Status: <b>In Service</b>			Regulatory Inspection			
PRESSURE VESSEL NAMEPLATE DATA						
"A" or "G" or "S" (Sask.) or BC Registration Number.  <b>CN 96122</b>			CRN Number  <b>M 9977.231</b>			
Vessel serial number: <b>95 – 8021 – 0</b>			Size: <b>96 in. X 20 ft</b>			
Shell thickness: <b>21.5 mm</b>			Shell material: <b>SA-516-70</b>			
Head thickness: <b>22.2 mm</b>			Head material: <b>SA-516-70</b>			
Tube wall thickness: <b>N/A</b>			Tube material: <b>N/A</b>			
Tube diameter: <b>N/A</b>			Tube length: <b>N/A</b>			
Channel thickness: <b>N/A</b>			Channel material: <b>N/A</b>			
MAWP	Shell: <b>250 PSI</b>		Operating pressure	Shell: <b>0-60 PSI Not in operation</b>

Internal Inspection Pictures

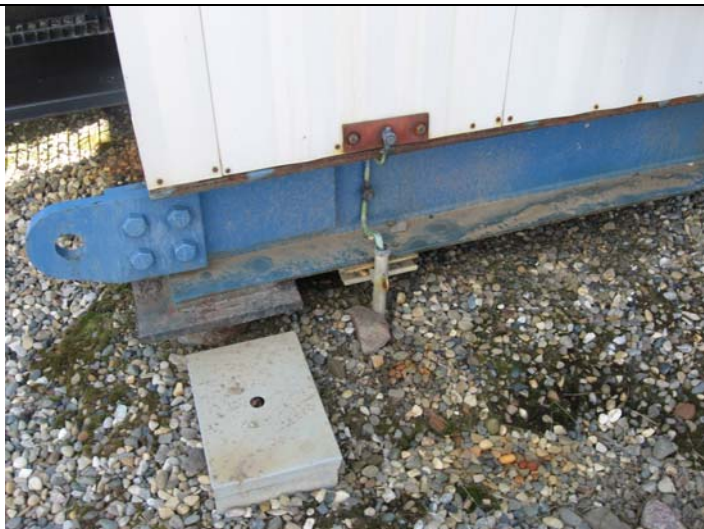
Ground cable

<b>External Inspection Items</b>	<b>G</b>	<b>F</b>	<b>P</b>	<b>N/A</b>	<b>Comments</b>
<b>Insulation</b> Verify sealed around manways, nozzles, no damage present, and there is no egress of moisture. Are straps secured?	X				<b>No damage to Insulation, no sign of moisture egress. No straps to support cladding. Secured with screws.</b>
<b>External Condition</b> Assess paint condition, areas peeling, record any corrosion, damage, distortion etc (record location, size and depth of corrosion or damage)	X				<b>Paint in good condition, West head No external corrosion observed.</b>
<b>Leakage</b> Record any leakage at flanges, threaded joints, weep holes on repads, etc.	X				<b>No leaks observed.</b>
<b>Skirt:</b> Assess condition of paint, fire protection, and concrete. Look for corrosion, buckling, dents, etc. Look at vessel surface area near supports. Verify no signs of leakage at attachment to vessel and attachment welds are acceptable. Is ground wire attached?	X				<b>Saddle: No distortion to saddles – no leaks detected at shell to saddle welds. Ground wire firmly attached to skid.</b>

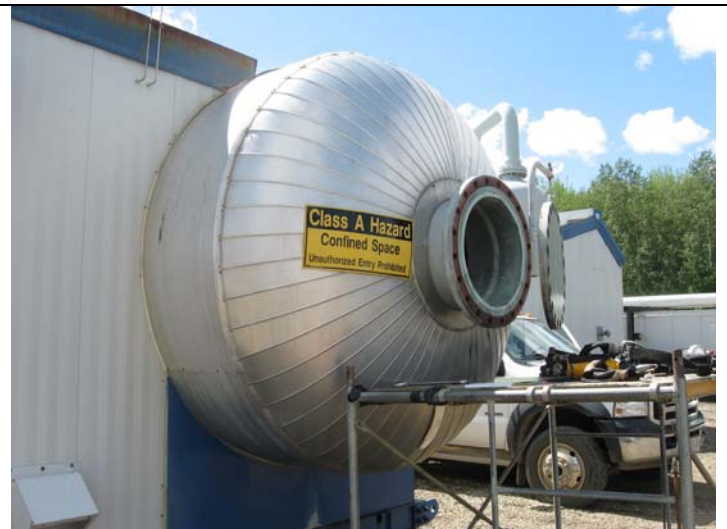
Man way access

<b>Internal Inspection Items</b>	<b>G</b>	<b>F</b>	<b>P</b>	<b>N/A</b>	<b>Comments</b>
<b>Coating</b> Assess coating. Describe area coated, general condition of coating.	X				<b>Good condition, no holidays or lifted coating – 2 small diameter chips I man way access.</b>
<b>Anodes.</b> How many, type, condition. % consumed. Are they being replaced?	X				<b>2 Anodes were found and consumed to less than – 5% max. Will not be replaced. Ground cable on East anode was broken, needs to be repaired.</b>
<b>Internal Piping</b> Is there any? If so, carbon or stainless steel. Describe condition, dents, corrosion, erosion, etc. Ensure supports are secure and any bolts are suitable for future use.				X	<b>No internal piping.</b>
<b>Level indicator / Float:</b> Intact? Free Movement?	X				<b>Good condition, no obstructions – free movement.</b>
<b>Thermal Well:</b> Intact, in place?	X				<b>Intact and in place.</b>

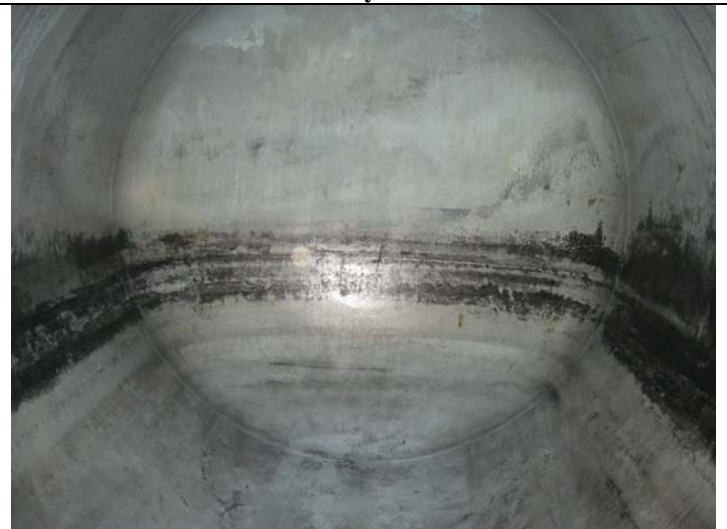
Coating

<b>Demister pad</b> Is it in place? Is it clean? If any corrosion is apparent in vessel, lift pad and check top head for corrosion.	X				<b>Demister pad in gas boot – some calcium in screens – not soiled.</b>
<b>Nozzles:</b> Unobstructed? Identify and corrosion, pitting – quantify.	X				<b>Coated – no failed areas.</b>
<b>Welds</b> Inspect all welds, including attachment welds. Record all service-related damages and if there is any discuss with Chief Inspector before closing.	X				<b>Good condition, no exposed metal – no previous corrosion.</b>
<b>Repairs Required. If yes, ensure procedure and copy of AB 40 is on file, and one sent to local ABSA, and Chief Inspector</b>				X	<b>No repairs required.</b>
<b>NDE Was any NDE done. ( MI coordinator to review results)</b>				X	<b>No internal NDE performed at this time.</b>
<p><b>Recommendations or corrective actions : Vessel is Fit for Service or describe corrective actions required)</b>                      (MIC to review corrective actions with Operations, discuss with Chief Inspector where necessary, and get remedial action implemented)  <b>Recommendation: 1.</b> Hand patch coating chips in man way access.  <b>Summary:</b> This vessel is in good overall condition, visual internal, external carried out – 2 small diameter chips in coating – no previous corrosion.  <b>Vessel fit for service.</b></p>

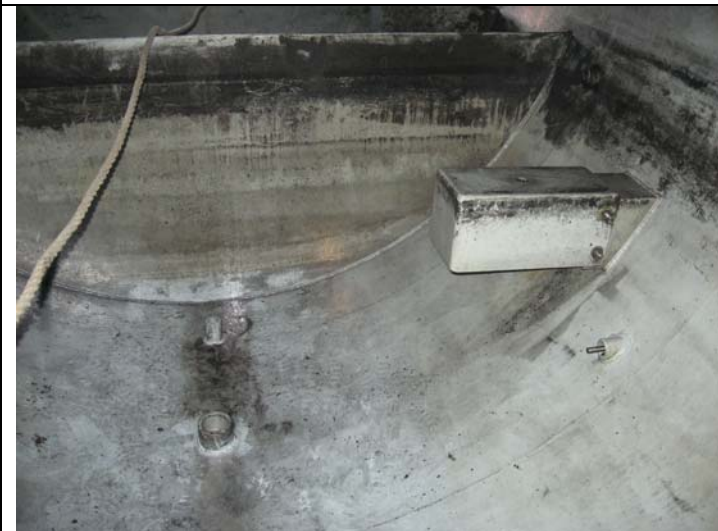
Over view of weir

<b>Trays</b> How many? Type of material. Are valves in place. Check for erosion/ corrosion; wear on tray valve legs. Cleanliness?				X	
<b>Baffles, deflector plates, etc.</b> If present, describe condition. Look closely at welds attached to vessel wall.	X				<b>Weir in place no exposed metal or previous corrosion.</b>
<b>East Head</b> Note all corrosion, erosion or mechanical damage. (If vessel is horizontal identify direction of this head)	X				<b>Good condition, no exposed metal – no previous corrosion.</b>
<b>West Head</b> Note all corrosion, erosion or mechanical damage. (If vessel is horizontal identify direction of this head)	X				<b>Good condition, no exposed metal – no previous corrosion.</b>
<b>Shell Sections</b> Record number of shell sections. Record location, size and depth of all erosion, corrosion or mechanical damage. Describe general condition. If any corrosion greater than corrosion allowance is observed in either shell or head, discuss with Chief Inspector before closing vessel.	X				<b>Two shell sections were found to form this vessel. The shell was coated and in good condition – no failed areas.</b>
