**Canadian Natural Resources Limited
GENERAL PRESSURE VESSEL INFORMATION**

| Facility: Saddle Hills Gas Plant | Location (LSD): 10-11-75-07W6M |
| Vessel Name Equipment Number: Glycol Contactor | |

Date: June 10, 2010

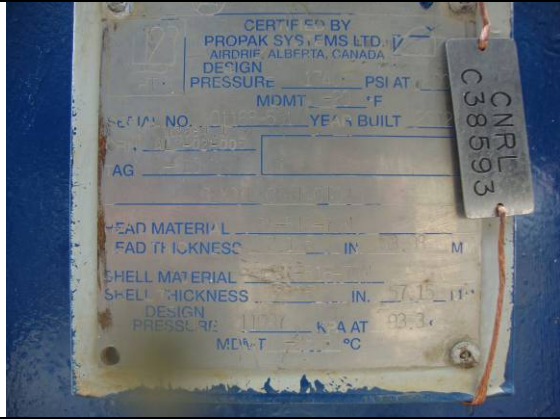
Vessel data plate

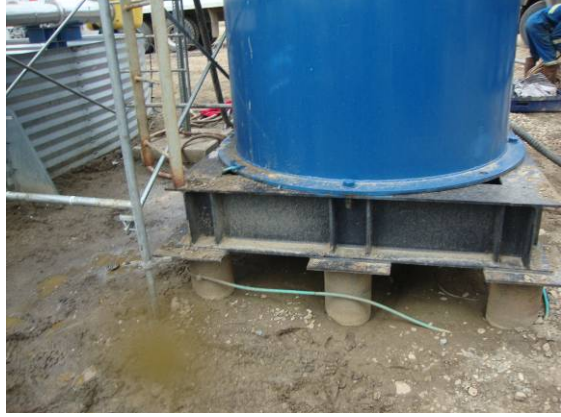
| External Inspection Items | G | F | P | N/A | Comments |
|--|---|---|---|---|--|
| Saddle/skirt Assess condition of paint, fire protection, concrete. Look for corrosion, buckling, dents, etc. Look at vessel surface area near supports. Verify no signs of leakage at attachment to vessel and attachment welds are acceptable. Ground wire attached? | X | | | | Skirt: bolted directly to support frame. Support frame welded to pilings No buckling or dents. No corrosion at attachment welds to vessel Ground wire attached to vessel and pilings. |

Vessel base and ground wire attached

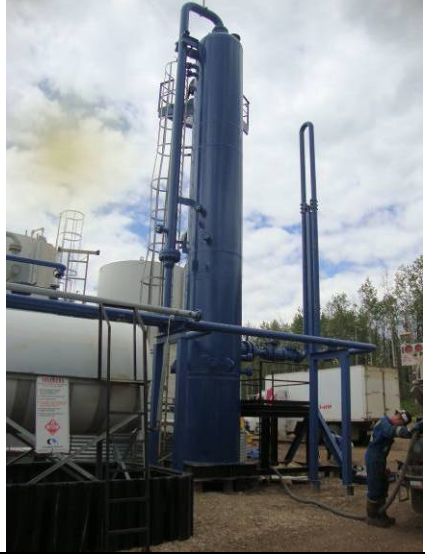
Vessel overview

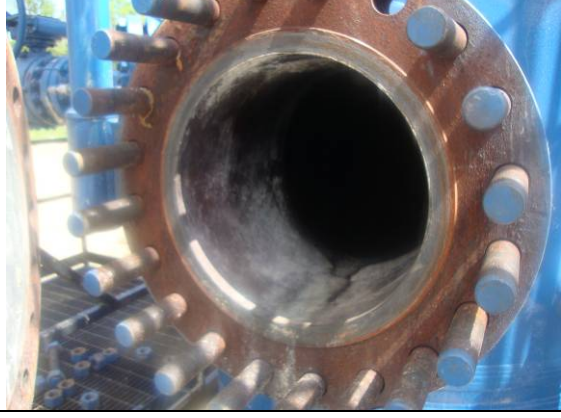
Bottom man way

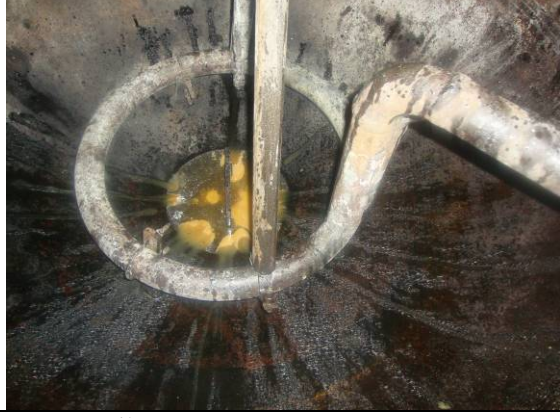
| Internal Inspection Items | G | F | P | N/A | Comments |
|--|---|---|---|---|--|
| Internal Piping Is there any? If so, carbon or stainless steel. Describe condition, dents, corrosion, erosion, etc. Ensure supports are secure and any bolts are suitable for future use. | X | | | | Coil in bottom in good condition – supports and clamps in place - no mechanical damage or dents. |

Bottom coil

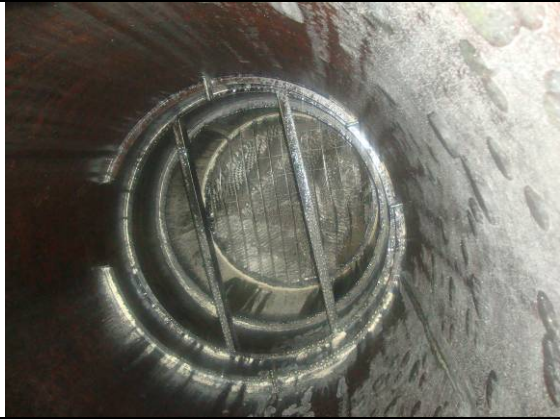
| Internal Inspection Items | G | F | P | N/A | Comments |
|--|---|---|---|---|--|
| Demister pad Is it in place? Is it clean? If any corrosion is apparent in vessel, lift pad and check top head for corrosion. | X | | | | Filter packing in top head is damaged and not in place. Packing view from bottom is in good condition and in place – no damage present. |

View up in the vessel at packing

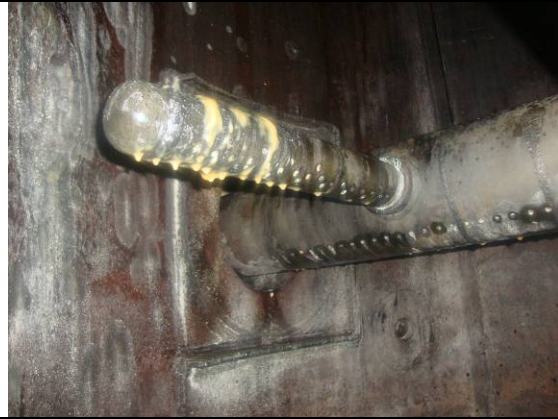
Piping attachment to shell

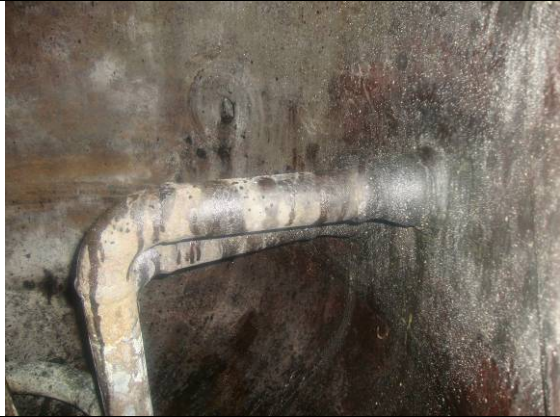
| Internal Inspection Items | G | F | P | N/A | Comments |
|--|---|---|---|---|--|
| Welds Inspect all welds, including attachment welds. Record all service-related damages and if there is any discuss with Chief Inspector before closing. | X | | | | Over all welds are in good condition – head to shell weld has no corrosion – no erosion or pitting. Attachment welds are in good condition no corrosion or erosion. |

Coil attachment weld to shell

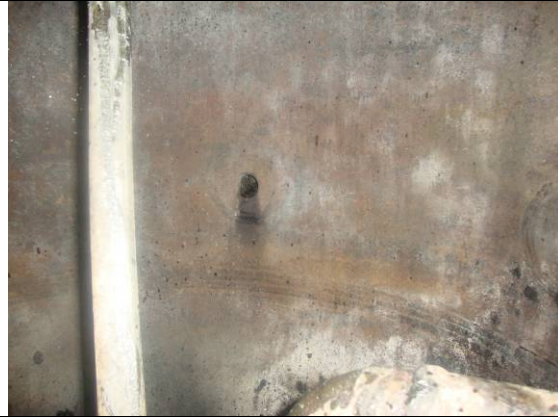
| Internal Inspection Items | G | F | P | N/A | Comments |
|--|---|---|---|---|--|
| Bottom Head Note all corrosion, erosion or mechanical damage. (If vessel is horizontal identify direction of this head) | X | | | | No mechanical damage- no corrosion or erosion. Drain nozzle is clean and unobstructed. |

Bottom nozzle and shell to head weld

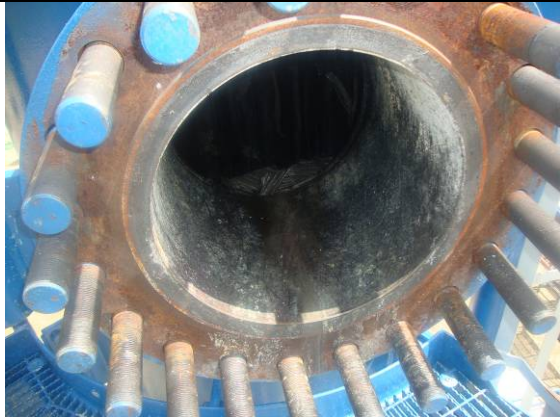
| Internal Inspection Items | G | F | P | N/A | Comments |
|--|---|---|---|---|--|
| Top Head Note all corrosion, erosion or mechanical damage. (If vessel is horizontal identify direction of this head) | X | | | | No mechanical damage. Man way gasket seating face is clean no mechanical or corrosion damage. |

Top man way

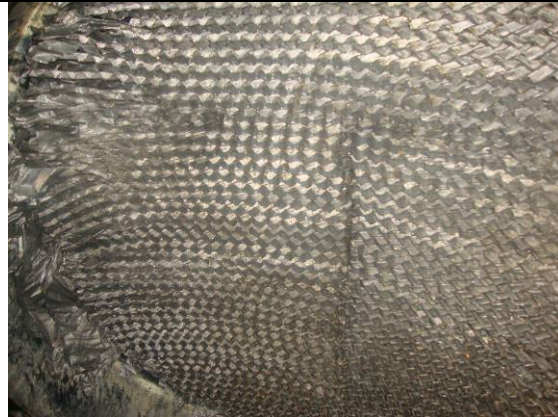
Packing in top head

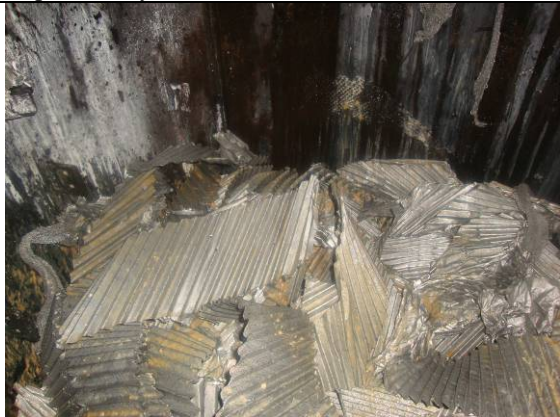
Damaged packing under top man way

| Internal Inspection Items | G | F | P | N/A | Comments |
|--|---|---|---|---|--|
| <p>Recommendations or corrective actions : Vessel is Fit for Service or describe corrective actions required) (MIC to review corrective actions with Operations, discuss with Chief Inspector where necessary, and get remedial action implemented) Recommendations: Replace damaged packing at top vessel.</p> <p>Summary: Vessel in good overall condition, Visual external and internal inspection performed on vessel. No visual defects observed.</p> <p>Vessel is fit for service.</p> | | | | | |

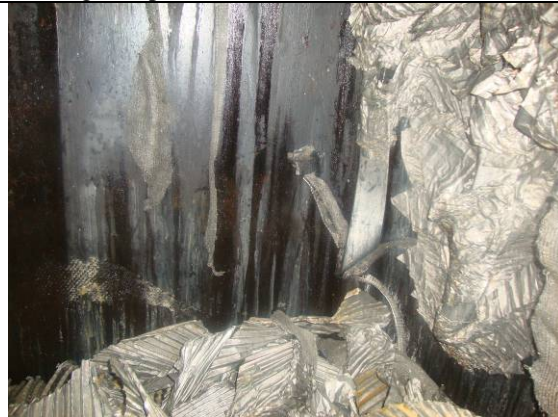
Shredded packing in top man way
