**PRESSURE VESSEL
VISUAL INSPECTION
REPORT**

Report #: **156825-KK-13**
 Inspect Date: 05/23/2012
 Page: 1 of 10
 Insp. Co. Job #: 156825

Insp. Comp: Matrix_Inspection District: St Albert - South Field: Duhamel
 Location: 04-07 Battery Unit / Skid #: N/A LSD: 04-07-045-21W4M
 Jurisdiction #: C51189 Equip Tag #: N/A Serial #: N/A
 CRN #: N/A Nat'l Bd #: N/A Year Built: 0
 Manufacturer: N/A Equipment Description: Other: Level Bridle
 Status: In Service - Equip. Type: Vessel: Category H Fitting Service: Sour
 MAWP Shell: N/A kPa @ N/A °C Volume: N/A Code Stamp: Y N
 MAWP Tube: N/A @ N/A Height/Length: N/A Insulated: Y N
 MDMT: N/A RT: N/A Size/Diameter.: 6 in. O.D. PWHT: Y N
 Support: Nozzles Vessel on Original CNRL Inventory List: Y N Manway: Y N
 C.A.: N/A Coated: No Clad: No J.E.: N/A Remote Access: -

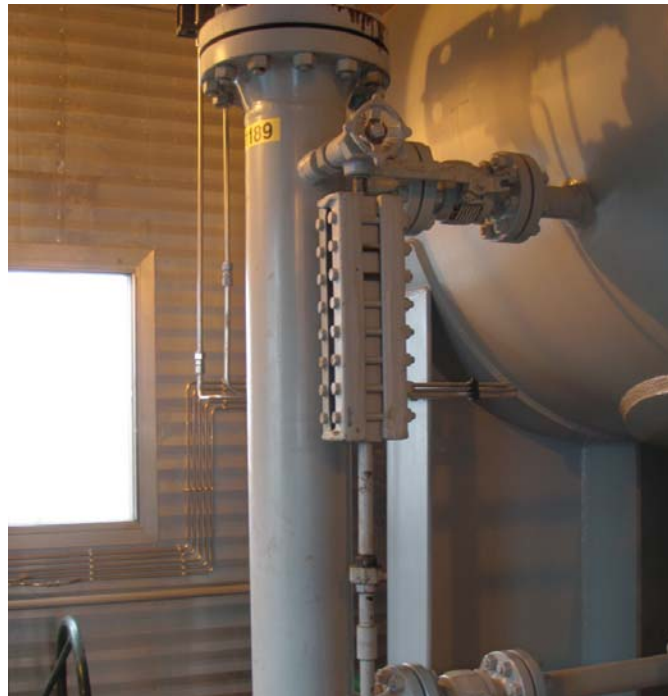
02-C51189 Overview

The vessel is secure and level, with properly aligned piping and external attachments.
 The paint is in fair condition, with isolated chipping noted.
 The paint is thick and rough in some locations.
 The attached piping is threaded and in good condition.
 The instrumentation near the top head is weeping and has deposited preproduct residue on the vessel.
 The PSV is removed for service at the time of the inspection.
 The plumbing for the PSV appears to be in good condition, and of adequate size and proper rating.
 The PSV service data has been supplied from the service company to update the static information in this report.

The overall condition of this vessel is good.

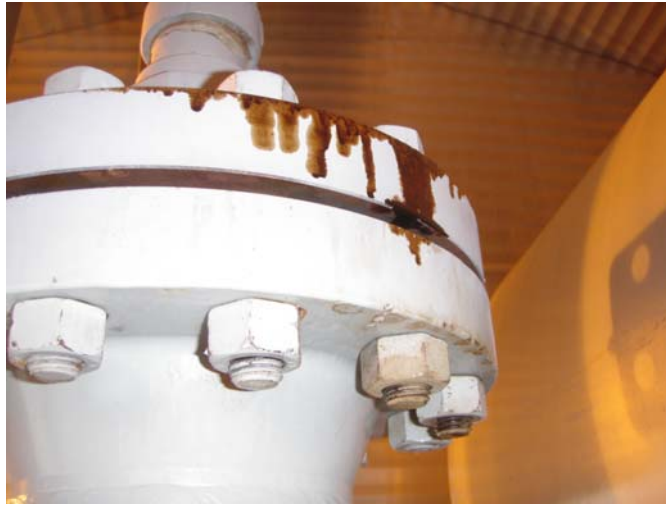
Isolated chipping paint throughout. No data plate. Instrumentation leaking onto top head.

03-C51189 Product Staining on Top Head

- Tighten / repair the weeping instrumentation connections to prevent product loss.
- Continue to perform regular maintenance and regulatory inspections to maintain equipment integrity and continued safe operation.
- Ensure PSV's are serviced, installed, and rated correctly before putting this equipment back into service post TAR.

Tighten / repair weeping instrumentation. Continue regular inspections to maintain integrity and continued safe operation. Ensure PSV properly rated and installed prior to post TAR startup.

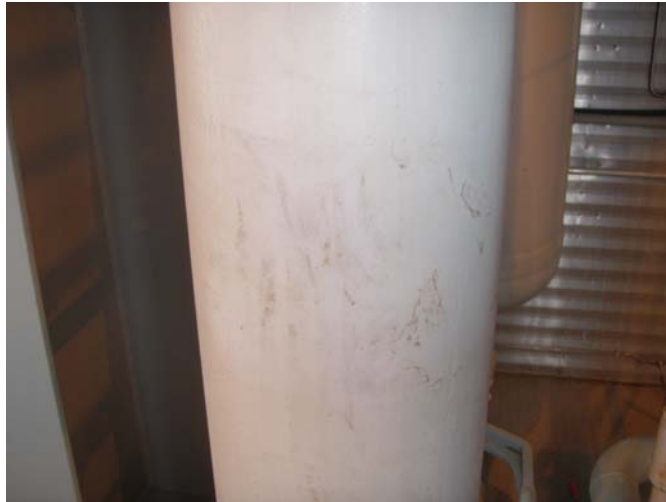
04-C51189 Rough Surfaces
