**PRESSURE VESSEL
VISUAL INSPECTION
REPORT**

Report #: **156825-KK-12**
 Inspect Date: 05/23/2012
 Page: 1 of 10
 Insp. Co. Job #: 156825

Insp. Comp: Matrix_Inspection District: St Albert - South Field: Duhamel
 Location: 04-07 Battery Unit / Skid #: N/A LSD: 04-07-045-21W4M
 Jurisdiction #: C51188 Equip Tag #: N/A Serial #: N/A
 CRN #: N/A Nat'l Bd #: N/A Year Built: 0
 Manufacturer: N/A Equipment Description: Other: Level Bridle
 Status: In Service - Equip. Type: Vessel: Category H Fitting Service: Sour
 MAWP Shell: N/A @ N/A Volume: N/A Code Stamp: Y N
 MAWP Tube: N/A @ N/A Height/Length: N/A Insulated: Y N
 MDMT: N/A RT: N/A Size/Diameter.: 6 in. O.D. PWHT: Y N
 Support: Nozzles Vessel on Original CNRL Inventory List: Y N Manway: Y N
 C.A.: N/A Coated: No Clad: No J.E.: N/A Remote Access: -

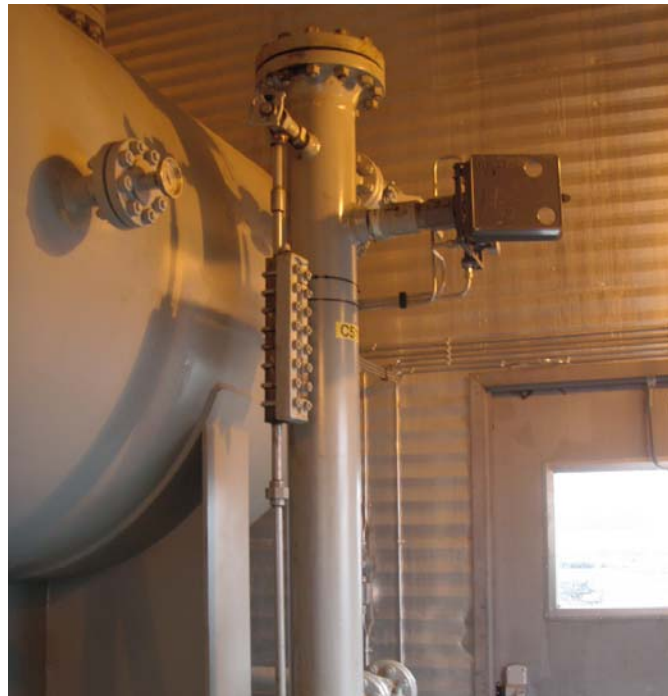
02-C51188 Overview

The vessel is secure and level, with properly aligned piping and external attachments.
 The paint is in fair condition, with isolated chipping noted.
 The paint is thick and rough in some locations.
 The attached piping is threaded and in good condition, with small weeping at the liquid level connections..
 The PSV is removed for service at the time of the inspection.
 The plumbing for the PSV appears to be in good condition, and of adequate size and proper rating.
 The PSV service data has been supplied from the service company to update the static information in this report.

The overall condition of this vessel is good.

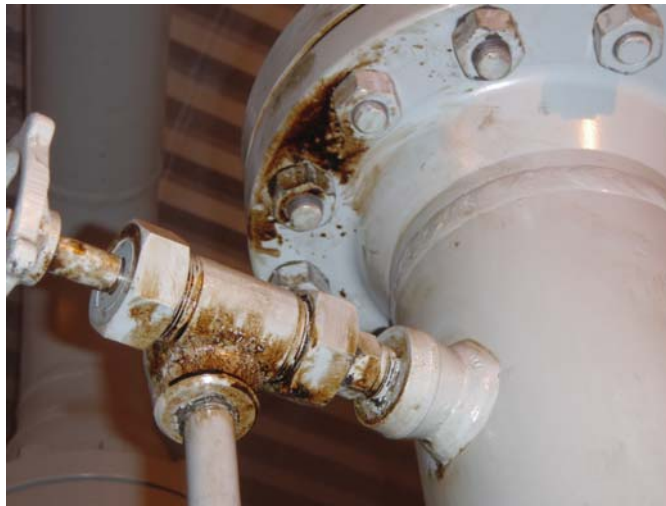
Isolated chipping paint throughout. No data plate. Threaded piping has weeping fittings.

03-C51188 Leaking Fittings at Level Gauge

Tighten / repair fittings as required to repair the weeping and product loss.

Tighten / repair threaded piping connections to prevent weeping / product loss. Continue regular inspections to maintain integrity and continued safe operation. Ensure PSV properly rated and installed prior to post TAR startup.
