Client: CNRL District: Med. Hat - West Field: Taber  
 Facility: 09-17-011-16W4 Unit / Skid #: N/A LSD: 09-17-011-16W4  
 Jurisdiction #: A0429910 Equip Tag #: N/A Serial #: V-2726B  
 CRN #: N7672.2 Nat'l Bd #: N/A Year Built: 1997  
 Manufacturer: Opsco '92 Industries Equipment Description: Test Separator  
 Status: In Service - Date Removed From Service: \_\_\_\_\_ Service: Sour  
 MAWP Shell: 280 Psi @ 100 °F Height/Length: 10 Ft. Code Stamp:  Y  N  
 MAWP Tube: \_\_\_\_\_ @ \_\_\_\_\_ Size/Diameter.: 36 in. O.D. Insulated:  Y  N  
 MDMT: -20 °F RT: RT-1 Volume: \_\_\_\_\_ PWHT:  Y  N  
 Support Type: Skirt Manway:  Y  N  
 C.A.: .125 in. Coated:  Y  N Clad:  Y  N J.E.: N/A (No Remote Access)  - \_\_\_\_\_

### External Inspection Results - VE

### External Visual Observations

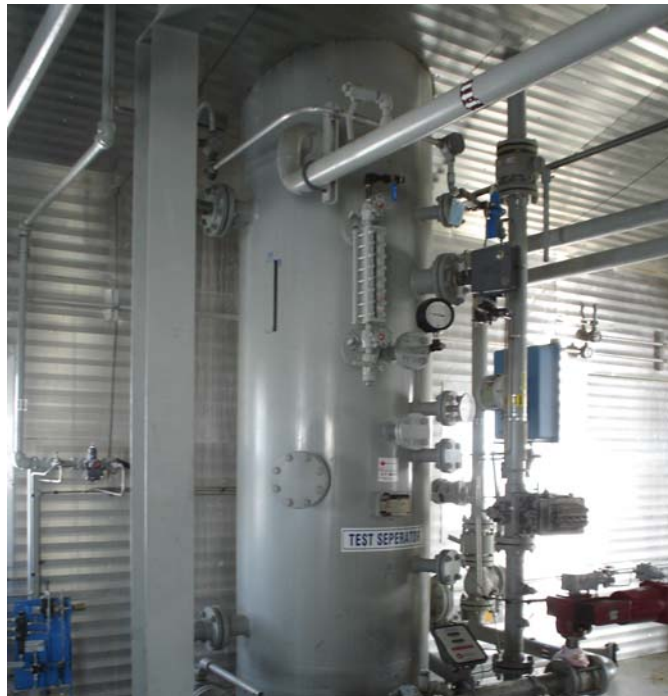
Figure 2\_Sideview\_16April2010

This Test Separator is un-insulated and painted.  
 At the time of inspection, the vessel was off-line due to a power outage.  
 Nameplate is secure and legible.  
 Shell, top head, and skirt are in good condition with a few minor paint chips. Negligible corrosion at exposed areas.  
 Limited visual access to bottom head. Appears to have 100% paint loss with less than 0.005" corrosion.  
 All anchor bolts in place and secure.  
 Sight glass in good condition, with no damage or defects. Threaded connections good.  
 Pressure gauge shows no concerns. Reading 60 psi.  
 Temperature gauge also no concerns. Reading 8 C.  
 Vessel is grounded on the SE corner of the building. Ground wire is securely attached with no damage visible.  
 No misalignment visible.  
 No leaks noted at time of inspection.

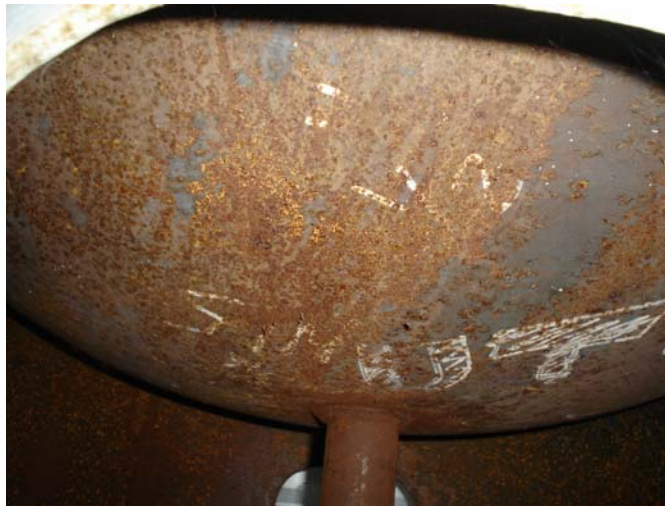
**Figure 3\_Bottom Head\_16April2010**

UT was carried out with GE DMS2 IRISNDT#31098.  
 TML 40 (bottom head) has a low UT reading at .304". Nominal head thickness is .470". Due to limited access to bottom head, only a small portion of the head was included in the scan.
