**PRESSURE VESSEL
VISUAL INSPECTION
REPORT**

Report #: **91590-MD-05**
 Inspect Date: 06/29/2011
 Page: 1 of 10
 Insp. Co. Job #: 91590

Insp. Comp: Matrix_Inspection District: St Albert - South Field: Morrin 1327
 Location: 11-16-031-20W4 Unit / Skid #: Group Inlet Bld LSD: 11-16-031-20W4
 Jurisdiction #: A0431756 Equip Tag #: _____ Serial #: 96-8771-1
 CRN #: M2318.21 Nat'l Bd #: _____ Year Built: 1997
 Manufacturer: WELLS-HALL FABRICATION LTD Equipment Description: Other: INLET SEPARATOR
 Status: In Service - Equip. Type: Vessel: Separator Service: Sweet
 MAWP Shell: 720 Psi @ 100 °F Volume: _____ Code Stamp: Y N
 MAWP Tube: _____ Psi @ _____ °F Height/Length: 114.17 in. Insulated: Y N
 MDMT: -20 °F RT: RT-1 Size/Diameter.: 36.00 in. PWHT: Y N
 Support: Skirt Vessel on Original CNRL Inventory List: Y N Manway: Y N
 C.A.: _____ in. Coated: Yes Clad: No J.E.: N/A Remote Access: - _____

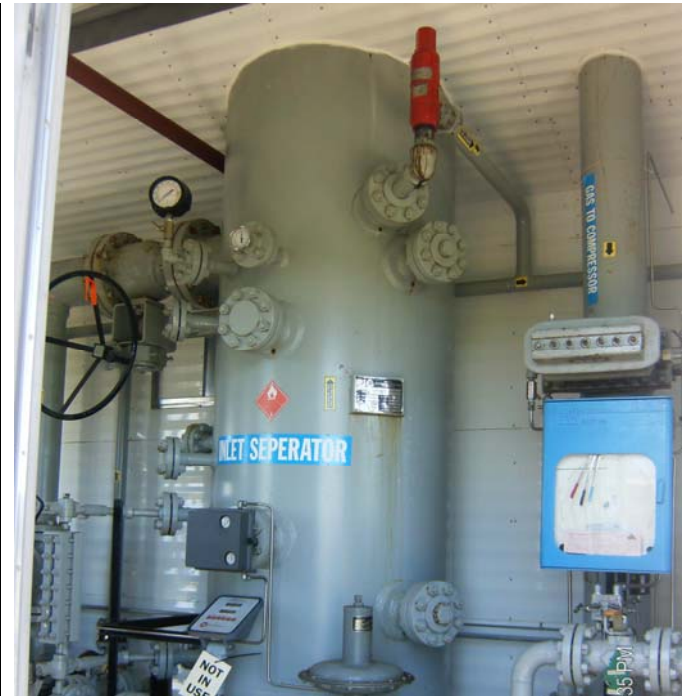
The overall condition of the separator is good. It should be noted that the separator was not in use during the inspection; the sight glass was empty and pressure was 0.

02 overview

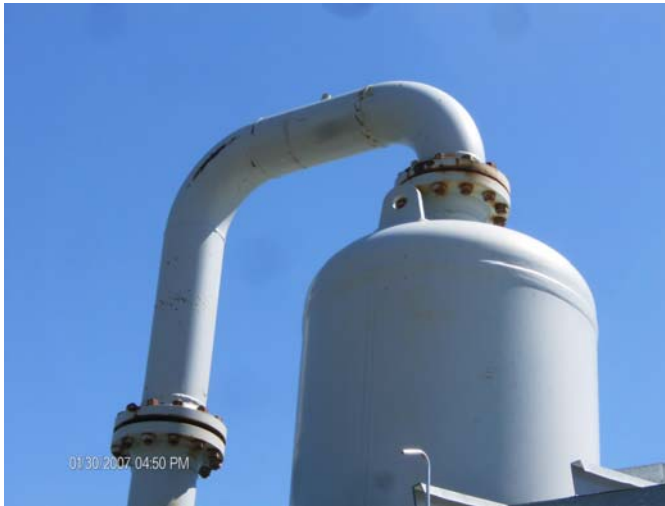
02.1 outside overview

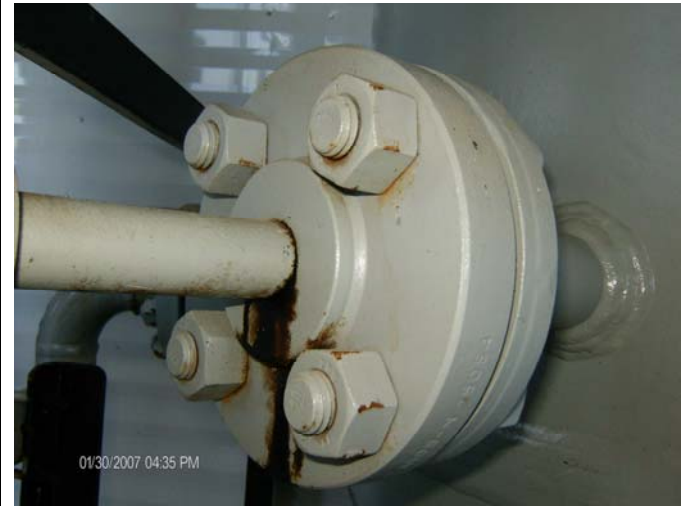
There is evidence of previsions leaks noted at the flange connections to the sight glass piping.

03 previous process leak

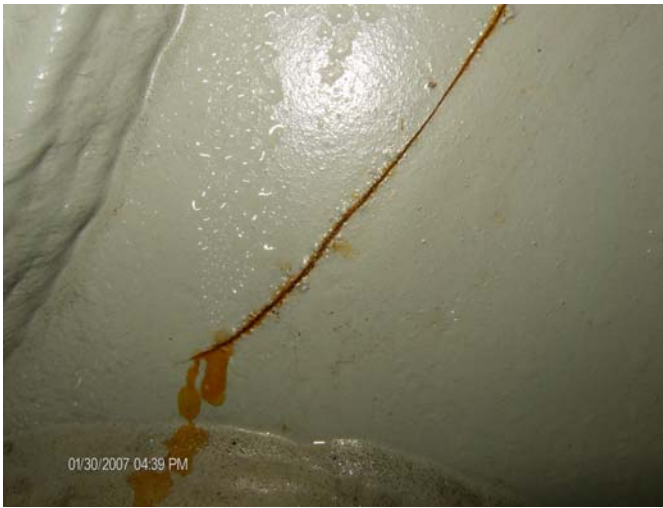
There is a scratch on the shell (north side ~ 7' from grade) extending upwards ~ 19". the depth was not mensurable due to how tight it is. This should be verified to be free of non-linear or crack-like indication prior to operating.

There is a scratch on the shell (north side ~ 7' from grade) extending upwards ~ 19". the depth was not mensurable due to how tight it is.

04 gouge like scratch

Buff off paint to perform MT examination to determine if any indication has propagated into the shell, or perform shear wave ultrasonic examination to determine if there is any depth to this suspect area.

Buff off paint to perform MT examination to determine if any indication has propagated into the shell, or perform shear wave ultrasonic examination to determine if there is any depth to this suspect area

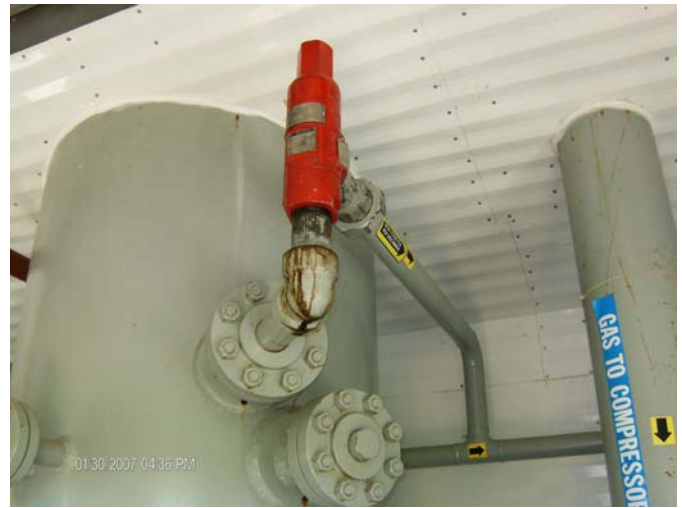
| Item | N/A | Condition | Comment (Check Status Bar or Press F1 for Help) | NCR | Action Item Integrity | Action Item Maintenance |
|---|---|---|--|---|---|---|
| PSV | <input type="checkbox"/> | Accept | proper venting and set pressure | <input type="checkbox"/> | <input type="checkbox"/> | <input type="checkbox"/> |

05 PSV overview

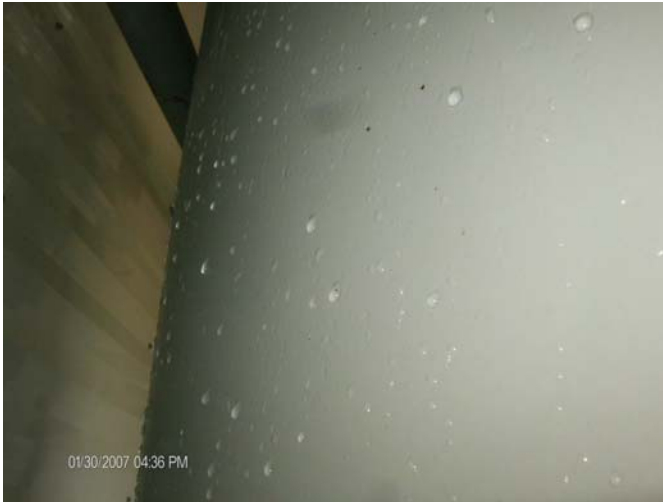
Condensation was observed on the inside building portion of separator at the time of inspection.

06 condensation on tank
