**PRESSURE VESSEL  
VISUAL INSPECTION  
REPORT**

Report #: **92242-CS-64**  
 Inspect Date: 06/23/2010  
 Page: 1 of 15  
 Insp. Co. Job #: 92242

Insp. Comp: Matrix\_Inspection District: Slave Lake Field: South Brintnell  
 Location: 12-09-081-22W4M Unit / Skid #: \_\_\_\_\_ LSD: 12-09-081-22W4M  
 Jurisdiction #: A0210398 Equip Tag #: \_\_\_\_\_ Serial #: L-40-191  
 CRN #: E8139.2 Nat'l Bd #: \_\_\_\_\_ Year Built: 1983  
 Manufacturer: CE Natco Equipment Description: Other: Treater  
 Status: In Service - Equip. Type: Vessel: Treater Service: Sweet  
 MAWP Shell: 75 Psi @ 219 °F Volume: \_\_\_\_\_ Code Stamp:  Y  N  
 MAWP Tube: \_\_\_\_\_ @ \_\_\_\_\_ Height/Length: \_\_\_\_\_ Insulated:  Y  N  
 MDMT: \_\_\_\_\_ RT: RT-3 Size/Diameter.: \_\_\_\_\_ PWHT:  Y  N  
 Support \_\_\_\_\_ Vessel on Original CNRL Inventory List:  Y  N Manway:  Y  N  
 C.A.: 0.125 in. Coated: \_\_\_\_\_ Clad: \_\_\_\_\_ J.E.: \_\_\_\_\_ Remote Access:  - \_\_\_\_\_

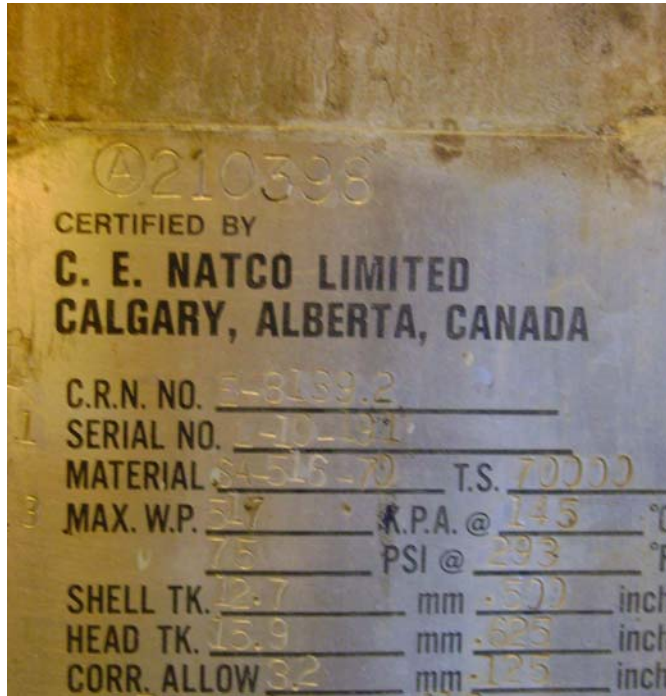
001\_A0210398\_Nameplate

-Data plate is secure, legible and contains sufficient static data.

Nameplate secure and legible.  
 Paint on shell in good condition. No corrosion visible.  
 Insulation has visible damage.  
 Pressure and temperature gauges in good condition with no damage.  
 Sight glass clean, clear and visible.  
 Vessel anchored to building floor. All anchor bolts in place and intact.  
 Vessel is adequately grounded.  
 No misalignment noted.

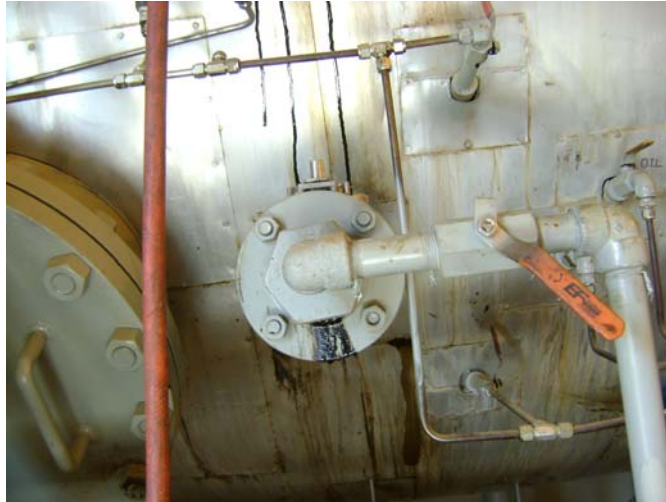
008\_A0210398\_Leak

Two (2) leaks were found at the connection of threaded piping, see attached photos.  
 PSV was not accessible at the time of the inspection.

- Properly fasten threaded piping and attached equipment to stop present leakage.
- Have someone confirm the PSV static data and ensure that has been serviced within the last 5 years.
- Continue with current inspection and PSV maintenance intervals to maintain the vessels integrity.
