**PRESSURE VESSEL
VISUAL INSPECTION
REPORT**

Report #: **92242-MD-34**
 Inspect Date: 06/24/2010
 Page: 1 of 9
 Insp. Co. Job #: 92242

An external visual inspection was performed on the Flare Knock Out Drum and the findings are as follows:

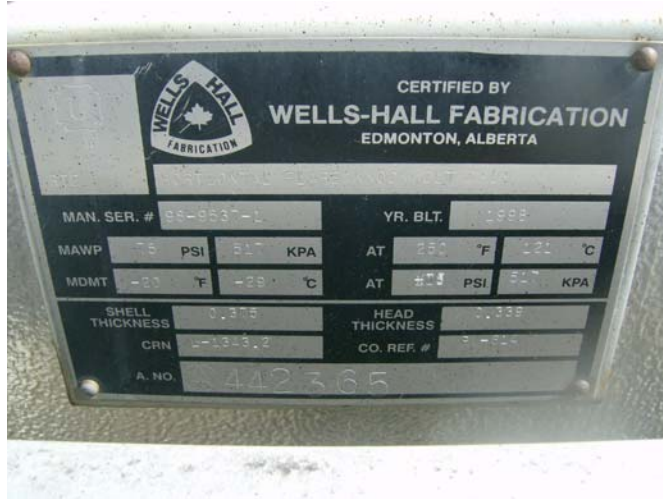
Figure 1_Dataplate

Data plate is legible and firmly attached.

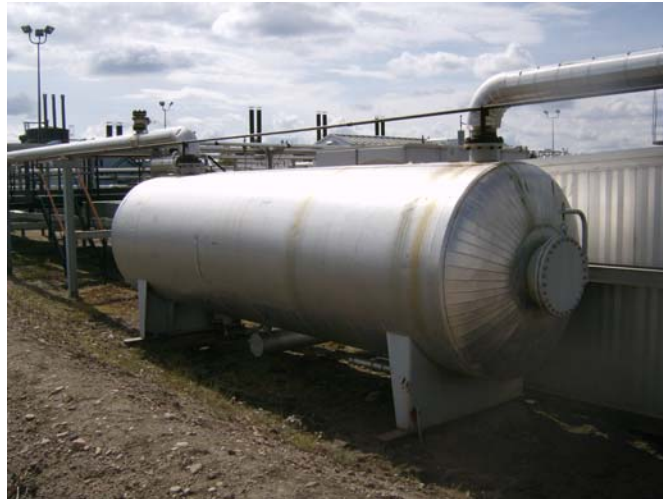
Figure 2_Flare knockout drum

The vessel was operating at time of inspection. No process leaks were noted.
 Minor sealant deterioration around vessels attachments and inspection cut out covers.
 Minor insulation damage on shell and heads.
 The data plate is firmly attached and legible.
 The visible un-insulated piping, bolting, and external attachments appear to be in good condition and firmly attached.
 The vessel is grounded through the skid it sits on.
 The vessel appears to be properly leveled and the saddles are bolted securely.
 The sight glass is covered partially by wrapped insulation but appears to be firmly attached, and in good working condition.
 No PSV required, vessel vents to atmosphere.
 External UT was performed with no significant wall losses noted. UT was carried out with GE DMS 2 IRISNDT#31069.
 All thickness values recorded were considered acceptable at the time of the inspection.
 See attached UltraMate UT file for complete thickness values.

Apply sealant to required areas to prevent CUI from occurring.
 Continue regular inspections to maintain vessel integrity and continued safe operation.
