**PRESSURE VESSEL  
VISUAL INSPECTION  
REPORT**

Report #: **92242-MD-40**  
 Inspect Date: 06/26/2010  
 Page: 1 of 9  
 Insp. Co. Job #: 92242

An external visual inspection was performed on the Flare Knock Out Drum and the findings are as follows:

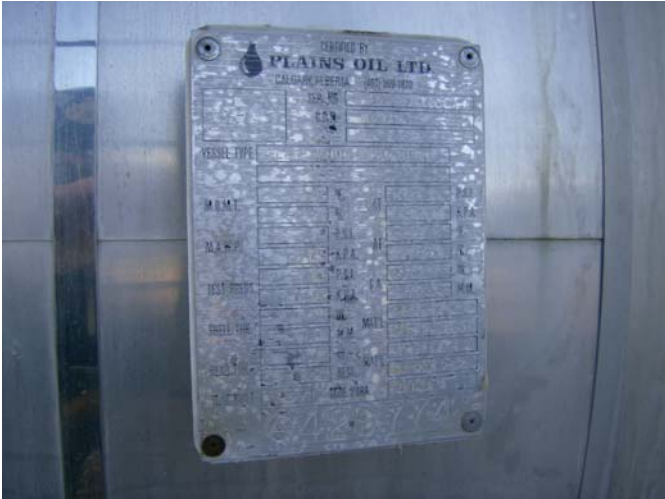
Figure 1\_Data plate

Data plate is legible and firmly attached.

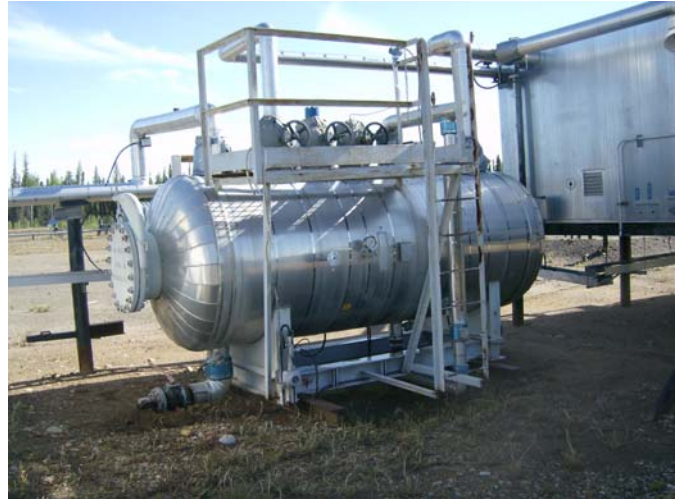
Figure 2\_Flare knock out drum

The vessel was operating at time of inspection. No process leaks were noted.  
 Minor sealant deterioration around vessels attachments and inspection cut out covers.  
 Minor insulation damage on shell and heads.  
 The data plate is firmly attached and legible.  
 The visible un-insulated piping, bolting, and external attachments appear to be in good condition and firmly attached.  
 The vessel is grounded through the skid it sits on.  
 The vessel appears to be properly leveled and the saddles are bolted securely.  
 The sight glass, temperature, and pressure gauges are clear, firmly attached, and appear too be working properly.  
 No PSV required, vessel vents to atmosphere.  
 External UT was performed with no significant wall losses noted. UT was carried out with GE DMS 2 IRISNDT#31069.  
 All thickness values recorded were considered acceptable at the time of the inspection.  
 See attached UltraMate UT file for complete thickness values.

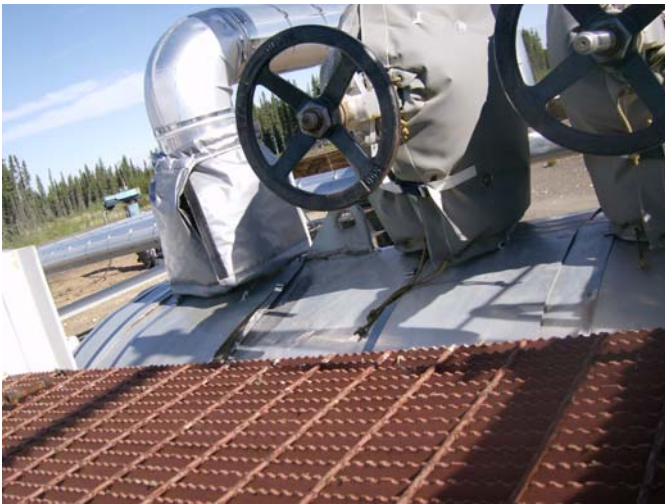
Figure 3\_Insulation damage

Minor sealant deterioration around vessels attachments and inspection cut out covers. Insulation damage on shell and heads.

Repair insulation, and apply sealant to required areas to prevent CUI from occurring.  
 Continue regular inspections to maintain vessel integrity and continued safe operation.

Apply sealant to required areas to prevent CUI from occurring.  
Continue regular inspections to maintain vessel integrity and continued safe operation.
