**CANADIAN NATURAL RESOURCES LTD**  
**PHASED ARRAY ULTRASONIC REPORT-04-08-031-18W4**

| <b>AFE / PO #</b> | | <b>Report Number</b><br><b>Client Number</b> | SG-001 PAUT-04-08-031-18w4-2016<br>AB-101-10062016-01 |
| <b>Item Inspected</b> | Circ seam, Long seam and Nozzle | <b>Material Type/Thickness</b><br><b>Material Grade</b> | Carbon Steel / 19.73mm<br>SA516-70 |

Carry out Phased Array Ultrasonic (PAUT) examination on the Bullet 04-08-031-18w4, circumferential seam, longitudinal seam welds and drain nozzle, in areas designated by the client (refer Figure 1). The examination shall consist of Phased Array sectorial and Time of Flight Diffraction scan, a 0° UT thickness verification and Manual shear wave (Transverse) scan. The examination shall cover the weld and its associated heat affected zones. Report all relevant indications and analyze in accordance with ASME V Section VIII Div. 1.

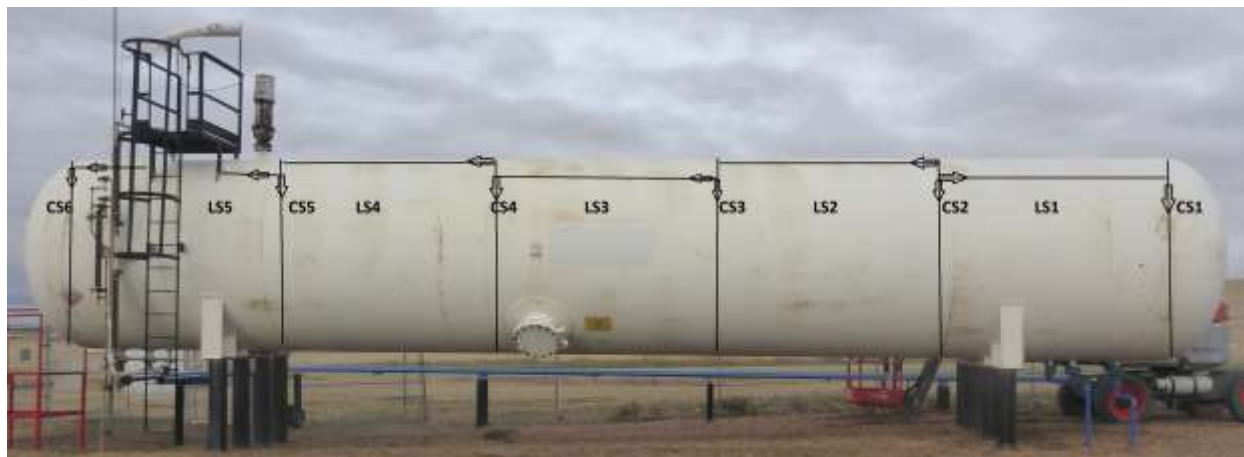
Figure 1: Item inspected by PAUT and direction of scan

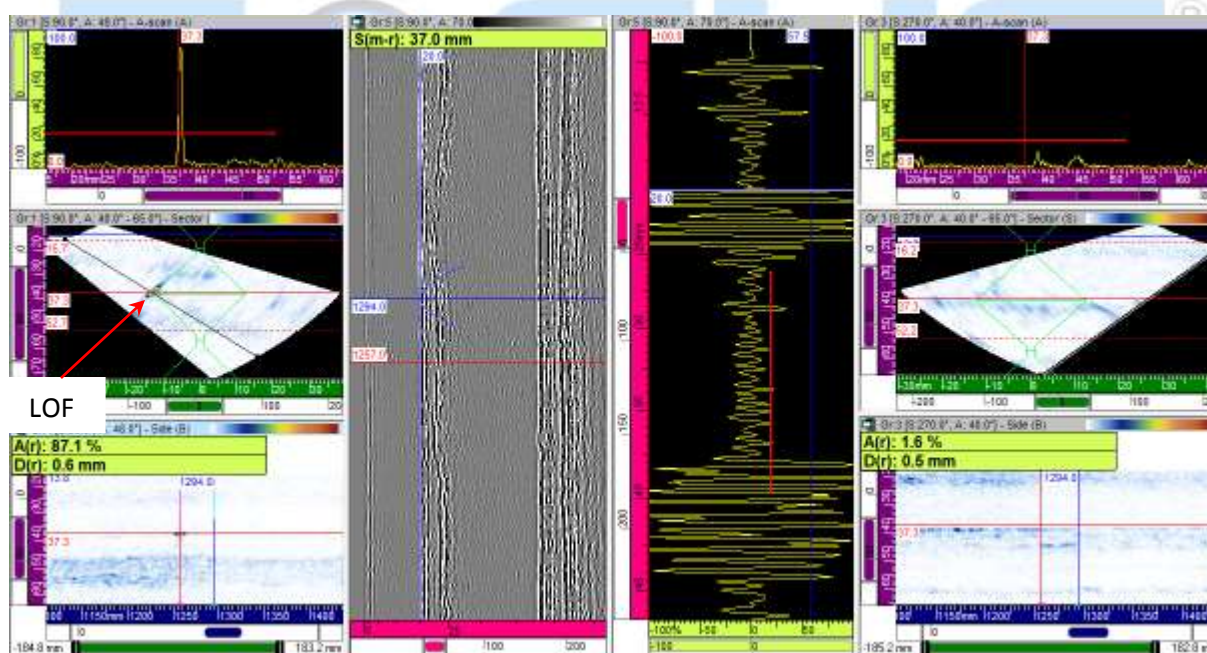
| Report #: | SG-01-PAUT-04-08-031-18w4 | | | | | Job#: | AB-101-10082016-01 | | | | Date: | 06 <sup>th</sup> October 2016 | |
|---|---|---|---|---|---|---|---|---|---|---|---|---|--|
| 2 | CS1-SC1 | 48° | 41.8 | 29.49 | 20.0 | >100% | 1290.0 | -15.0 | 10.0 | 1.5 | 1.1 | LOF | |

Figure 6: CS1-SC1 INDICATION-LOF
