**Canadian Natural Resources Limited
GENERAL PRESSURE VESSEL INFORMATION**

Job 10.112837

| Facility: Chowade Gas Gathering | Location (LSD): b-48-L/94-B-09 |
| Vessel Name Equipment Number: Test Separator | |

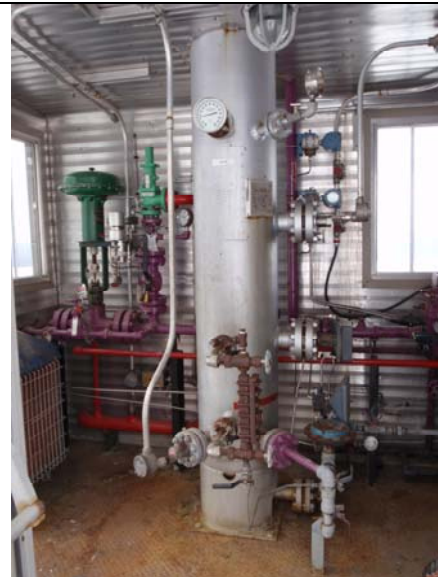
Overview

| External Inspection Items | G | F | P | N/A | Comments |
|--|---|---|---|---|---|
| External Condition Assess paint condition, areas peeling, record any corrosion, damage, etc (record location, size and depth of corrosion or damage) | X | | | | Paint in good overall condition - no corrosion – no damage |
| Saddle/skirt Assess condition of paint, fire protection, and concrete. Look for corrosion, buckling, dents, etc. Look at vessel surface area near supports. Verify no signs of leakage at attachment to vessel and attachment welds are acceptable. Ground wire attached? | X | | | | Skirt in good overall condition: bolted directly to skid floor – no buckling or dents – no corrosion - no sign of leaking – ground wire attached to skid |
| Anchor Bolts Hammer tap to ensure secure. Look for cracking in treads or signs of deformation. | X | | | | Vessel is securely bolted to skid floor – no sign of deformation |

| External Inspection Items | G | F | P | N/A | Comments |
|--|---|---|---|---|---|
| <p>Recommendations or corrective actions : Vessel is Fit for Service or describe corrective actions required) (MIC to review corrective actions with Operations, discuss with Chief Inspector where necessary, and get remedial action implemented) Recommendations: Summary: This vessel is in good condition, visual external and ultrasonic thickness inspection carried out – head metal thickness detected below nominal minus corrosion allowance. Thickness calculations carried out to ensure sufficient metal exists for safe operation. Short term corrosion rate based on greatest thickness loss (head) 0.178mm per year. Retirement Date to “T”min is year 2086. Vessel is fit for service.</p> | | | | | |

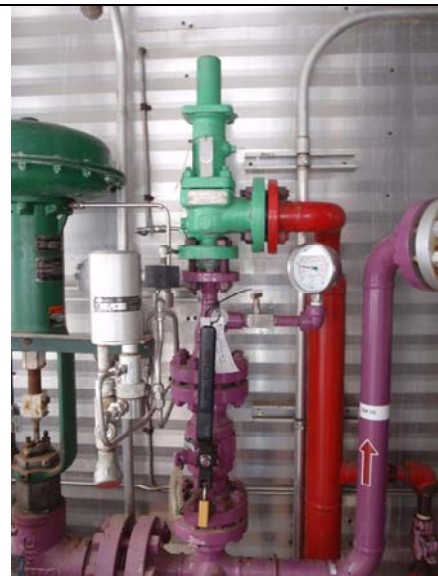
| External Inspection Items | G | F | P | N/A | Comments |
|--|---|---|---|---|---|
| PSV Ensure PSV is set at pressure at or below that of vessel. | X | | | | PSV is set at MAWP – seal intact – block valve in place: locked open – outlet piping does not reduce form PSV discharge orifice size |

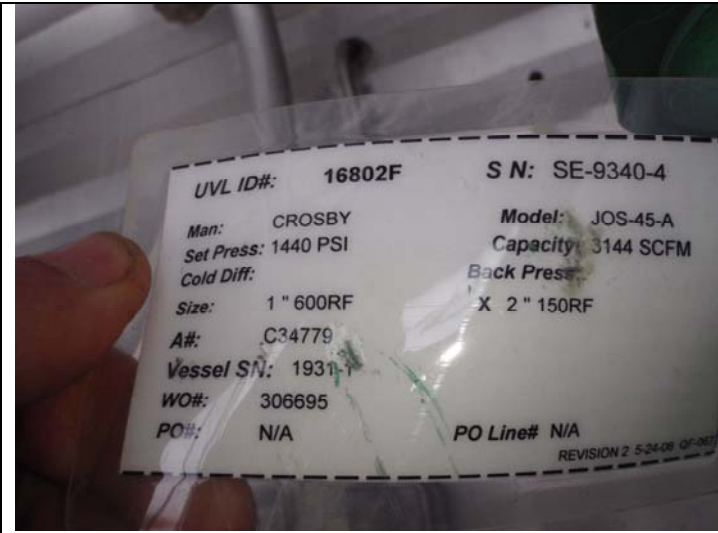
PSV Tag

| PSV Tag # | Manufacture / Model / Serial | Set Pressure (PSI / kPa) | Capacity (scfm) | Size | Block Valve | Location | Service by Date |
|---|---|---|---|---|---|---|---|
| 16802F | Crosby / JOSE 45/A / SE12825-3 | 1440 PSI | 3145 | 1 x 2 | Yes – lock open | Inlet piping | Unified 09/2010 |

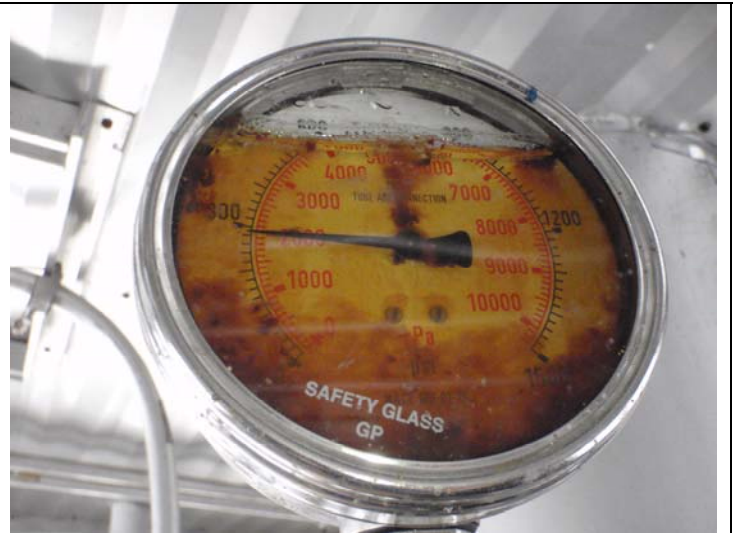
Pressure Gauge

| External Inspection Items | G | F | P | N/A | Comments |
|--|---|---|---|---|---|
| Gauges Ensure gauges are visible, working, no leakage, and suitable for range of MAWP/ Temp. | X | | | | Pressure gauge dirty, clouded fluid – within range for service: 0 – 1500 PSI and -40 – 160 °F |
