**PRESSURE VESSEL
VISUAL INSPECTION
REPORT**

Report #: **91517-CA-37**
 Inspect Date: 04/20/2011
 Page: 1 of 10
 Insp. Co. Job #: 91517

An external visual and UT corrosion survey inspection was performed on A2704234, dehydrator at the 06-29 site to help determine suitability for continued service.

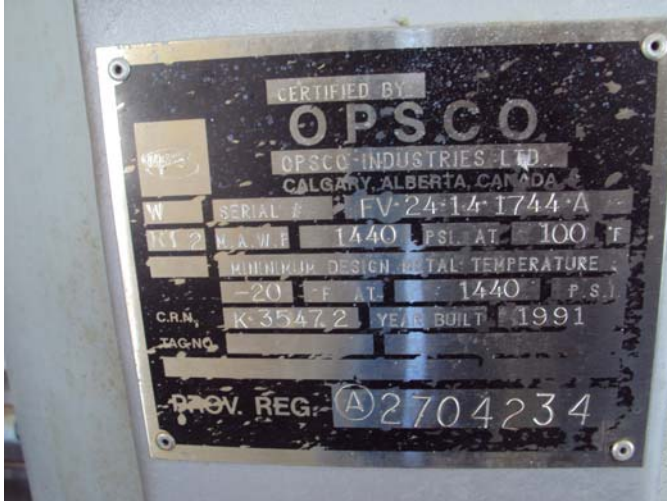
01-DATA PLATE

The data plate was firmly affixed to the shell and was both clean and readable

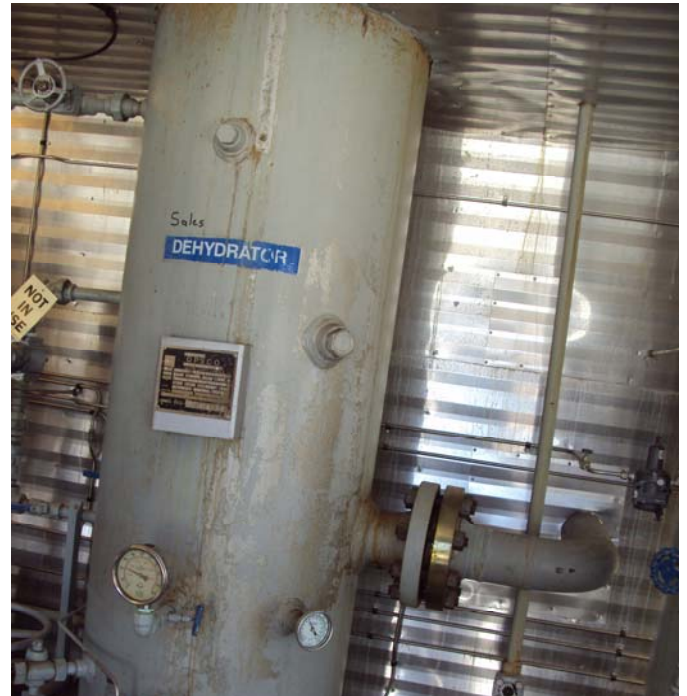
02-VESSEL OVERVIEW INSIDE

The roof to shell interface was previously sealed, but the seal has failed, allowing environmental ingress and staining on the shell

Clean and repaint the vessel as required to ensure continued corrosion protection

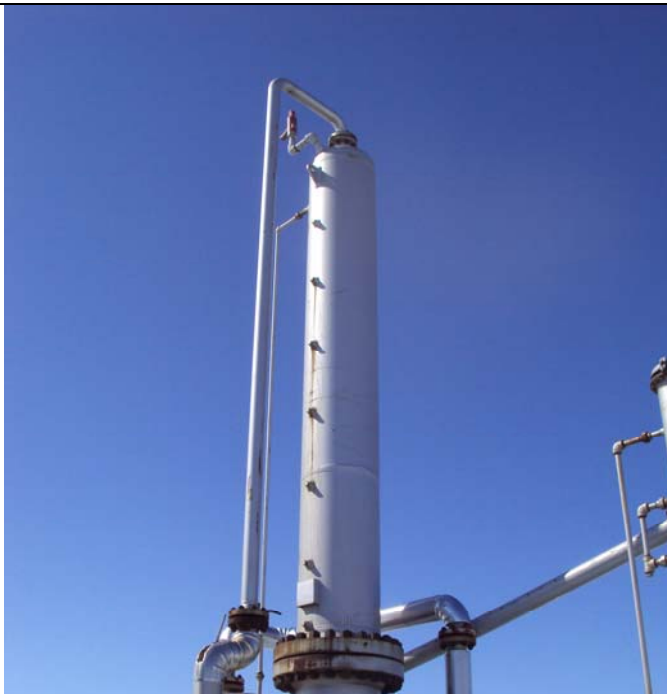
03-VESSEL OVERVIEW OUTSIDE

The heads, shell and nozzles are painted. The paint was found in good condition with no chips and flakes and all surfaces were free of extensive external corrosion and pitting

Vessel is straight and level with minor surface corrosion

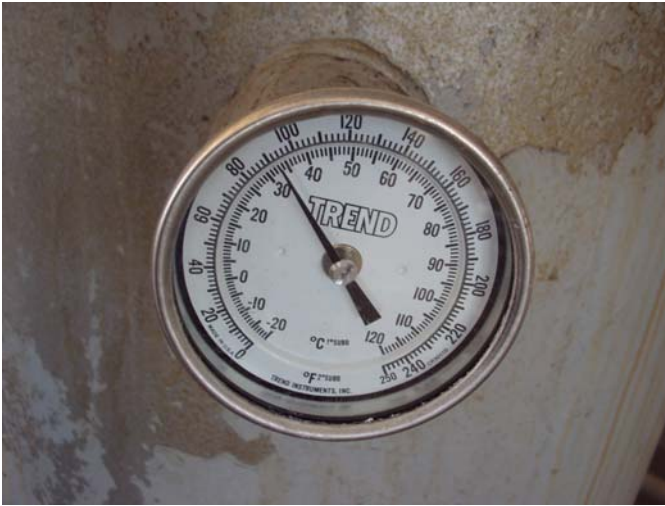
05-TEMP GAUGE

The temperature gauge was clear and readable. The sight glass was clear and readable

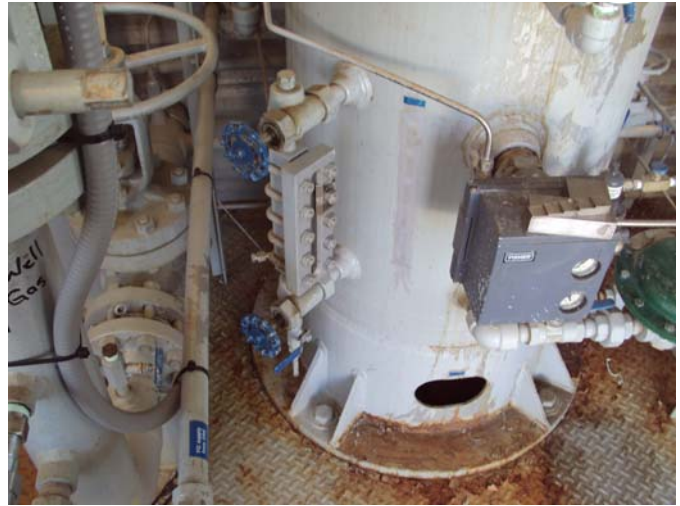
06-SKIRT AND BASE

The vertical vessel has a skirt style support. The support is bolted to the structure. No deformation or deflection was noted. The paint is well adhered and the support was free of corrosion.

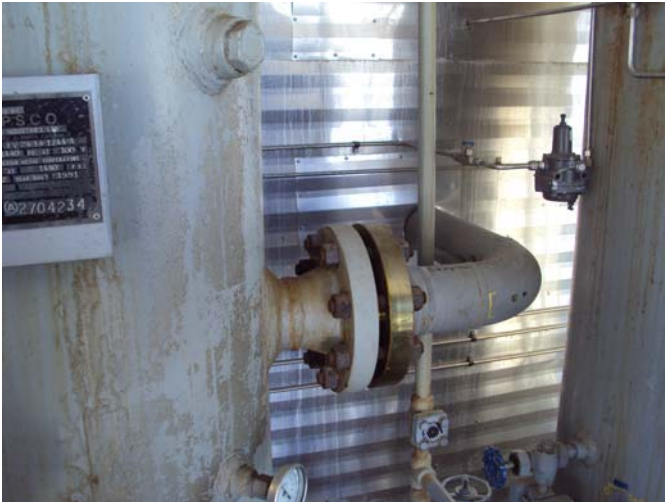
07-FLANGED CONNECTION

All flange bolting was fully engaged but surface corrosion was found on flanges and flange bolting.
