**Canadian Natural Resources Limited
GENERAL PRESSURE VESSEL INFORMATION**

District: Swan hills , AB	Skid No. Dehy 2
Facility: Waskahigan Gas Gathering	Location (LSD): 06-14-63-24W5M
Vessel Name Equipment Number: Glycol contactor	
Orientation: Vertical	
Status: In service	Regulatory Inspection

PRESSURE VESSEL NAMEPLATE DATA

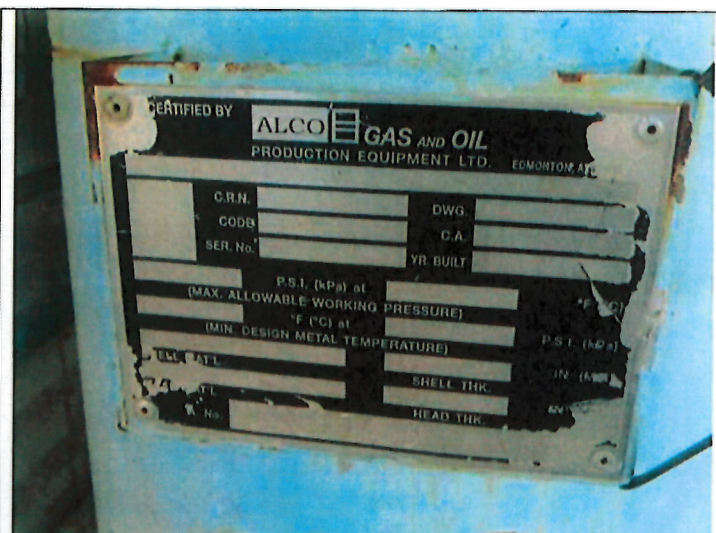
Data Plate

"A" or "G" or "S" (Sask.) or BC Registration Number. A0416743		CRN Number: F-9578,231	
Vessel serial number: 97C5832 09B		Size: 20 in x 29 ft	
Shell thickness: 0.875 in		Shell material: SA 516 70N	
Head thickness: 0.819 in		Head material: SA 516 70N	
Tube wall thickness:		Tube material:	
Tube diameter:		Tube length:	
Channel thickness:		Channel material:	
Design pressure	Shell: 1440 PSI	Operating pressure	Shell:
	Tubes:		Tubes:
Design Temp.	Shell: 130 Deg F	Operating temperature	Shell:
	Tubes:		Tubes:
X-ray: RT-2		Heat treatment: Yes	
Code parameters: ASME VIII, Div 1		Coated: Nil	
Manufacturer: Alco Gas & Oil		Year built: 1997	
Corrosion allowance: 1.6mm		Manway: No

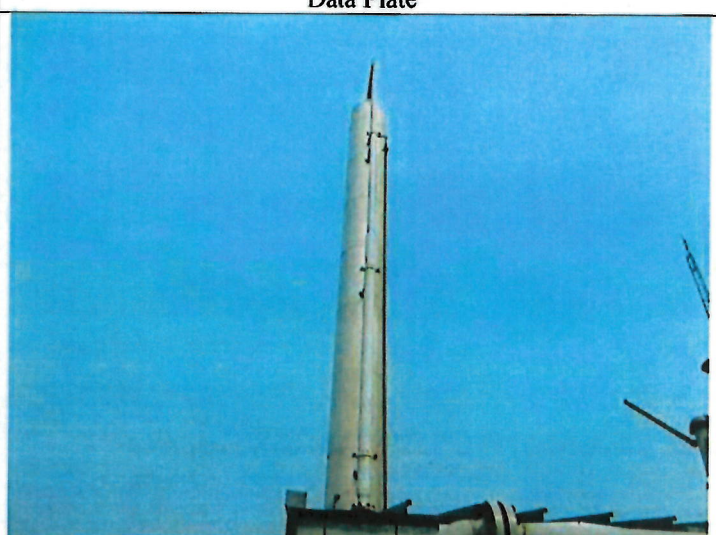
External Overview

External Inspection Items	G	F	P	N/A	Comments
Insulation Verify sealed around manways, nozzles, no damage present, and there is no egress of moisture.	X				The top half of the vessel is insulated - no open or torn sections.
External Condition Assess paint condition, areas peeling, record any corrosion, damage, etc (record location, size and depth of corrosion or damage)		X			The bottom half of the vessel Paint is in fair condition with minor chips in the paint- No corrosion or exposed metal.
Leakage Record any leakage at flanges, threaded joints, weep holes on repads, etc.	X				No leaks present.
Saddle/Skirt Assess condition of paint, fire protection, concrete. Look for corrosion, buckling, dents, etc. Look at vessel surface area near supports. Verify no signs of leakage at attachment to vessel and attachment welds are acceptable. Ground wire attached?	X				Skirt is firmly bolted to skid deck – no buckling or dents present. Paint is in good condition – no corrosion – no leaks. Skid package is grounded.

Anchor Bolts Hammer tap to ensure secure. Look for cracking in treads or signs of deformation.	X				Skirt is firmly bolted to skid deck.
Concrete foundation Check for cracks, spalling, etc.				X	
Ladder / Platform Describe general condition, ensure support is secure to vessel, describe any hazards.				X	
Nozzle Assess paint, look for leakage, and ensure stud threads are fully engaged. Record any damage, deflection, etc. Are nozzles gusseted?	X				All studs fully engaged to nuts – no short bolts. No distortion – no leaks. No gussets present.
Gauges Ensure gauges are visible, working, no leakage, and suitable for range of MAWP/ Temp.	X				Pressure gauge (0-1500 PSI) Suitable for MAWP of Vessel Temperature Gauge (0-250 °F) Suitable for Range Gauges are clear and visible.
External Piping Ensure pipe is well supported. All clamps, supports, shoes, etc. in place. Look for evidence of structural overload, deflection, etc. Paint condition, external corrosion?	X				Well supported, no deflection, all clamps in place. Paint is in good condition – no corrosion.

Valving Ensure no leaks are visible. Valves are properly supported and chained if necessary.	X				Valves are properly supported, no leaks.
PSV Ensure PSV is set at pressure at or below that of vessel. Discharge piping is same size as inlet to valve and is properly supported and routed. Ensure no block valves between PSV and vessel or if there are they are locked open.	X				Located on mid shell – set at mawp of vessel. Seal is intact / no block valve / discharges to closed header.
NDE methods Was UT/ MPI done on vessel (MI coordinator to review results)	X				Ultrasonic corrosion survey carried out – pipe metal thickness detected below nominal minus corrosion allowance. Thickness calculations carried out: UT point 4430(3" elbow) – nominal thickness is 5.5mm / min thickness is 4.7mm / T min thickness is 3.1mm
Recommendations or corrective actions: (Vessel is Fit for Service or describe corrective actions required) (MIC to review corrective actions with Operations, discuss with Chief Inspector where necessary, and get remedial action implemented) Recommendations: No recommendations at this time. Summary: Vessel is in overall good condition, visual external inspection and ultrasonic corrosion survey performed - pipe metal thickness detected below nominal minus corrosion allowance. Thickness calculations carried out to ensure sufficient metal exists for safe operation. Corrosion rate based on greatest thickness loss – no corrosion rate to assess. Vessel is fit for service.

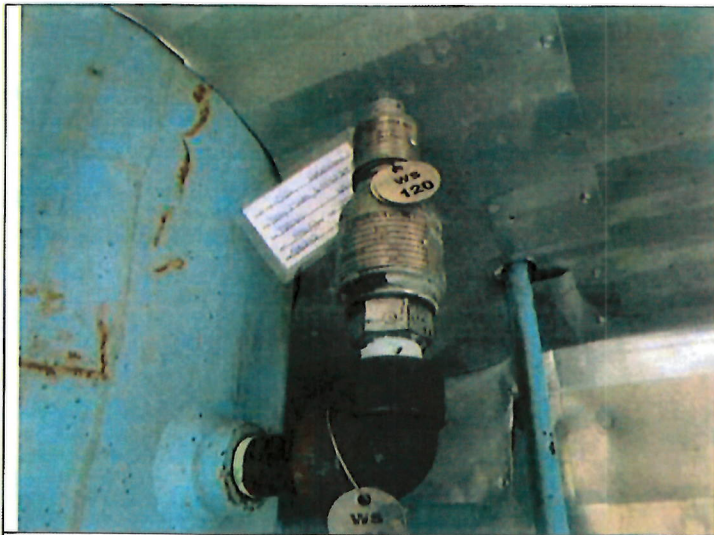
PSV Overview

PSV Tag	Manufacture / Model / Serial	Set Pressure (PSI / Kpa)	Capacity (scfm / usgpm)	Size	Block Valve	Location	Service by / Date
G36242	Mercer // 814421117R // 738065	1440 PSI	2925 Scfm	1 X 1	No	Mid Shell	Pentair 06/2014

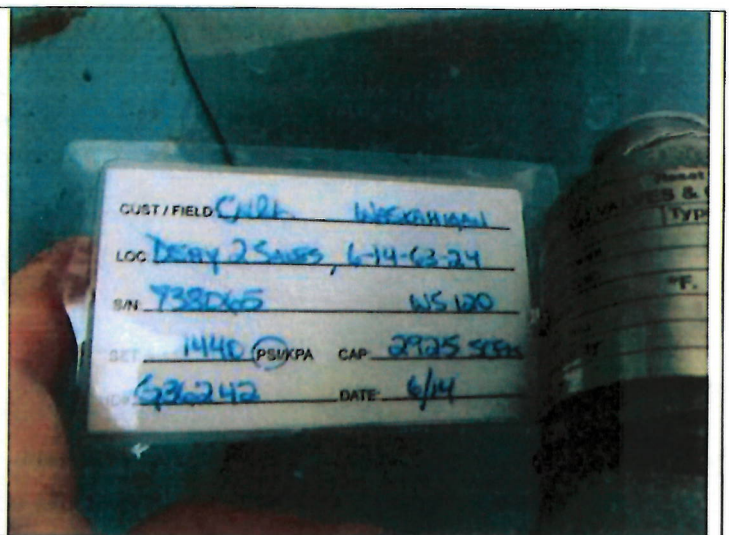
PSV Service Tag

MFG: MERCER
MODEL: 9117D51T1E2
SERIAL: 938065
SET PRES: 9929 kPa
CAPACITY: 2925 scfm
SERVICED BY: PENTAIR
SERVICE DATE: 06/2014
SIZE: 1" x 1"
CODE STAMP: UV/NB
BLOCK VALVE: NO
CRN: OGB841.5C
LOCATION: UPPER SHELL
TAG: G36242

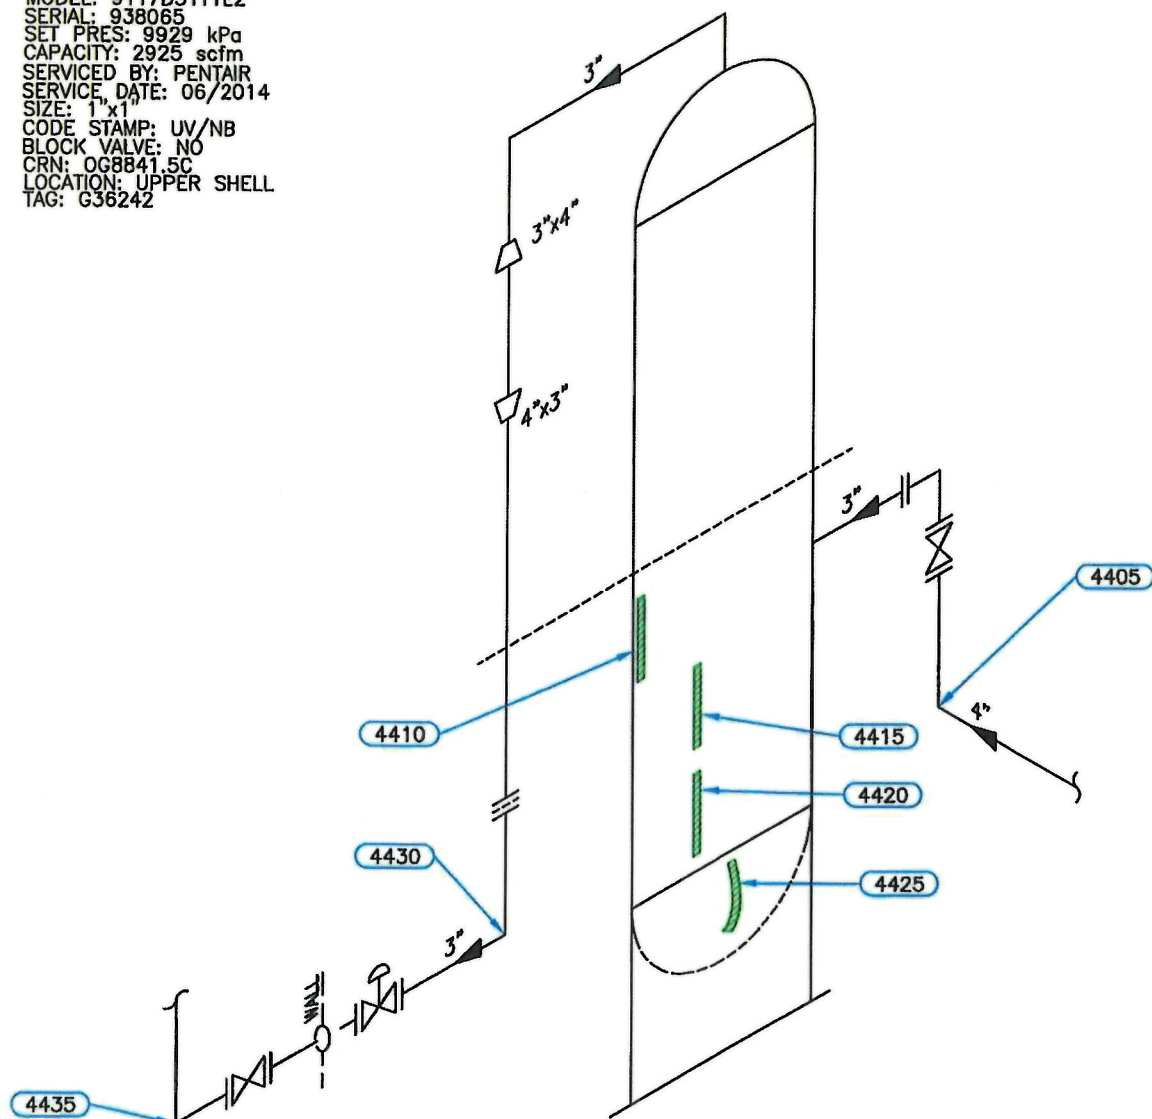
DWG.# 277

Test Point	THICKNESS DATA				Flag	T-Min	C.A.	Nom.	Short Term	Long Term	Ave. mm/py	Retirement Date
4410												
Description: MID SHELL												
2014 7												
Min. Thick.	22.7		20.60		1.6		22.20					
Average:	22.8							0		0		
Analysis:												
4415												
Description: LOWER SHELL												
2014 7												
Min. Thick.	22.8		20.60		1.6		22.20					
Average:	22.9							0		0		
Analysis:												
4420												
Description: LOWER SHELL												
2014 7												
Min. Thick.	22.5		20.60		1.6		22.20					
Average:	22.6							0		0		
Analysis:												
4425												
Description: BOTTOM HEAD												
2014 7												
Min. Thick.	21.5		19.20		1.6		20.80					
Average:	22.7							0		0		
Analysis: 2014/07 MIN SCAN @ SKIRT WELD.

Test Point	THICKNESS DATA				Flag	T-Min	C.A.	Nom.	Short Term	Long Term	Ave. mm/pt	Retirement Date
4405												
Description: 4" 90° ELBOW												
2014 7												
Min. Thick.	7.8				7.53		1.1	8.60				
Average:	8.3								0	0		
Analysis:												
4430												
Description: 3" 90° ELBOW												
2014 7												
Min. Thick.	4.7				4.81	3.1	.7	5.50				
Average:	5.2								0	0		
Analysis: RETIREMENT DATE: 2048												
4435												
Description: 3" 90° ELBOW												
2014 7												
Min. Thick.	8				6.65		1	7.60				
Average:	8.3								0	0		
Analysis:
