**Canadian Natural Resources Limited
GENERAL PRESSURE VESSEL INFORMATION**

Job # 05.002999

District: Fort St. John BC.	Skid No.
Facility: Milligan Main	Location (LSD): b-63-G/94-H-02W6M
Vessel Name Equipment Number: Glycol Contactor	
Orientation: Vertical	
Status: Out of Service	Repair / Alteration Inspection

CNRL Procedure 4: Installation of Nozzles (PWHT Vessel)

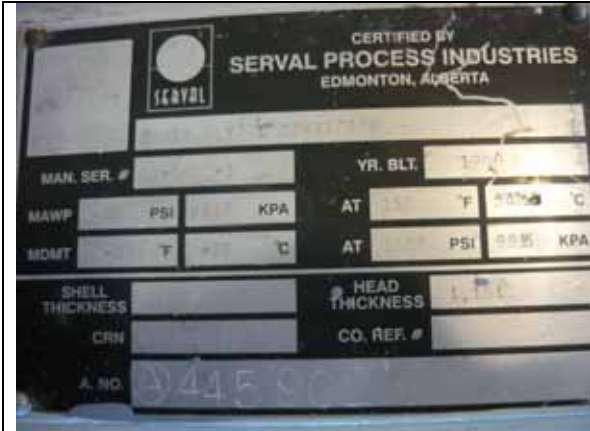
vessel data plate

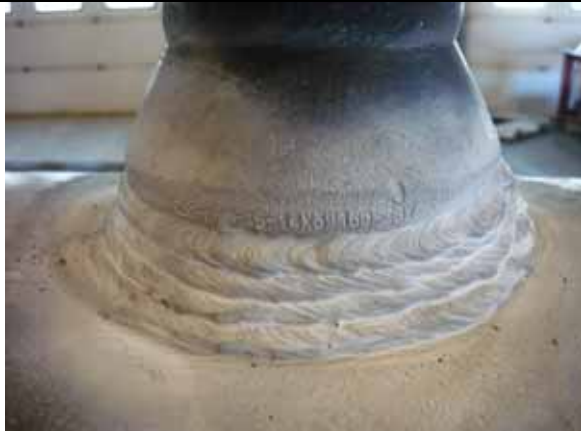
nozzle attachment

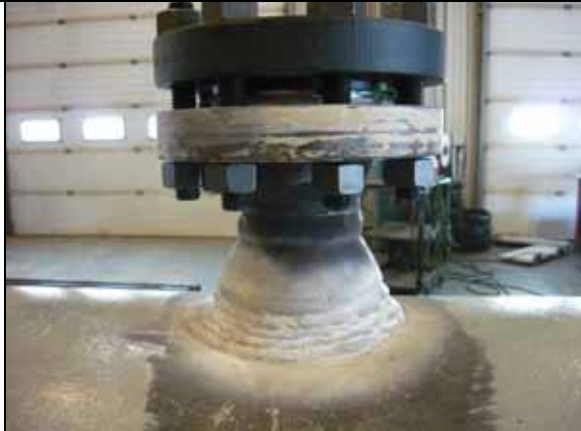
nozzle overview

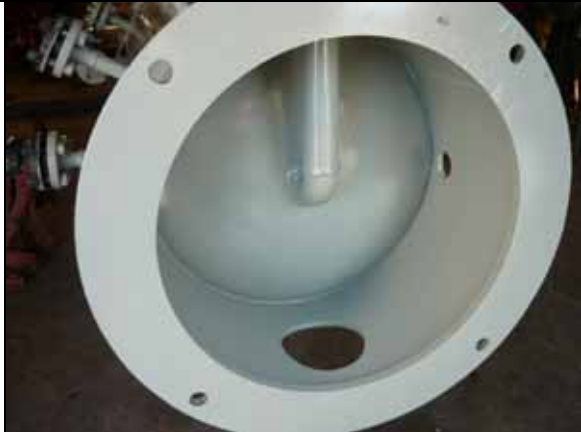
vessel bottom head

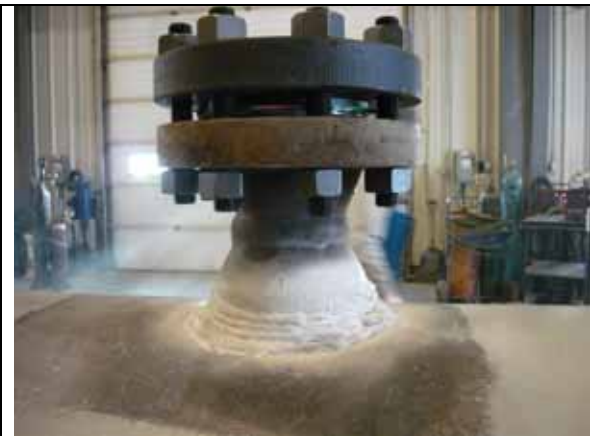
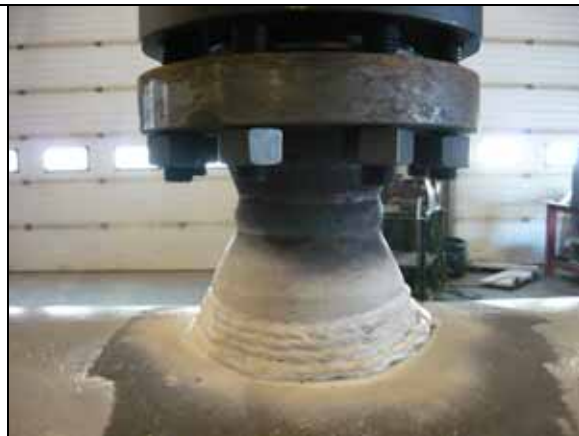
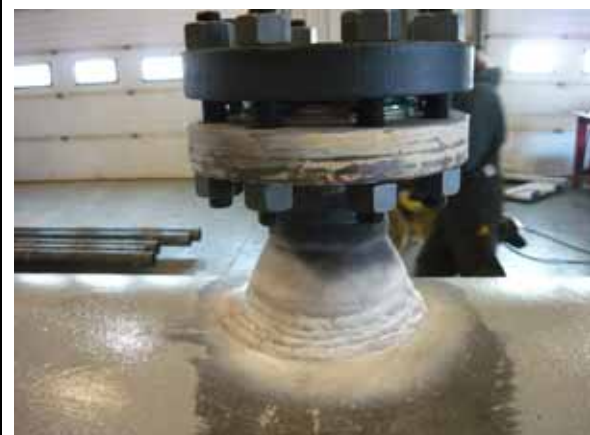
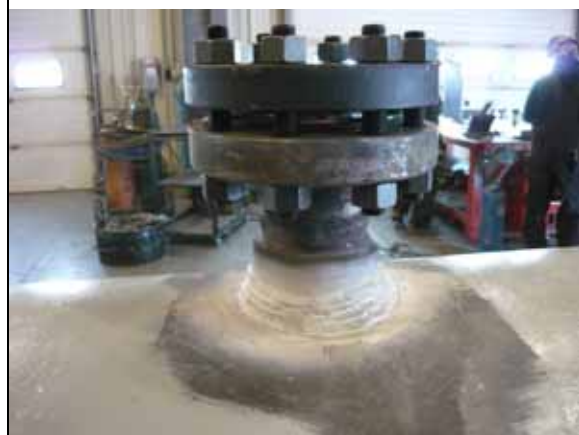
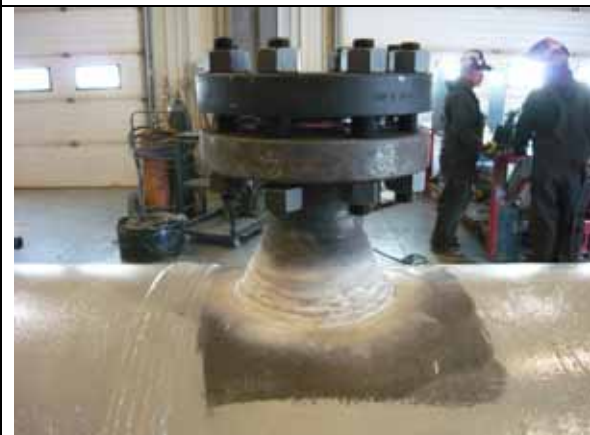
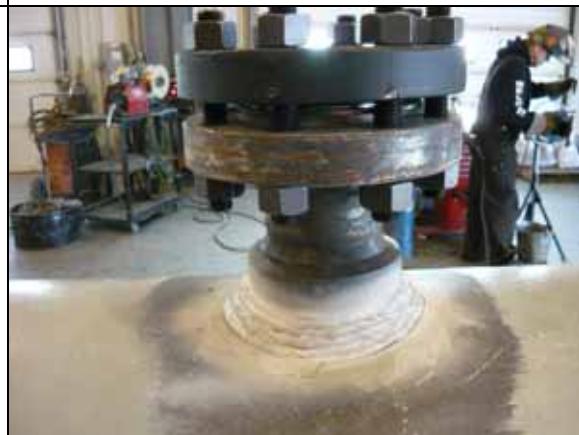
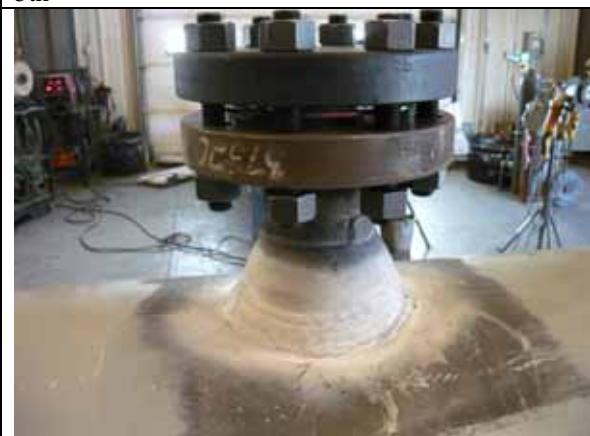
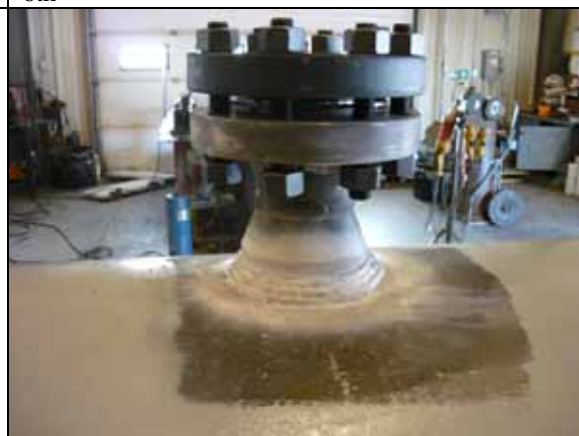
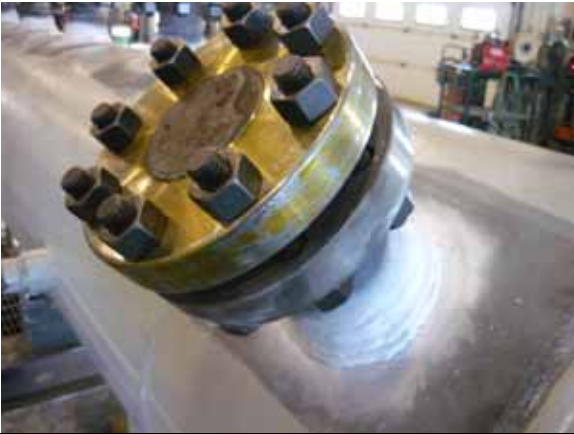
top replaced nozzle 1st.

2nd

3rd

4th

5th

6th

7th

8th

9th

Concrete foundation Check for cracks, spalling, etc.				X	
Ladder / Platform Describe general condition, ensure support is secure to vessel, describe any hazards.				X	
Nozzle Assess paint, look for leakage, and ensure stud threads are fully engaged. Record any damage, deflection, etc. Are nozzles gusseted?				X	
Gauges Ensure gauges are visible, working, no leakage, and suitable for range of MAWP/ Temp.				X	
External Piping Ensure pipe is well supported. All clamps, supports, shoes, etc. in place. Look for evidence of structural overload, deflection, etc. Paint condition, external corrosion?				X	
Valving Ensure no leaks are visible. Valves are properly supported and chained if necessary.				X	
PSV Ensure PSV is set at pressure at or below that of vessel.				X	
NDE methods Was UT/ MPI done on vessel (MI coordinator to review results)				X	
Repairs Required:	X				<ol style="list-style-type: none"> 1. Install 9 new nozzles – 3 inch diameter – between trays for cleaning on line. 2.

Procedure 4: Installation of Nozzles			
Section	Comments	Sign Off	Date
Scope	Reviewed.	D. Wiedman	25 Mar 2009
Procedure	Procedure reviewed with repair group.	D. Wiedman	25 Mar 2009
Cut Out			
Step 1	Shell was radiographed and trays identified – nozzle insertion areas marked out.	D. Wiedman	25 Mar 2009
Step 2	Ultrasonic thickness inspection carried out to ensure metal is sound before nozzle openings cut out.	D. Wiedman	25 Mar 2009
Step 3	No laminations detected.	D. Wiedman	25 Mar 2009
Step 4	Lay out checked and approved by Authorized inspector.	D. Wiedman	25 Mar 2009
Step 5	Vessel steamed out for 12 hours and then vessel was sent for bake out – 650 deg for 1 hour.	D. Wiedman	25 Mar 2009
Step 6	Nozzle openings cut into shell of vessel at all tray areas.	D. Wiedman	25 Mar 2009
Weld Preparation			
Step 7	Cut out areas on shell are cleaned up and nozzles are prepped for stub on installation.	D. Wiedman	25 Mar 2009

Step 8	Areas surrounding weld prep is cleaned for installation.	D. Wiedman	25 Mar 2009
Step 9	MT inspection carried out on prep areas. No defects detected.	Paladin Inspections	26 Mar 2009
Hydrogen Bake Out and Sulphur Removal			
Step 10	Bake out completed using induction coils – 650 deg F for 1 hour.	D. Wiedman	26 Mar 2009
Step 11	Bake out completed using induction coils – 650 deg F for 1 hour.	D. Wiedman	26 Mar 2009
Step 12	Bake out completed using induction coils – 650 deg F for 1 hour.	D. Wiedman	26 Mar 2009

Preheat and Welding			
Post Weld Heat Treated Equipment			
Step 13	Pre heat maintained at 350 deg F.	D. Wiedman	27 Mar 2009
Step 14	Interpass temp not exceeded.	D. Wiedman	27 Mar 2009
Step 15	New welding rods used – seal broken in presence of authorized inspector.	D. Wiedman	27 Mar 2009
Step 16	PWHT carried out 1150 deg F for 1 hour.	D. Wiedman	27 Mar 2009
Post Welding NDE			
Step 17	MT inspection carried out 12 hours after PWHT cool down period.	Paladin Inspections	27 Mar 2009
Step 18	Hydro Test carried out at 1.5 x MAWP = 2152.5 PSI. for 1 hour / Passed.	Gerry Avery	27 Mar 2009
Documentation			
Step 19	Bring It Welding responsibility.		28 Mar 2009
Step 20	Bring It Welding responsibility.		28 Mar 2009

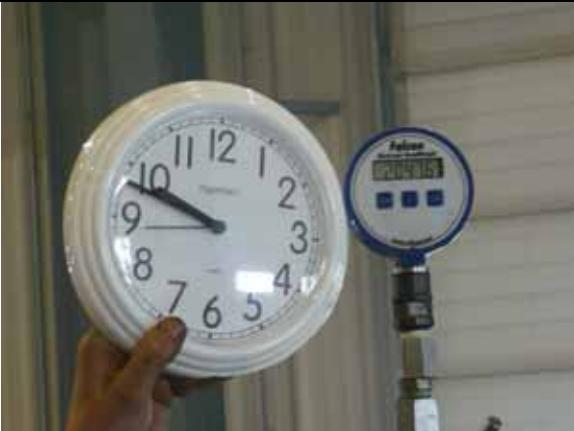
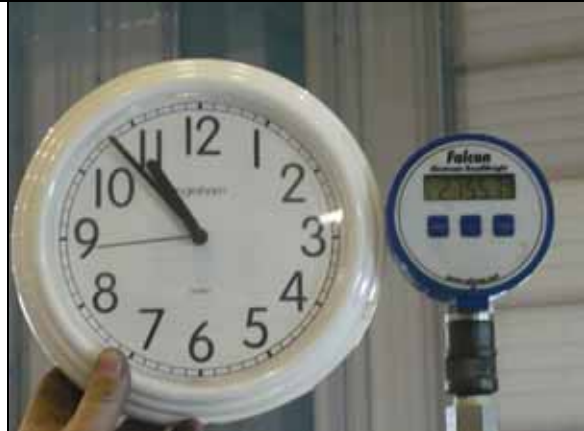
Notes: Vessel filled with water start at 8:30 and completed at 9:15 AM.
 Hydro started at 9:45, pressure set at 1027.1 PSI and held for 10 minutes.
 At 10:18 am pressure increased to 2093.8 PSI and held.
 10:54 pressure at 2157.3 PSI.
 10:56 drop pressure to 1041 PSI.
 11:00 pressure drop to 0 PSI and test completed.

pressure test

pressure test completion time

<p>Recommendations or corrective actions : Vessel is Fit for Service or describe corrective actions required) (MIC to review corrective actions with Operations, discuss with Chief Inspector where necessary, and get remedial action implemented) Recommendations: See repairs required. Summary: Vessel is in overall good condition, visual inspection performed during pressure test of vessel after repairs. No leaks were detected. Vessel is fit for service.</p>
