ULTRASONIC REPORT

CUSTOMER / CLIENT:	Cnrl	CLIENT JOB NO.:		REPORT NO. :	240318-1 ucc
CONTRACTOR:	Same As above	CLIENT CODING:		DATE:	Mar 18 2024
PROJECT:	Ut on Flare Knockout C45029			TECHNICIAN:	Curtis Coleman
LOCATION / LSD:	15-20-85-17W6	CLIENT APPROVER:	Kris Viswabharathi	ASSISTANT:

A zero degree ultrasonic inspection was performed on Flare knockout Drum C45029 located at 15-20-85-17W6 by client request. Areas of inspection include vessel heads, shell and associated piping. See page two for readings, pictures, and areas of concern.

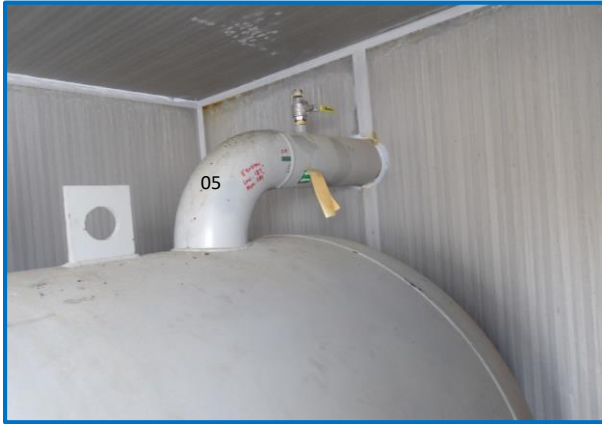
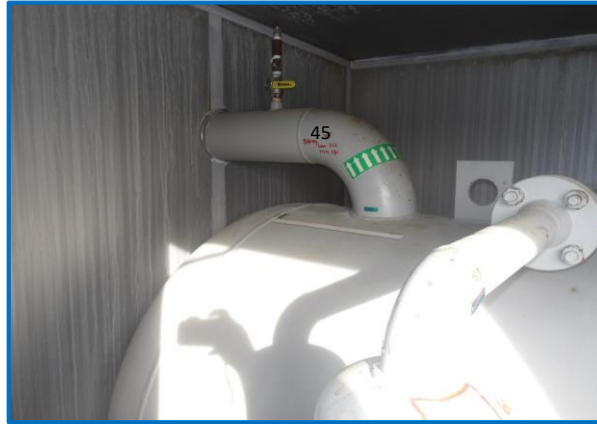
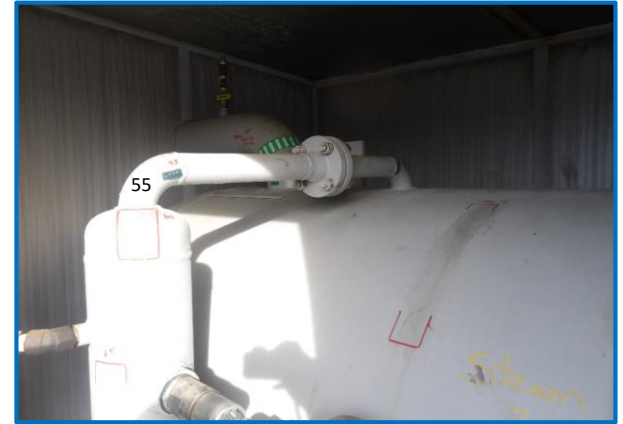
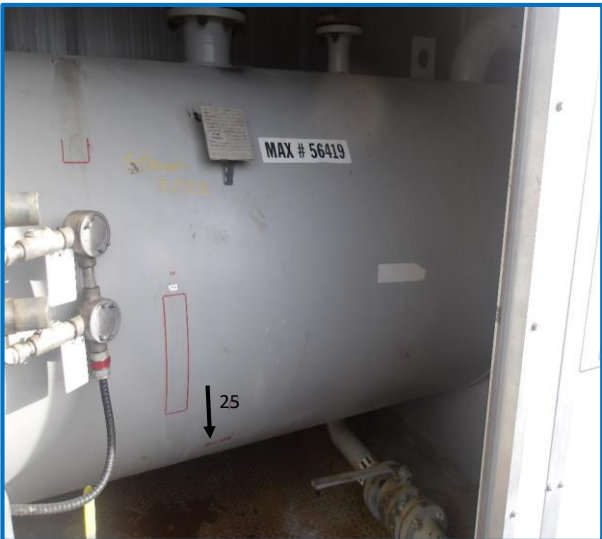
location	size	nominal	ref	low	avg	%wall loss
5	6.625"	.280"	0.207	0.187	0.206	33
25	48"	.375"	0.392	0.298	0.387	20
45	6.625"	.280"	0.307	0.222	0.306	20.7
55	2.375"	.218"	0.168	0.122	0.152	44
