**Canadian Natural Resources Limited
GENERAL PRESSURE VESSEL INFORMATION**

District: Grande Prairie, AB		Skid No.				
Facility: Pass Creek Field		Location (LSD): 05-05-61-19 W5M				
Vessel Name Equipment Number: Line Heater						
Orientation: Horizontal						
Status: Not in Service			Regulatory Inspection			
PRESSURE VESSEL NAMEPLATE DATA						
"A" or "G" or "S" (Sask.) or BC Registration Number. A 429575			CRN Number: H-9622.12			
Vessel serial number: 1893 H401-5			Size: 55 in x 20 ft			
Shell thickness: 9.5 mm			Shell material: SA 36			
Head thickness: 9.5 mm			Head material: SA 36			
Tube wall thickness:			Tube material:			
Tube diameter:			Tube length:			
Channel thickness:			Channel material:			
Design pressure	Shell: 9308 kPa		Operating pressure	Shell:		
	Tubes:			Tubes:		
Design Temp.	Shell: 93°C		Operating temperature	Shell:		
	Tubes:			Tubes:		
X-ray: RT-1			Heat treatment: HT			
Code parameters: ASME B 31.3			Coated: No			
Manufacturer: Plains Oil Ltd.			Year built: 1996

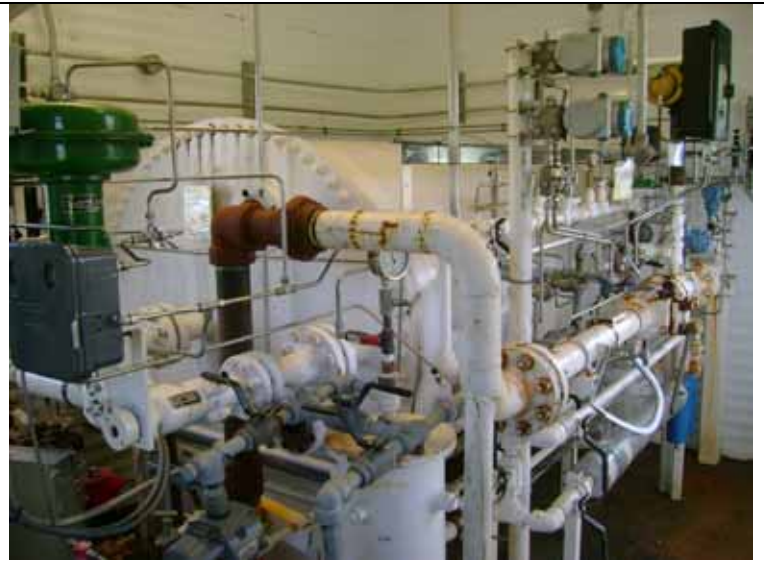
Data Plate

CALGARY, ALBERTA 14031 700-1870	
W	SER. NO. 1893 H-01-9
RT 100%	C.N.N. M9672.12
HT	CAPACITY 5.64 M ³ .31 M ³ COIL
HEATER TYPE LINE HEATER	
SHELL DIM. 6.4 X 1372 X 4572	
PRESS. RAT.	P.S.I. AT
PRE 9308	K.P.A. 93 °C
PRESS. RAT.	P.S.I. AT
POST 9308	K.P.A. 93 °C
TEST PRESS.	P.S.I. MAT'L 88.9 X 7.62
PM 13962	K.P.A. PRE SA 106B
TEST PRESS.	P.S.I. MAT'L 88.9 X 7.62
POST 13962	K.P.A. POST SA 106B
#COILS PRE 6	TREBOX RAT. 748,000 BTU
#COILS POST 8	DRY WEIGHT 4002 KG
YEAR BUILT 1996	CONC. ALLOW. IN 3.2 MM
BODY NO. 429575

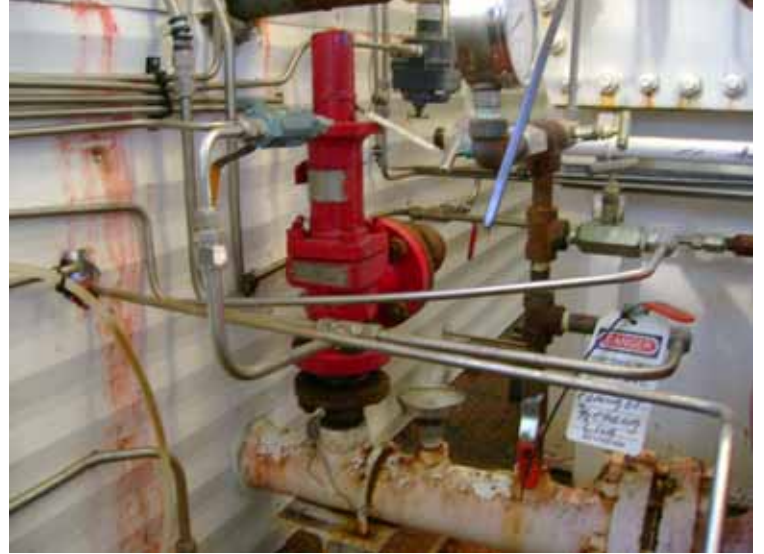
PSV Tag

VALVE ID #: 2124F	
MAKE:	CROSBY
TYPE/MODEL	JOS-45/A
SERIAL NUMBER:	SE-23127-1
SET PRESSURE	1480 PSI
CAPACITY:	5759 SCFM
COLD/DIFF PRESSUR	PSI
INLET SIZE 1 RF	OUTLET SIZE 2 RF
OTHER/CRN	0G0201.2C

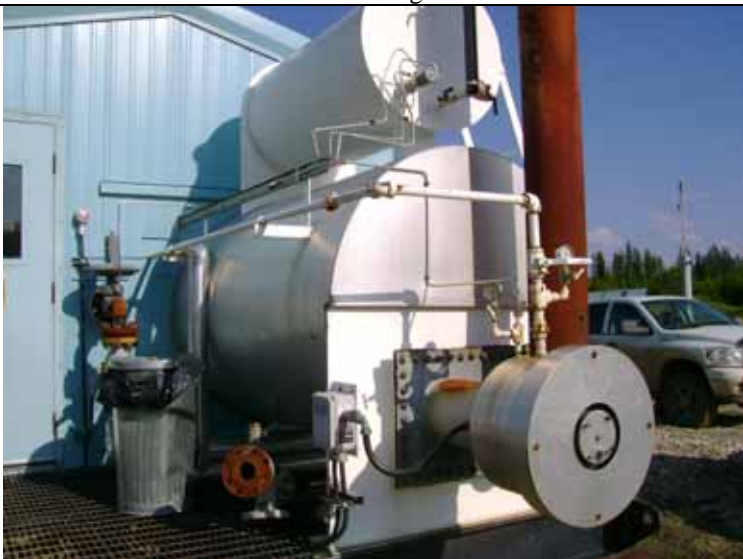
Valving Ensure no leaks are visible. Valves are properly supported and chained if necessary.	X				Well supported – no leaks.
PSV Ensure PSV is set at pressure at or below that of vessel.	X				Located on inlet piping – set above MAWP of 1 st and 2 nd Pass coils. Seal intact No block valve Discharge piping same size as outlet orifice.
NDE methods Was UT/ MPI done on vessel (MI coordinator to review results)	X				Ultrasonic thickness survey carried out on piping – no metal thickness detected below nominal minus corrosion allowance.
<p>Recommendations or corrective actions : Vessel is Fit for Service or describe corrective actions required) (MIC to review corrective actions with Operations, discuss with Chief Inspector where necessary, and get remedial action implemented)</p> <p>Recommendations: 1. Reset PSV to MAWP of coils (1350 PSI) or below to ensure proper protection.</p> <p>Summary: This line heater is in good overall condition, visual external and ultrasonic thickness survey carried out on piping – no metal thickness detected below nominal minus corrosion allowance.</p> <p>Line heater is not fit for service with current PSV set pressure.</p>
