Pressure Equipment Integrity Management System External Visual Inspection Form

Owner: <u>NuVista Energy Ltd</u>	District/Area: <u>W5 Alberta North</u>
Facility: <u>Wapiti</u>	Location (LSD) ♦: <u>04-15-69-10 W6M</u>
A Number ♦: <u>413607</u>	Serial Number ♦: <u>C-9906-A/B</u>
CRN ♦: <u>L3369.213</u>	Vessel Type: <u>Line Heater</u>
Description ♦: <u>Line Heater</u>	Process: <u>Well Line Heater</u>
Tag No: _____	Status ♦: <u>In Service</u>

A#: 413607 Vessel Description: Line Heater Location(LSD): 04-15-69-10 W6M

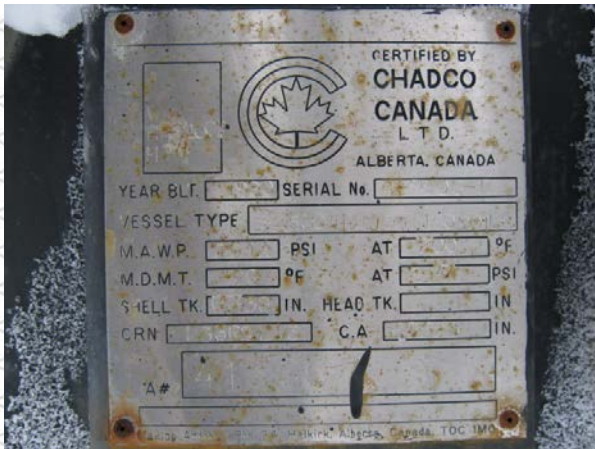
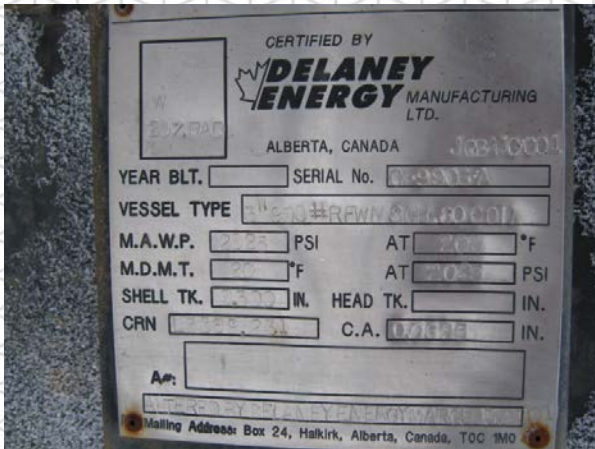
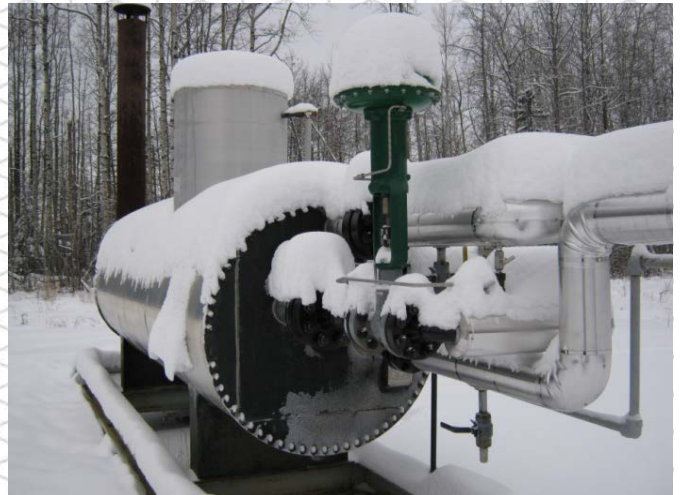
Sketch / Image Area

Ultrasonic thickness survey carried out – piping metal thickness detected below nominal minus 12.5% mill tolerance for corrosion allowance. Nominal thickness on 2 inch sch 160 is 8.7 mm / min thickness is 7.5 mm.
