**EQUIPMENT DEFICIENCY SUMMARY**

District:	Fort St John	Facility	CECIL DV OIL	Location/LSD	11-23-084-18W6
Equipment Name	TEST SEPARATOR			Prov Reg No.:	2683896
Serial No.:	VS6487	Equip No.:		National Board No.:

## PRESSURE EQUIPMENT DATA REPORT

## ULTRASONIC CORROSION SURVEY REPORT

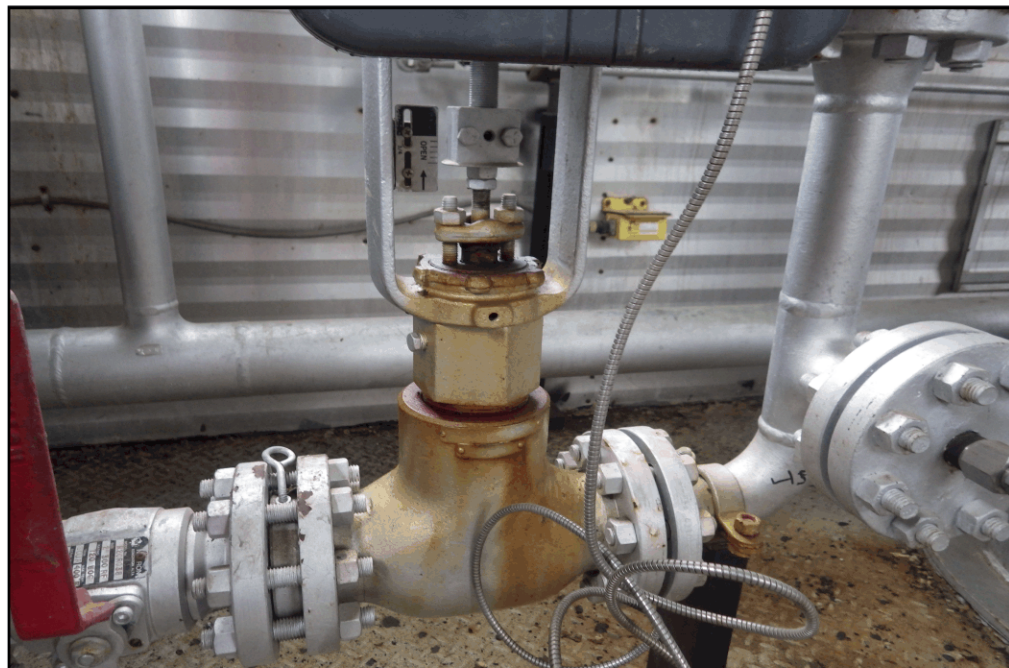
Minor leak was found on Outlet Piping Flange Thrd , details :Weeping from Connection  
 Minor leak was found on Nozzle Bolted , details :Weeping from Connection

LEAKS

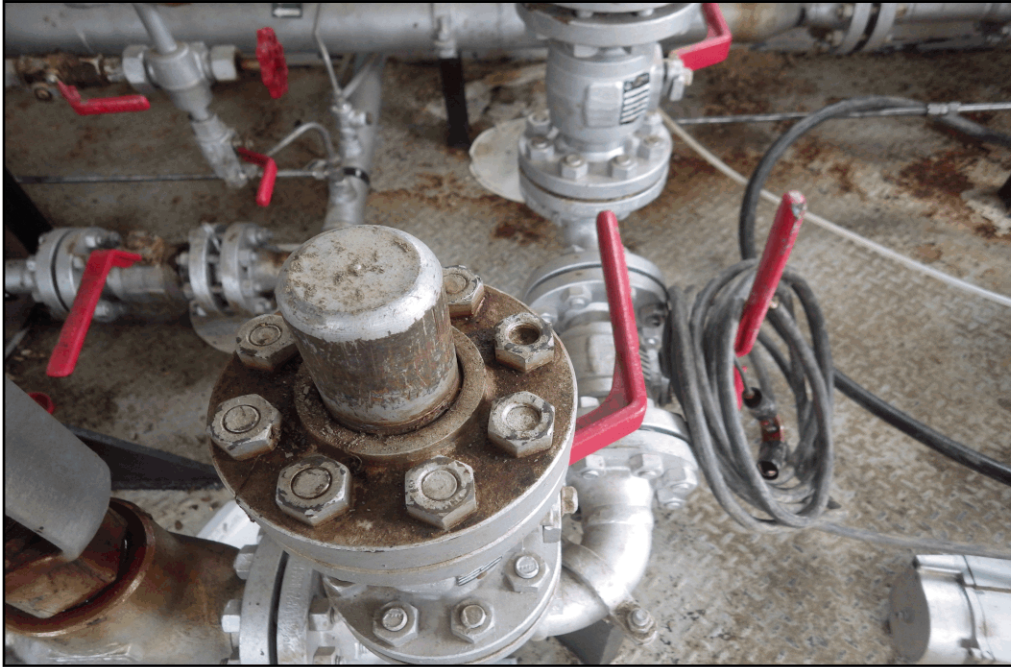
<b>VISUAL EXTERNAL INSPECTION</b>	LATEST VTE DATE USED IN SUMMARY		September 26, 2018		
<b>DEFICIENCY</b>	<b>RECOMMENDATION</b>		<b>QUALITY ACTION</b>		<b>RESULT</b>
Nuts not fully engaged					Concern

Bolting	Thread engagement	Gaskets	Flange Rating	
Manway	NA				Accept
Vessel	NA				Accept
Inlet Piping	Accept	Accept	Accept	Accept	Accept
Outlet Piping	Accept	Nuts not fully engaged	Accept	Accept	Concern
Other Piping	Accept	Accept	Accept	Accept	Accept

SHORTBOLTED CONNECTION ON LIQUID OUTLET FLANGE

SHORT BOLT ON FLANGE

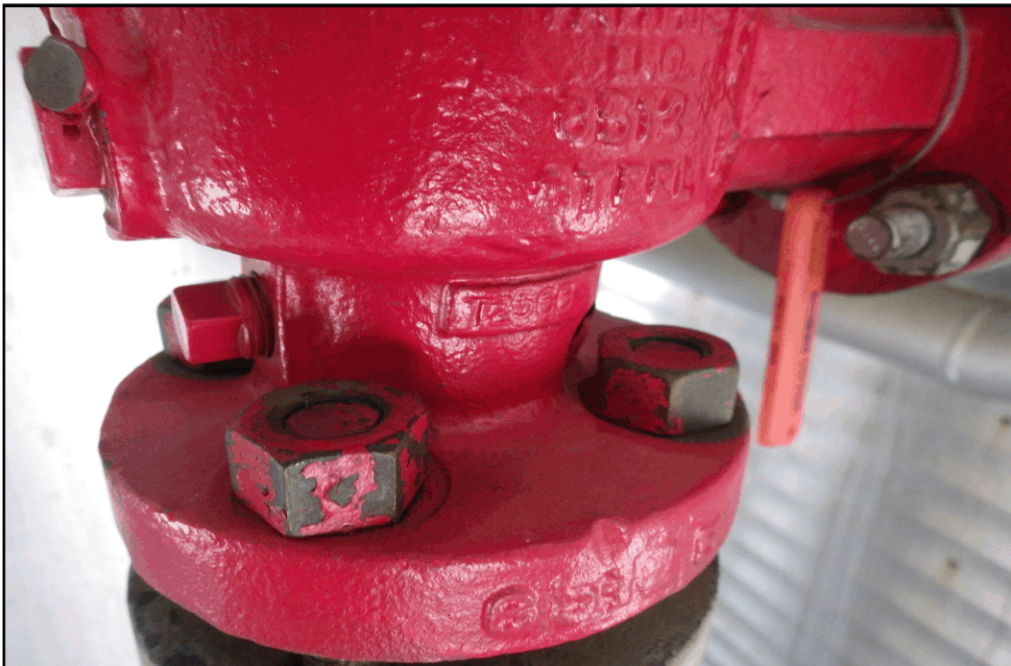
SHORT BOLT ON PSV
